New Indoor Aquatics Facility Feasibility Study

City of Regina

City of Regina Lawson Aquatic Centre

Building Suitability and Existing Condition Assessment
April 25, 2022

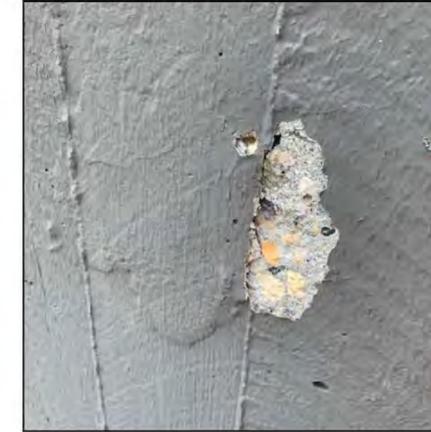
Figure 4.4.2 Spalling, Concrete Buttress

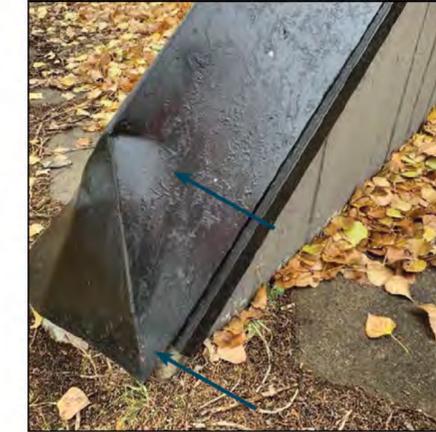
Figure 4.4.3 Corrosion and Damage, Concrete Buttresses, Steel Cap

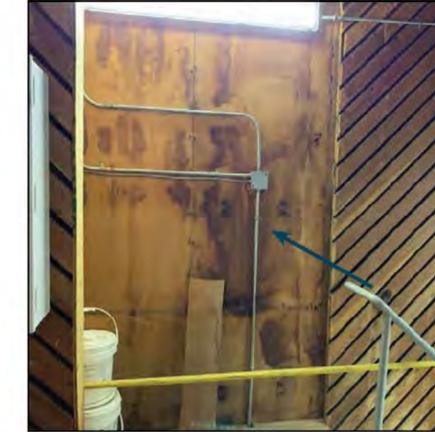
Figure 4.4.4 Water Staining at Interior Finish, West Wall, First Penthouse Level Above Fitness Center

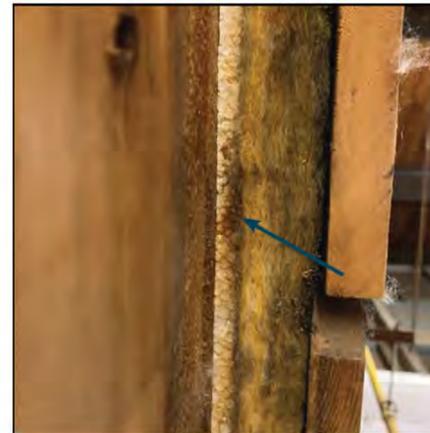
Figure 4.4.5 Water Staining at Interior Finish, West Wall, First Penthouse Level Above Fitness Center 2

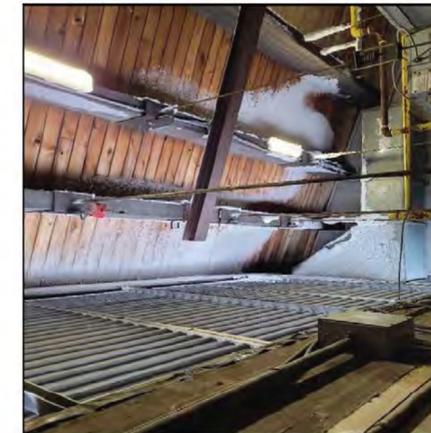
Figure 4.4.6 Frost Accumulating at Ceiling, as Provided by Client

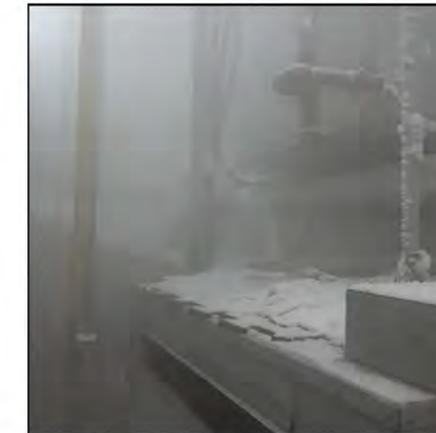
Figure 4.4.7 Frost and Snow Covered Interior, as Provided by Client

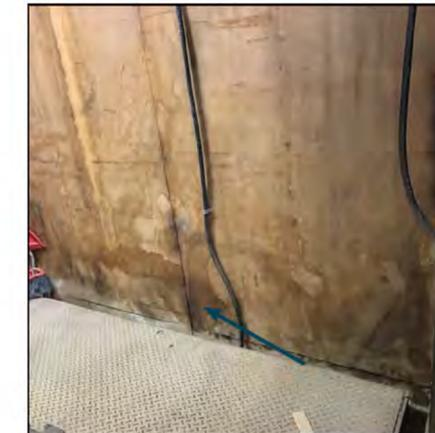
Figure 4.4.8 Water Staining, West Wall, Second Level Penthouse Above Fitness Center

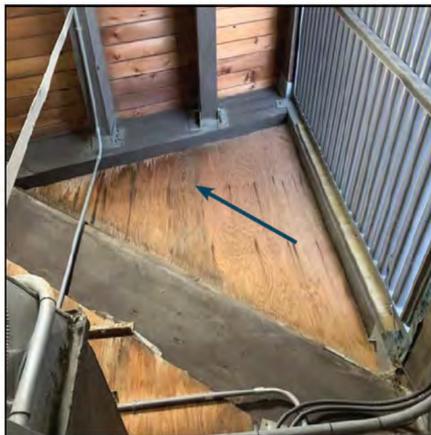
Figure 4.4.9 Water Staining, West Wall, Second Level Penthouse Above Fitness Center

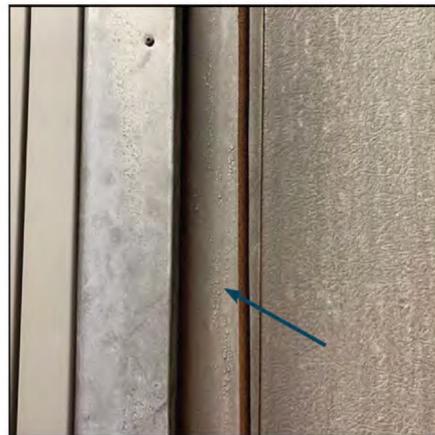
Figure 4.4.10 Condensation Build Up at the Interior Wall Between the Penthouse Levels

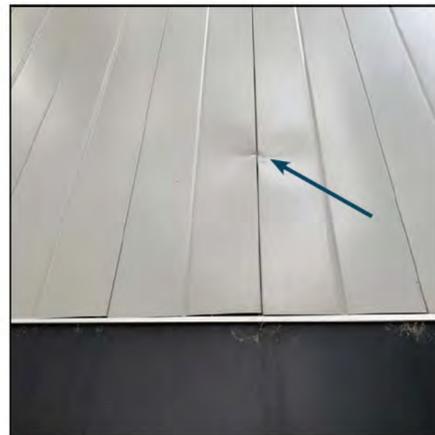
Figure 4.4.12 Damaged Metal Cladding, West Wall

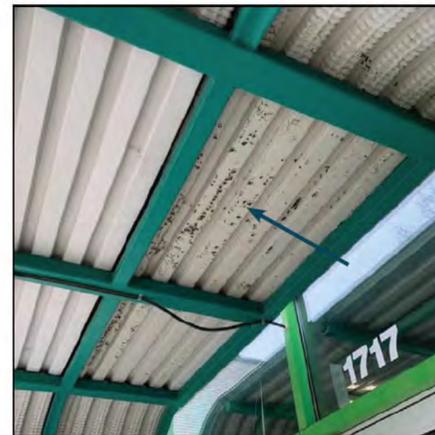
Figure 4.4.17 Peeling Paint and Corrosion, Underside of Canopy, Linking Building

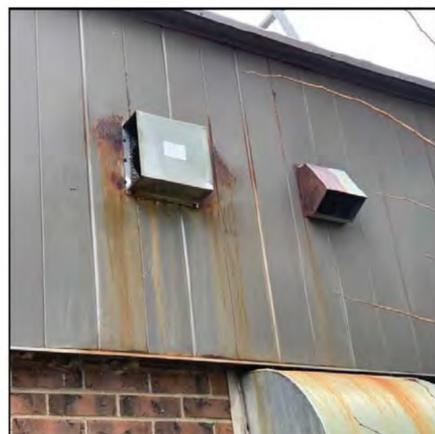
Figure 4.4.14 Corrosion of Metal Cladding, North Elevation

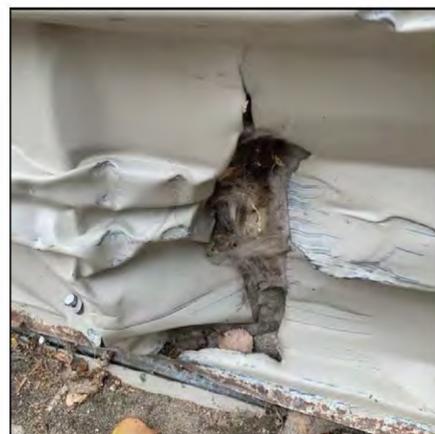
Figure 4.4.15 Batt Insulation Exposed Due to Impact Damage and Corrosion at Base of Wall, East Wall

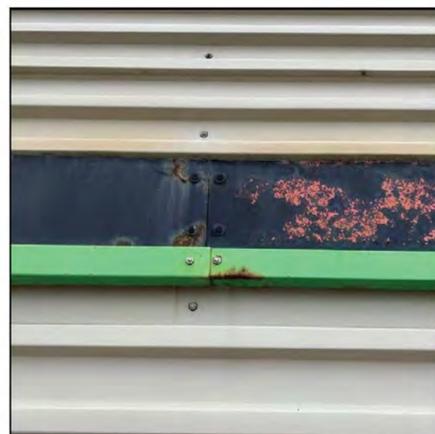
Figure 4.4.16 Corrosion at Steel Band, Fieldhouse

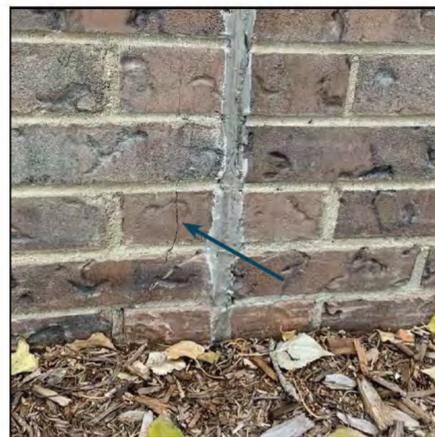
Figure 4.4.27 Cracking at Brick Veneer Near Vertical Control Joint

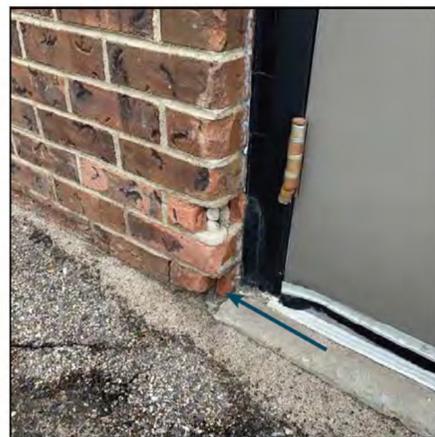
Figure 4.4.28 Impact Damage to Brick Veneer

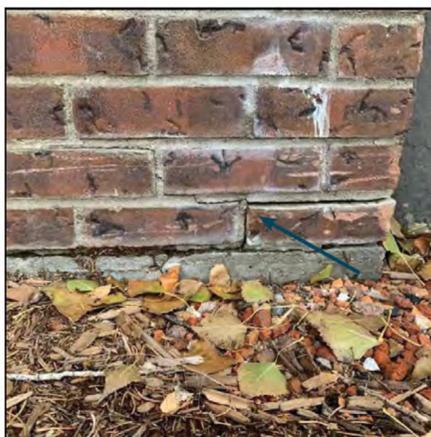
Figure 4.4.29 Deteriorating Mortar Around Bricks

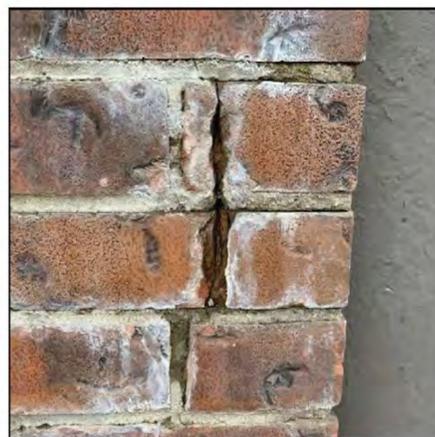
Figure 4.4.30 Large Crack with Wetness and Water Staining, West Elevation

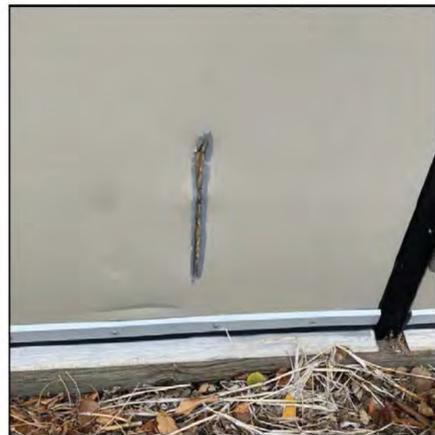
Figure 4.4.42 Damage to Door Exteriors, Fieldhouse

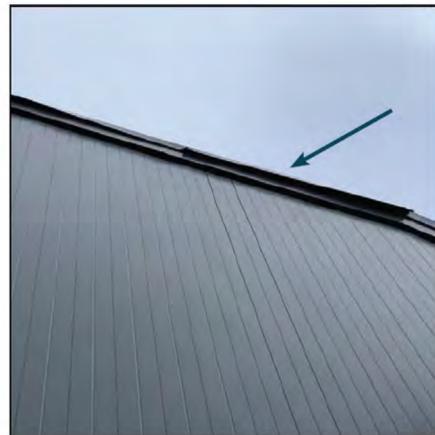
Figure 4.4.44 Loose Cap Flashing, West Elevation

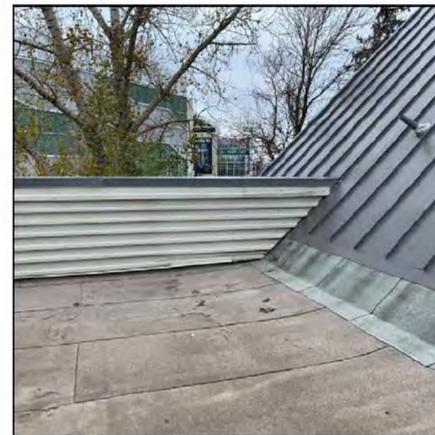
Figure 4.4.49 Wear of Modified Bituminous Membrane, South Roof

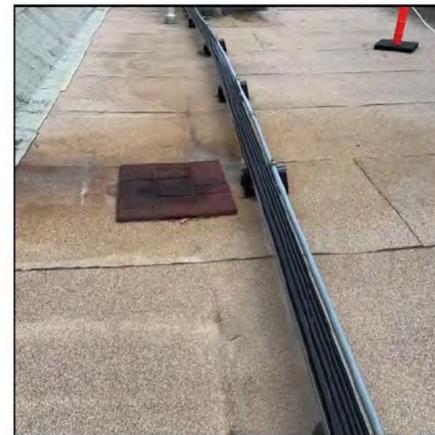
Figure 4.4.50 Staining, South Roof

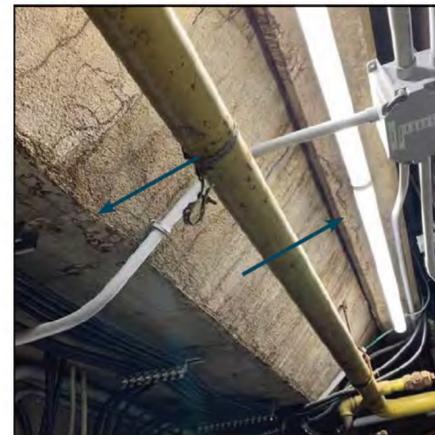
Figure 4.4.51 Signs of Water Leakage Below South Roof

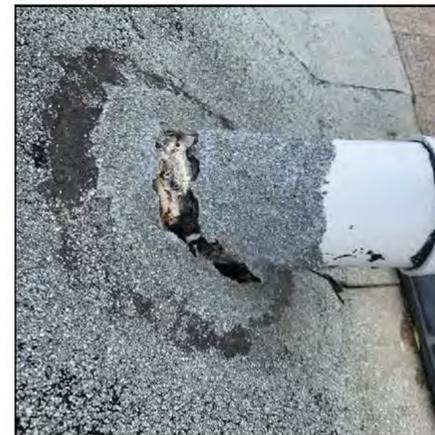
Figure 4.4.52 Splitting of Roofing Membrane at Penetration, South Roof

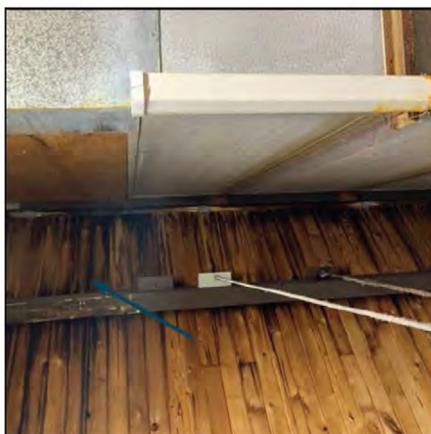
Figure 4.4.45 Water Staining at Roof Deck

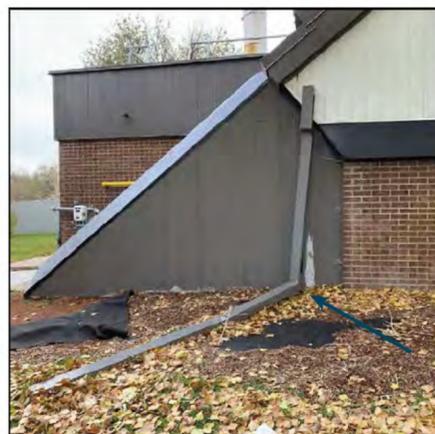
Figure 4.4.46 Damaged Downspout, West Elevation

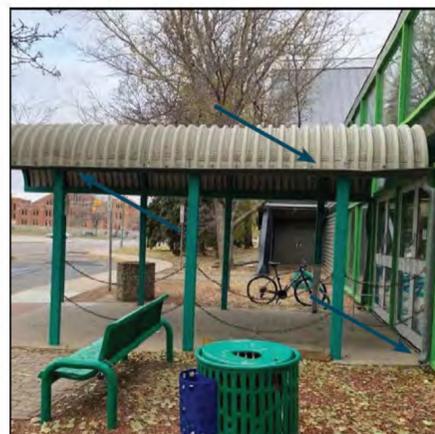
Figure 4.4.47 Locally Damaged Eavestrough and Downspout Discharging at Base of Building, Linking Building Canopies

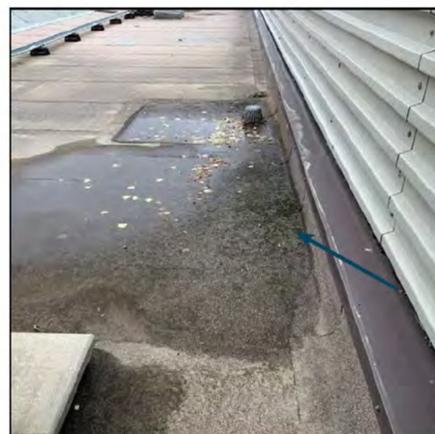
Figure 4.4.48 Ponding with Vegetation, South Low Sloped Roof

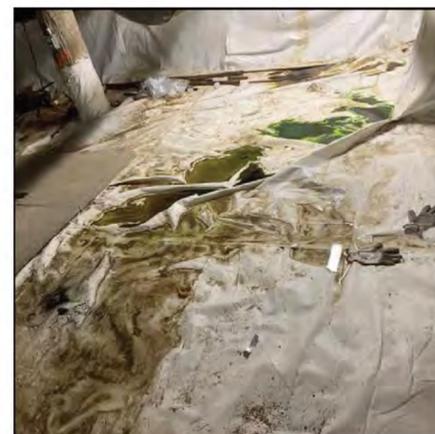
Figure 4.4.55 Ponding at Crawspace likely due to a glycol leak.

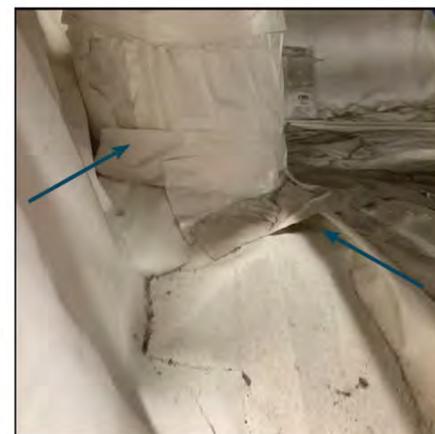
Figure 4.4.56 Debonding of Permalon Membrane, Crawspace

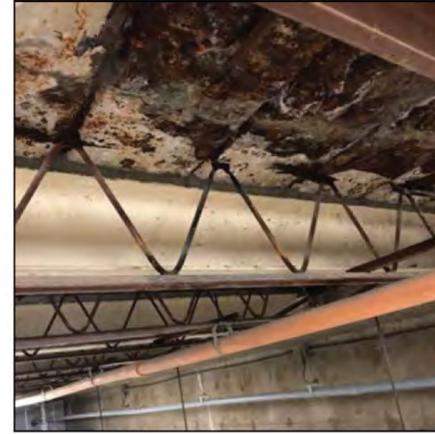
Figure 5.3.10 Corroded Steel Floor Joist

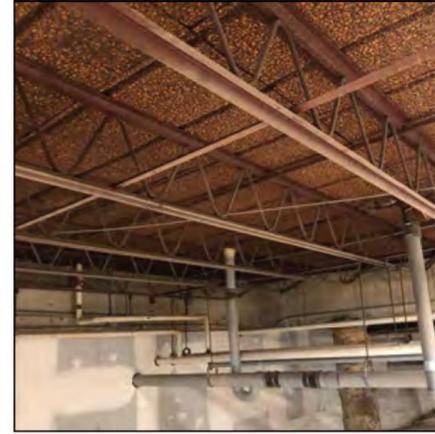
Figure 5.3.11 Underside of Main Floor Corrosion

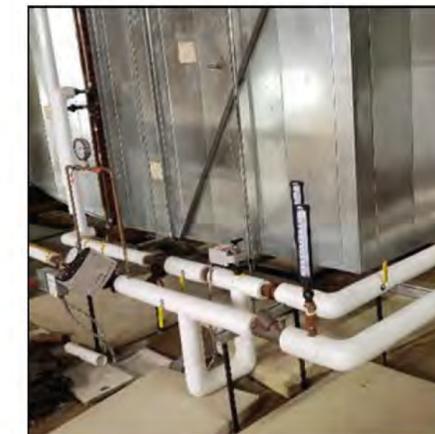
Figure 6.5.4 Freeze-Damaged Pool Ventilation Reheat Coil
