2550 Broad Street , Regina, SK HAZMAT Assessment

Project #: SQ1RG18101
August 28, 2018

Squareone Consulting Ltd. was authorized by Connie Conard of Brandt Developments Ltd. to conduct a Hazardous Materials Assessment at 2550 Broad Street, Regina, SK. The assessment was conducted on August 24, 2018 by Squareone's Desmond Slack.

406 Broadway Ave E, Regina, SK HAZMAT Assessment

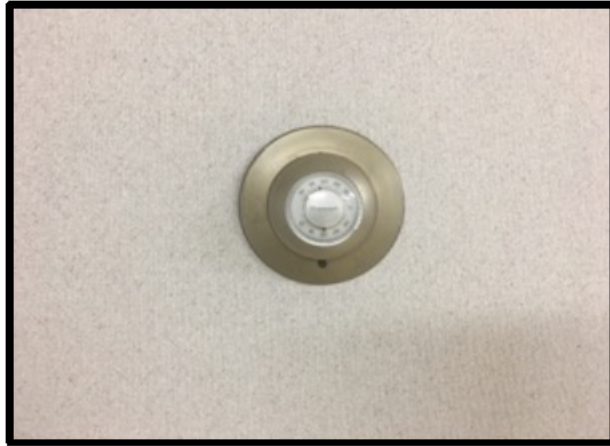
During the building assessment, a mercury containing thermostat and lighting tubes were found.

- Approximately ten (10) mercury containing thermostat was observed.

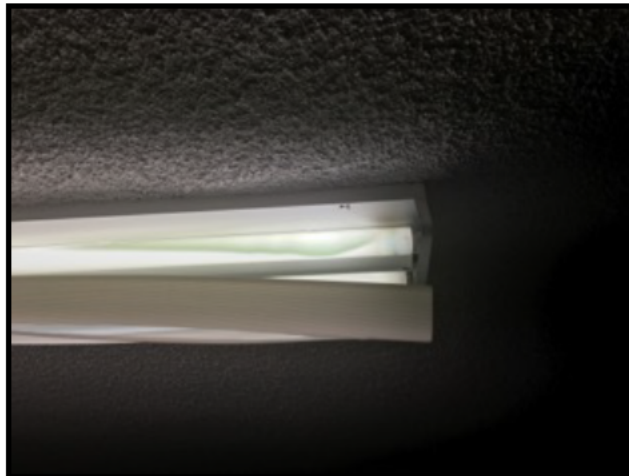
- Approximately 480 fluorescent lighting tubes were counted.

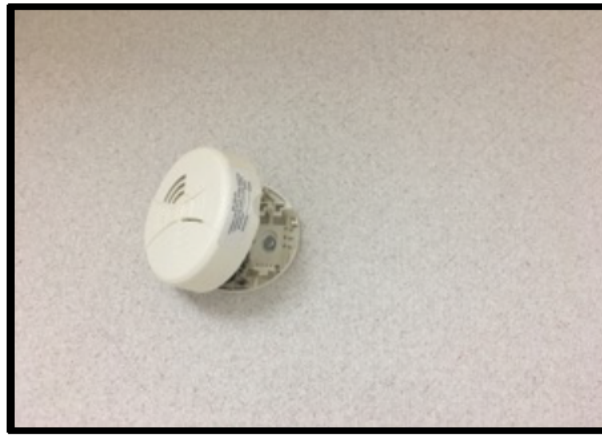
During the assessment, 14 radioactive component products are considered to radioactive components.

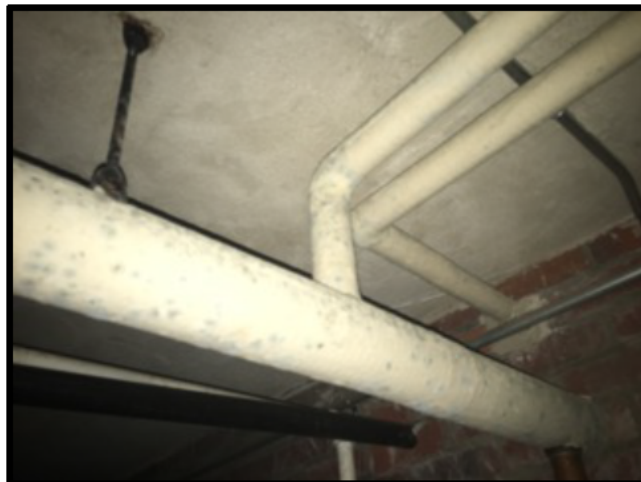
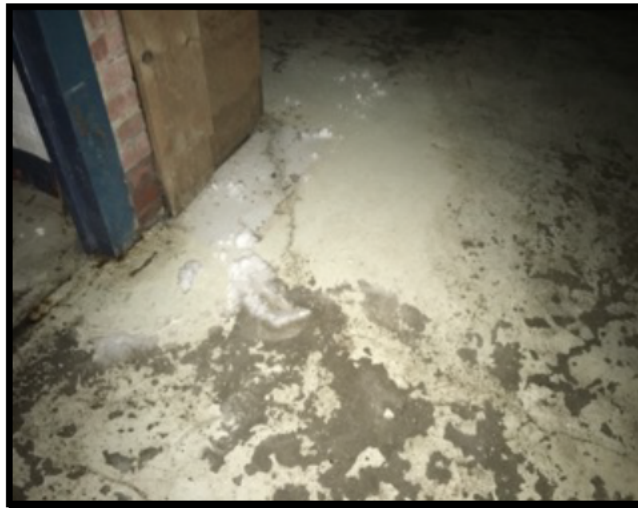
During the assessment, visible water damage was identified in different areas throughout the building. Excess amounts of water were noted in the mechanical room, along with visible calcium hydroxide deposits on the concrete floor in the mechanical room.

During the assessment, visible water damage was identified in different areas throughout the building. Excess amounts of water were noted in the mechanical room, along with visible calcium hydroxide deposits on the concrete floor in the mechanical room. If demolition is to occur no special safety activities are required. If unprotected persons are to occupy the building for long periods of time, then proper remediation should be done.

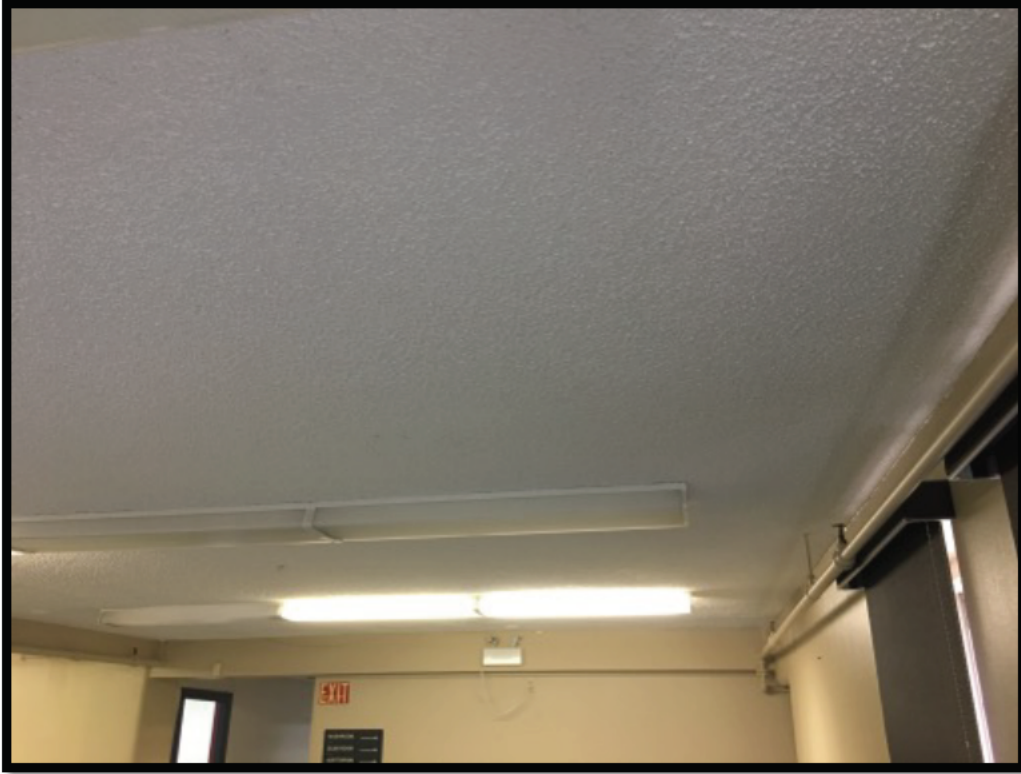
Sample A5 – Ceiling Texture / Main Floor Lobby

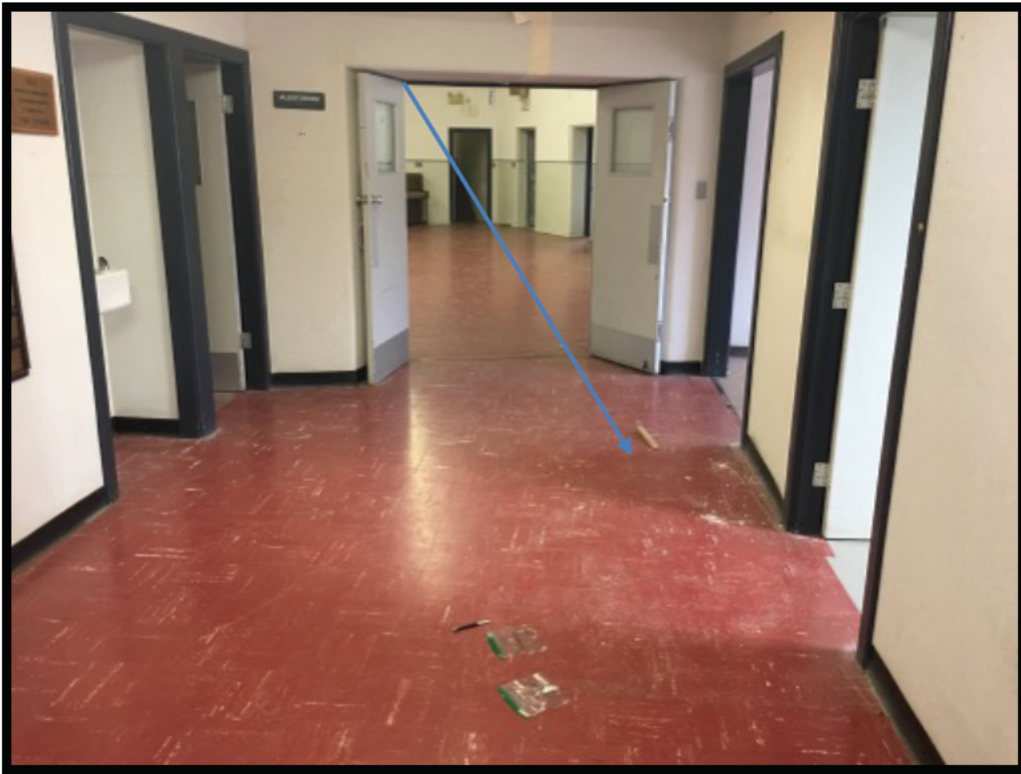
Sample A7 – Red Floor Tile/ Auditorium Entrance

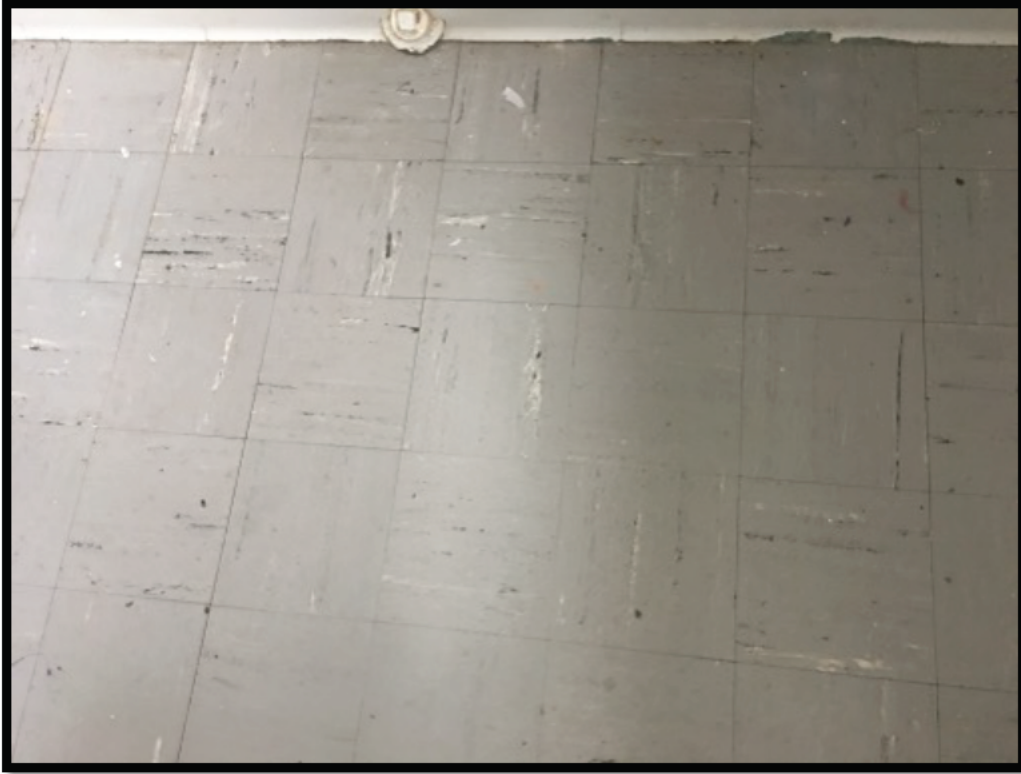
Sample A9 – Blue Floor Tile / Main Women’s Washroom

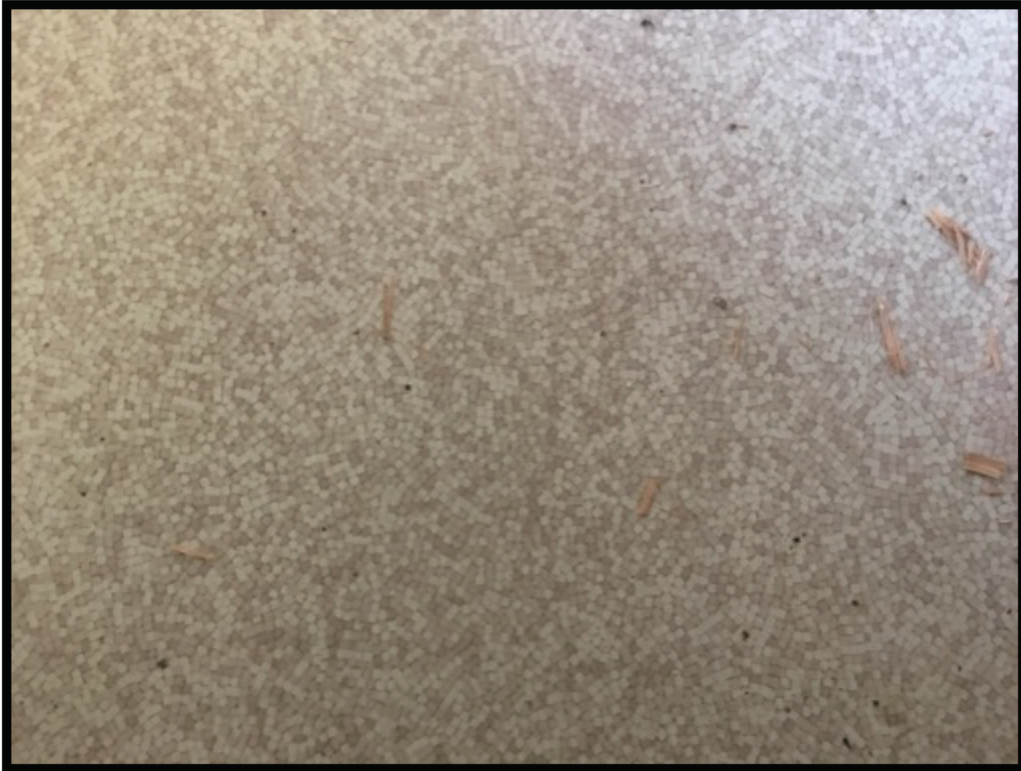
Sample A14 – Square-patterned Vinyl Flooring / Auditorium Kitchen

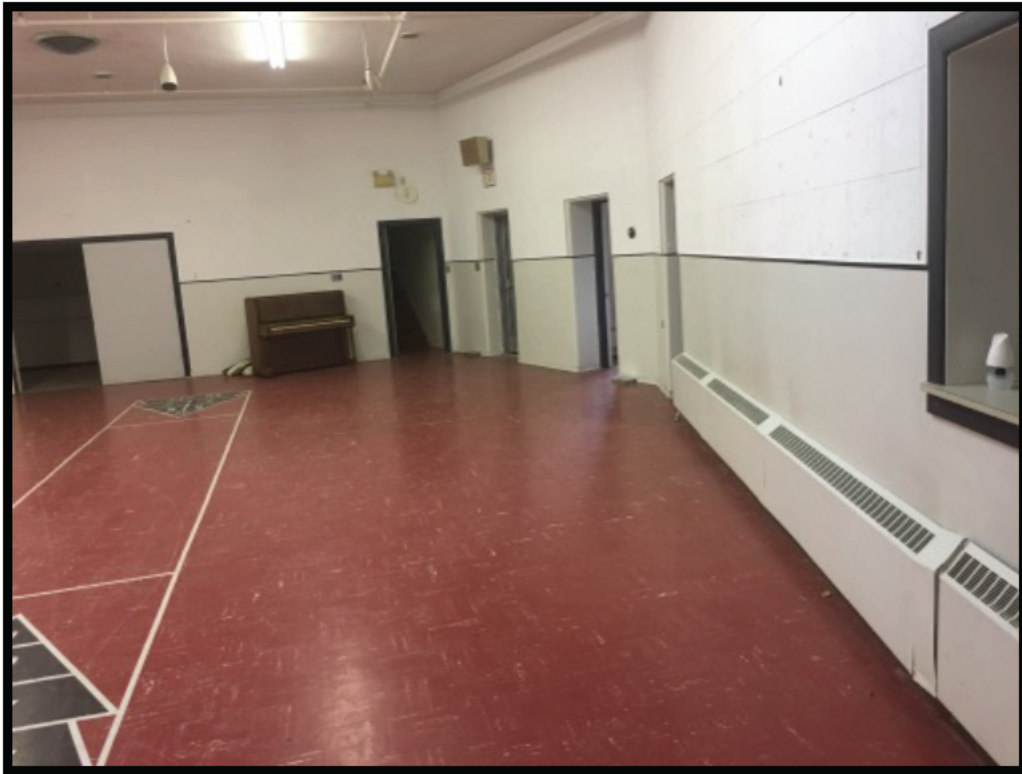
Sample A16 – Joint Compound; Walls / Auditorium

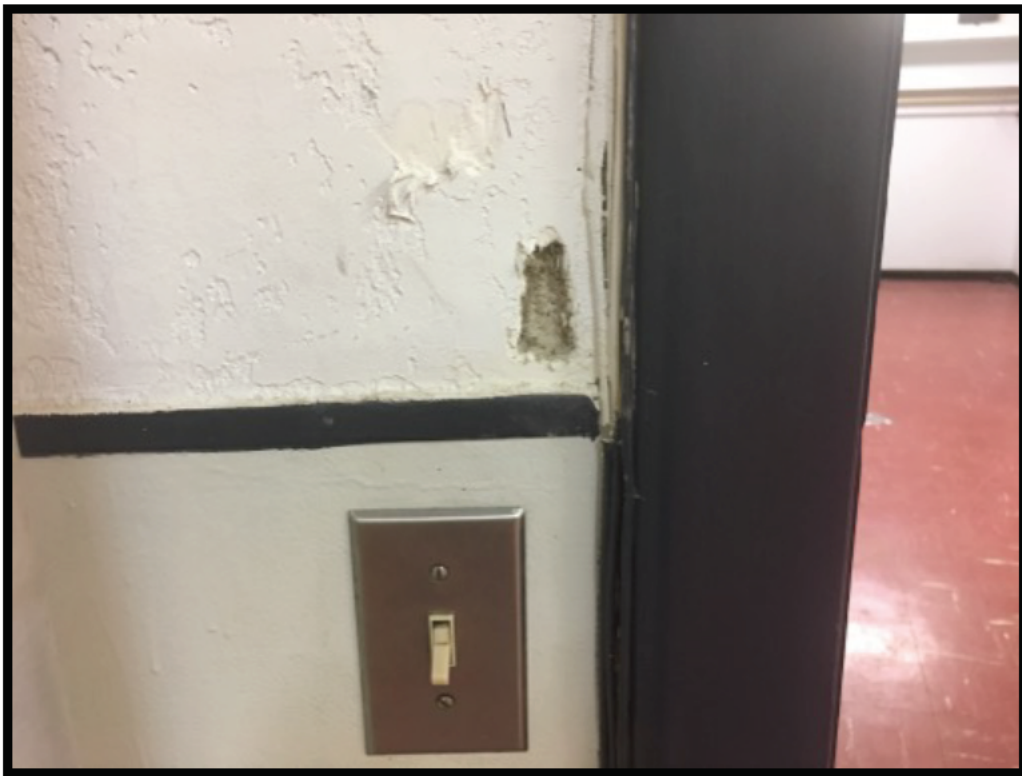
Sample A18 – Grey Wall Material Insulation / Auditorium

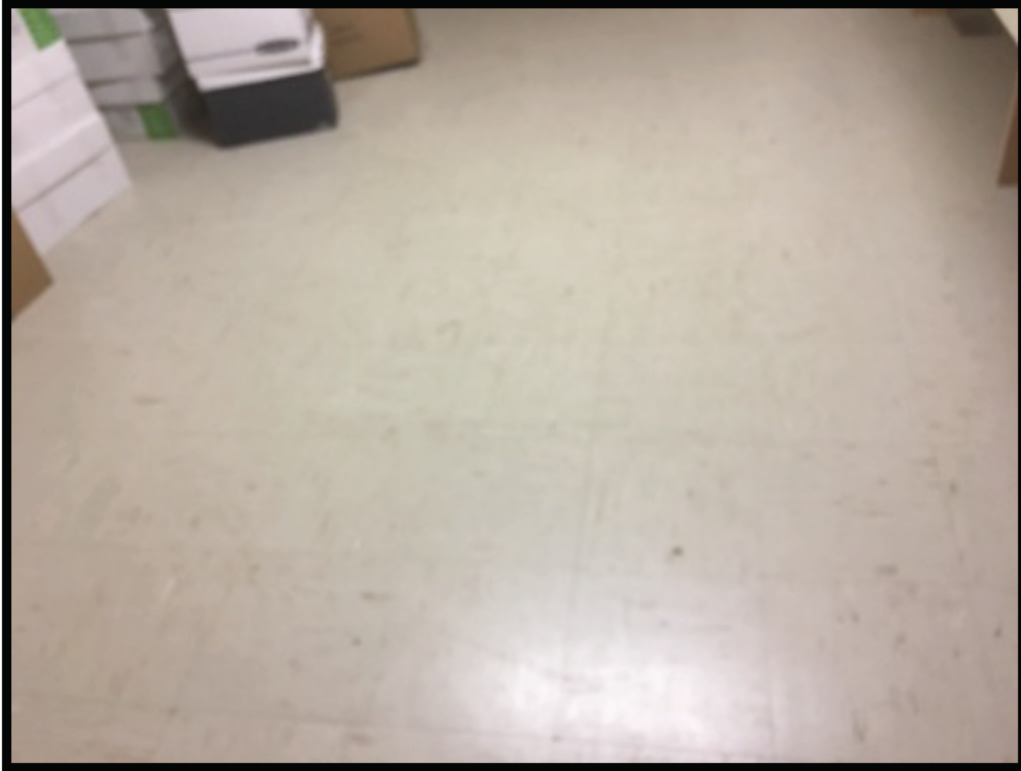
Sample A21 – 12x12 Cream Floor Tile / Upper Auditorium

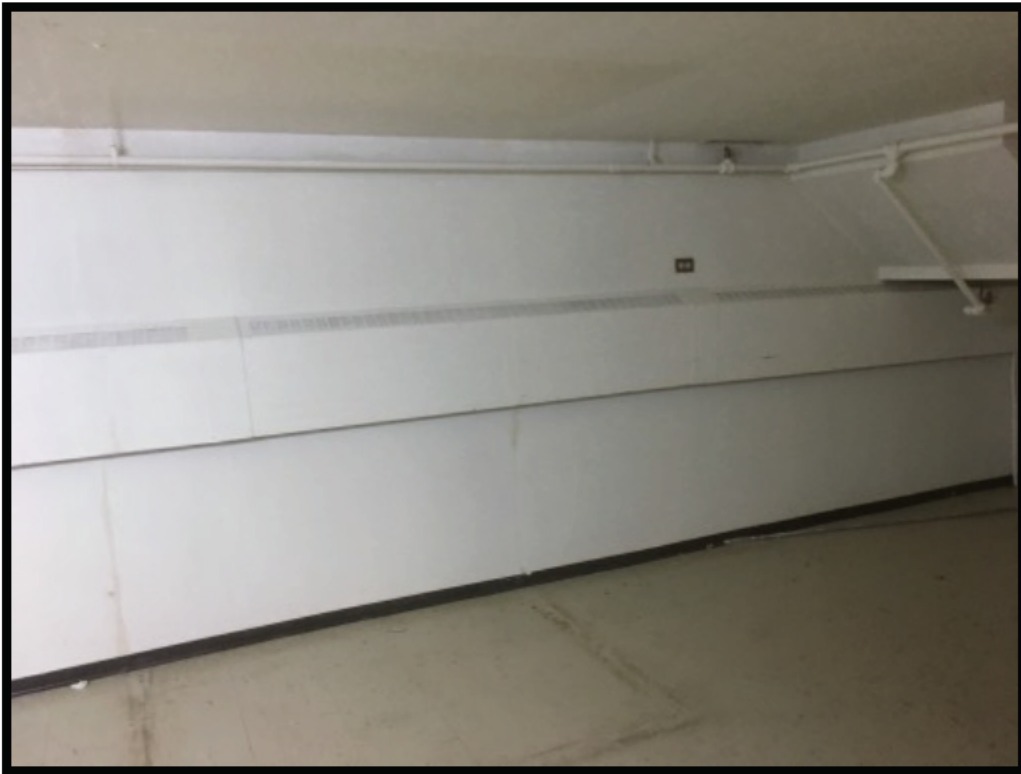
Sample A23 – Joint Compound; Walls & Ceiling/ Auditorium Storage Rm

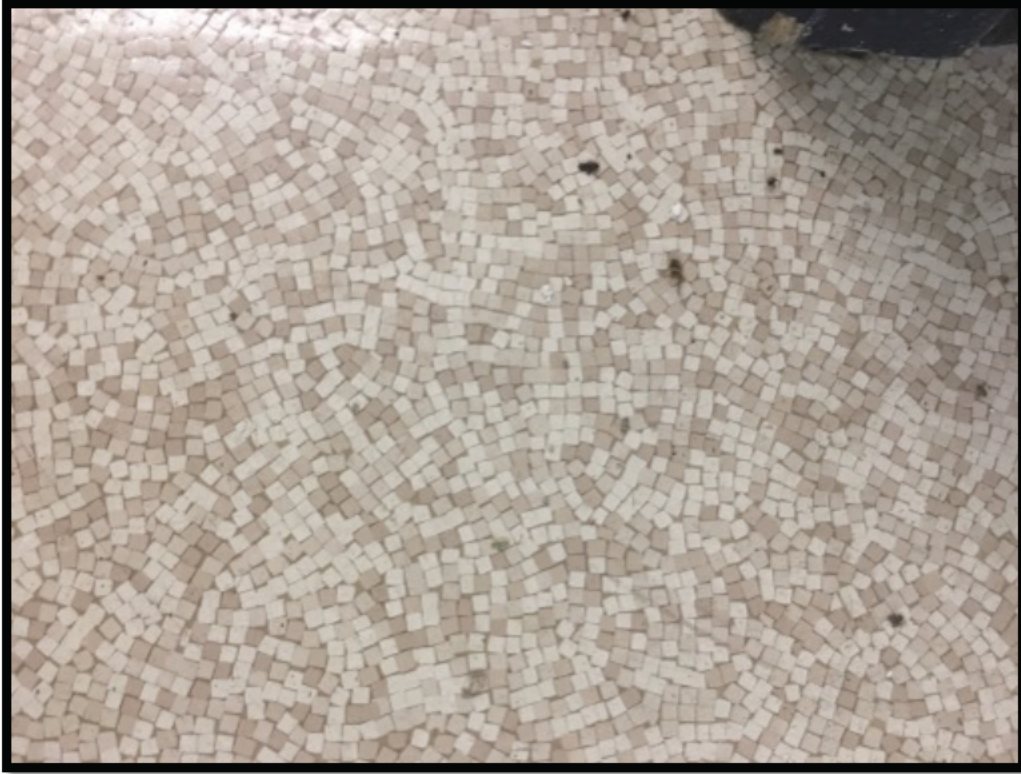
Sample A26 – Square-patterned Vinyl Flooring / Main Floor NW Hallway

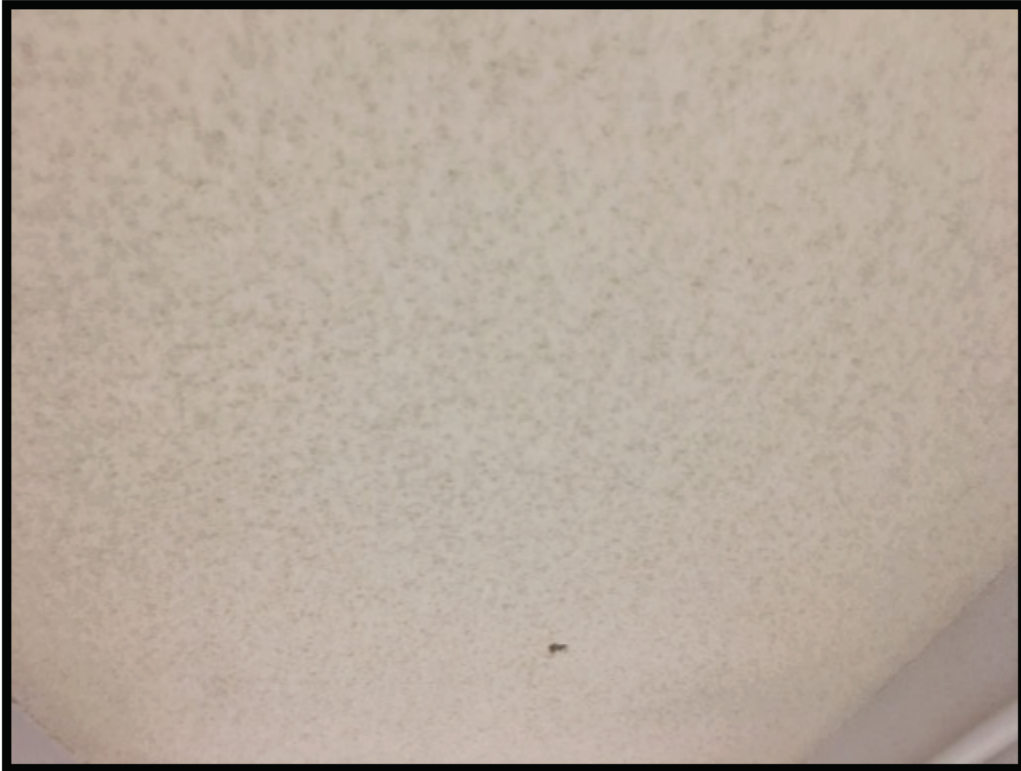
Sample A28 – Ceiling Texture / Main Floor NW Hallway

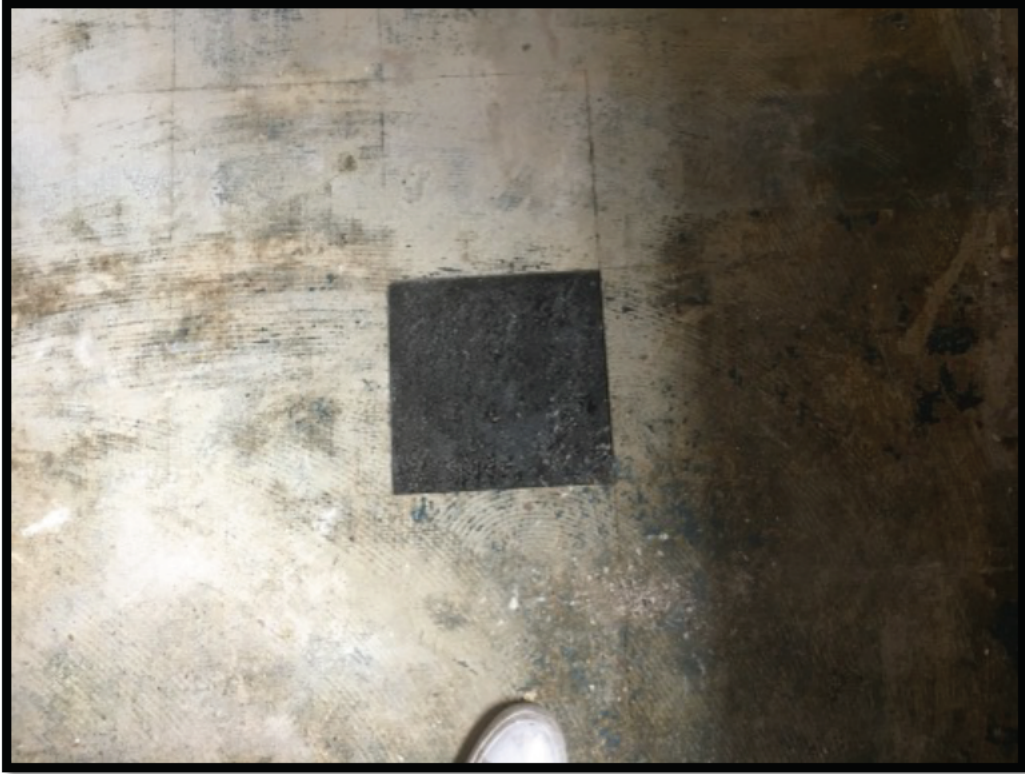
Sample A35 – Blue 9x9 Tile / Main Room 3

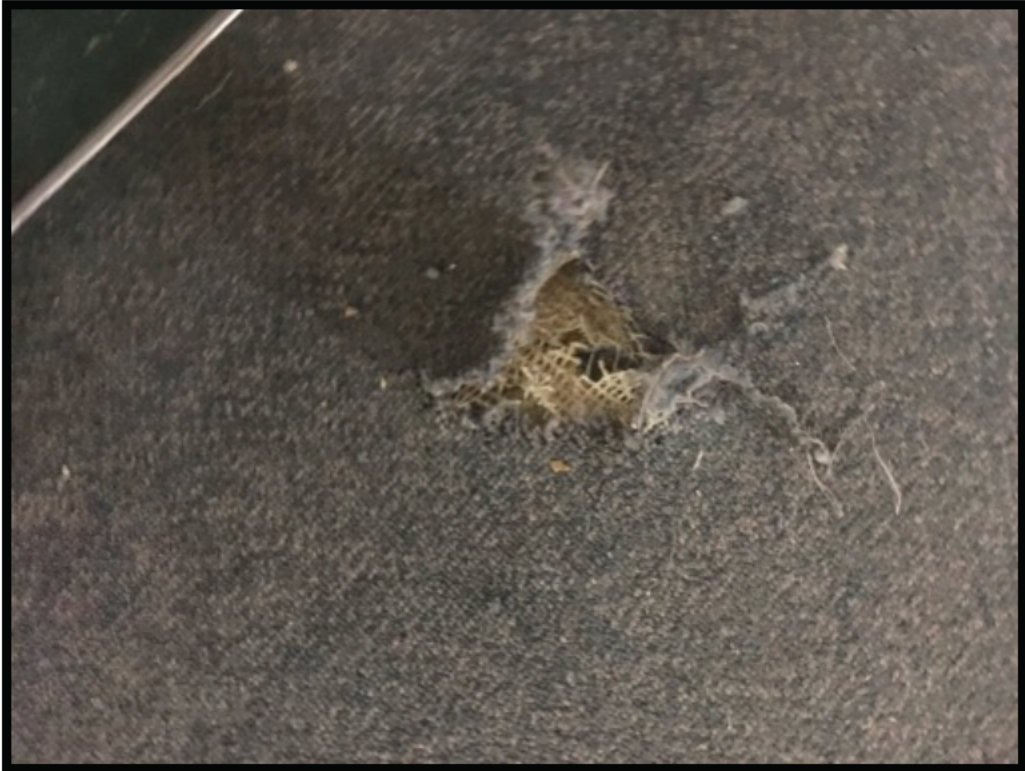
Sample A36 – Grey 9x9 Floor Tile/ Main Room 3

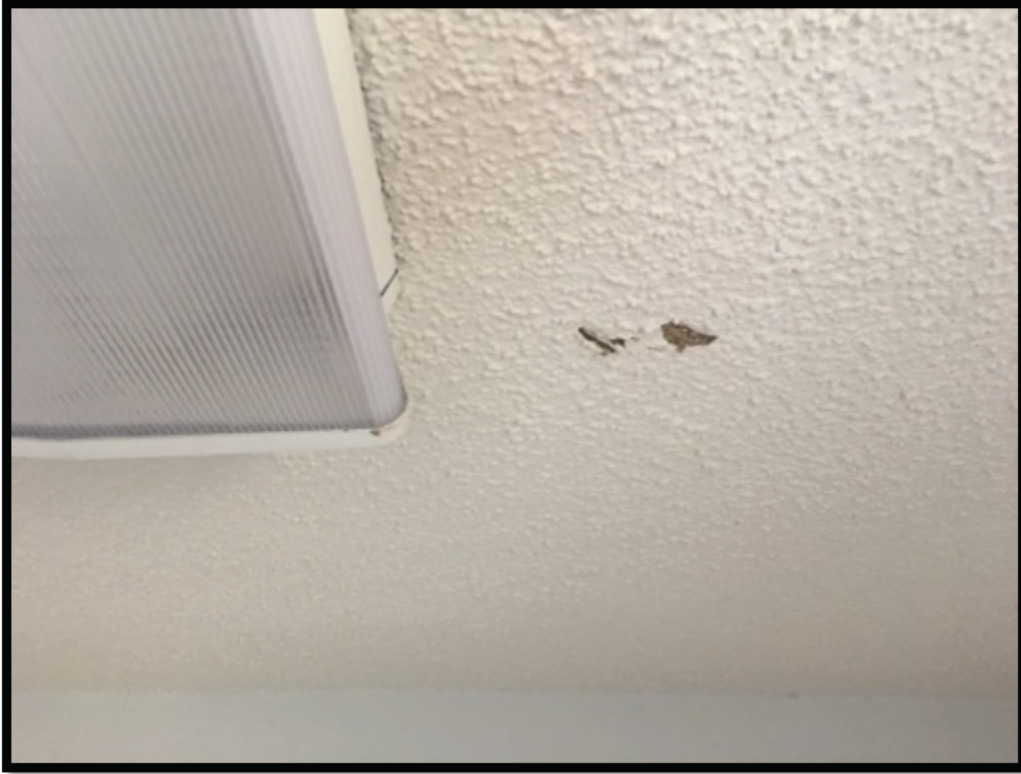
Sample A39 – Ceiling Texture / Upstairs, Room 1

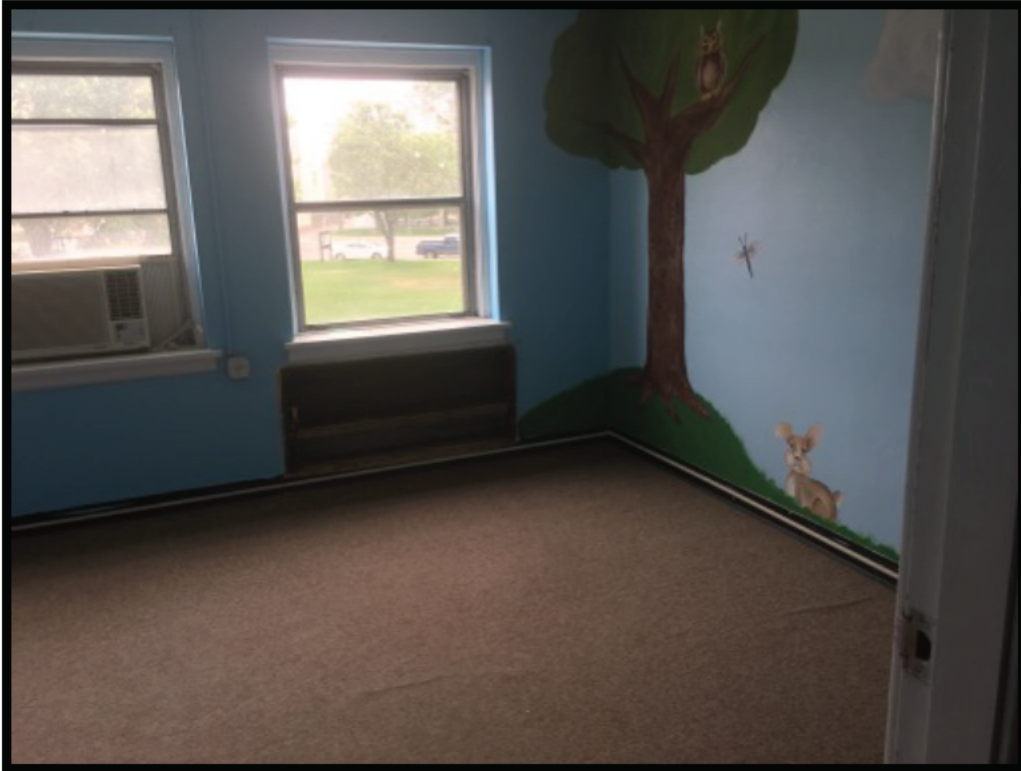
Sample A45 – Joint Compound / Upstairs Room 113

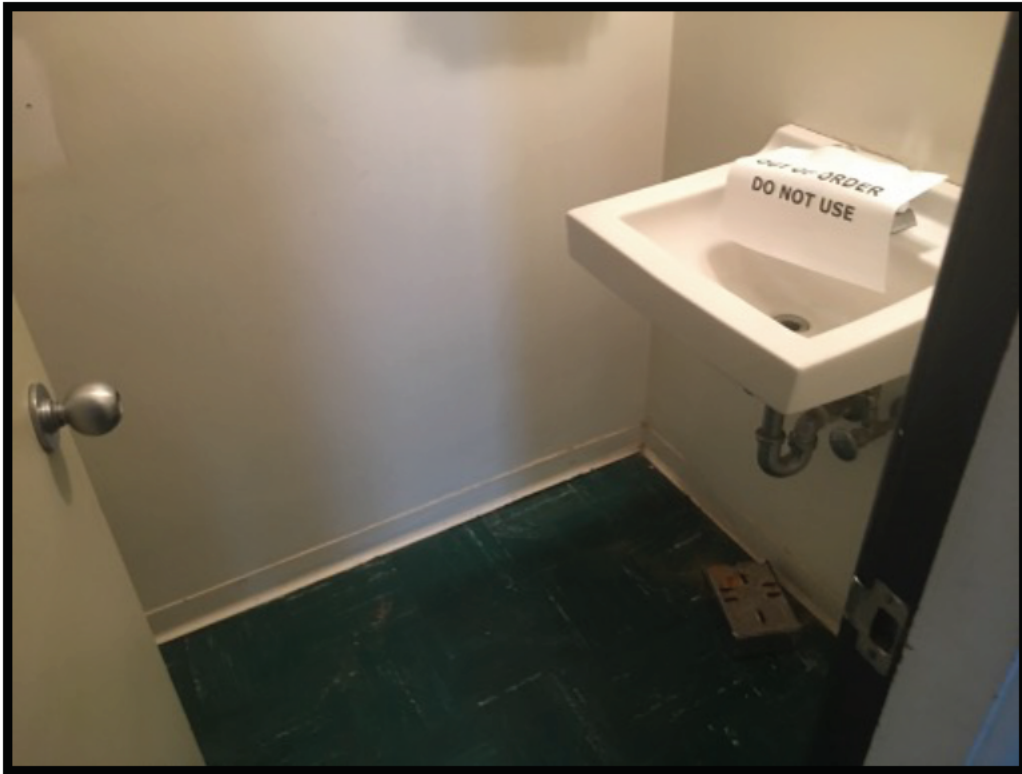
Sample A48– Green Floor Tile / Upstairs Hallway; Janitor's Room

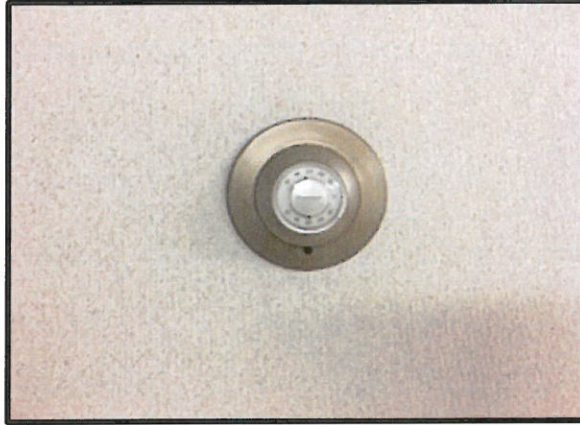
- Approximately ten (10) mercury containing thermostat was observed.

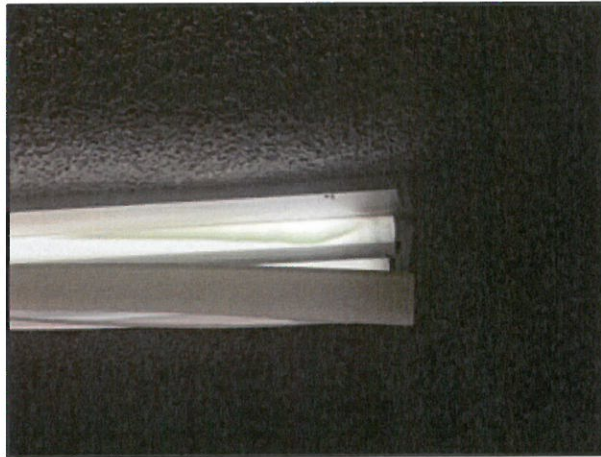
- Approximately 480 fluorescent lighting tubes were counted.

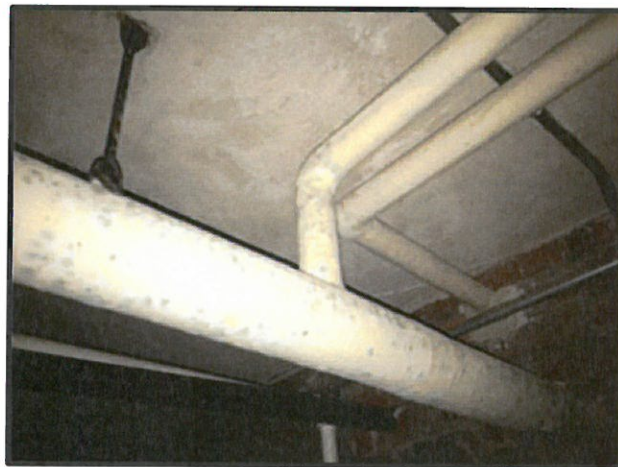
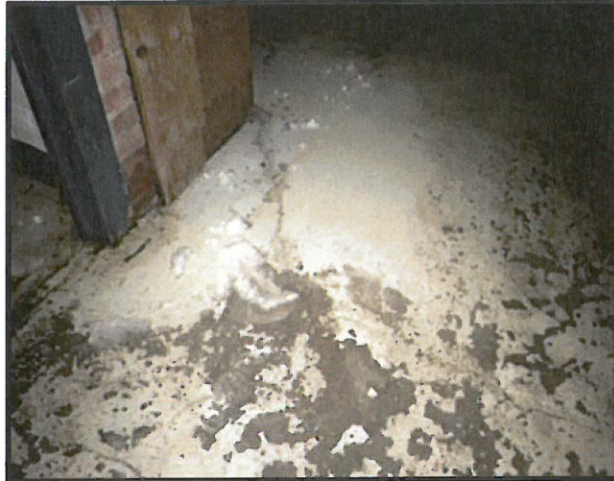
During the assessment, visible water damage was identified in different areas throughout the building. Excess amounts of water were noted in the mechanical room, along with visible calcium hydroxide deposits on the concrete floor in the mechanical room.

During the assessment, visible water damage was identified in different areas throughout the building. Excess amounts of water were noted in the mechanical room, along with visible calcium hydroxide deposits on the concrete floor in the mechanical room. If demolition is to occur no special safety activities are required. If unprotected persons are to occupy the building for long periods of time, then proper remediation should be done.

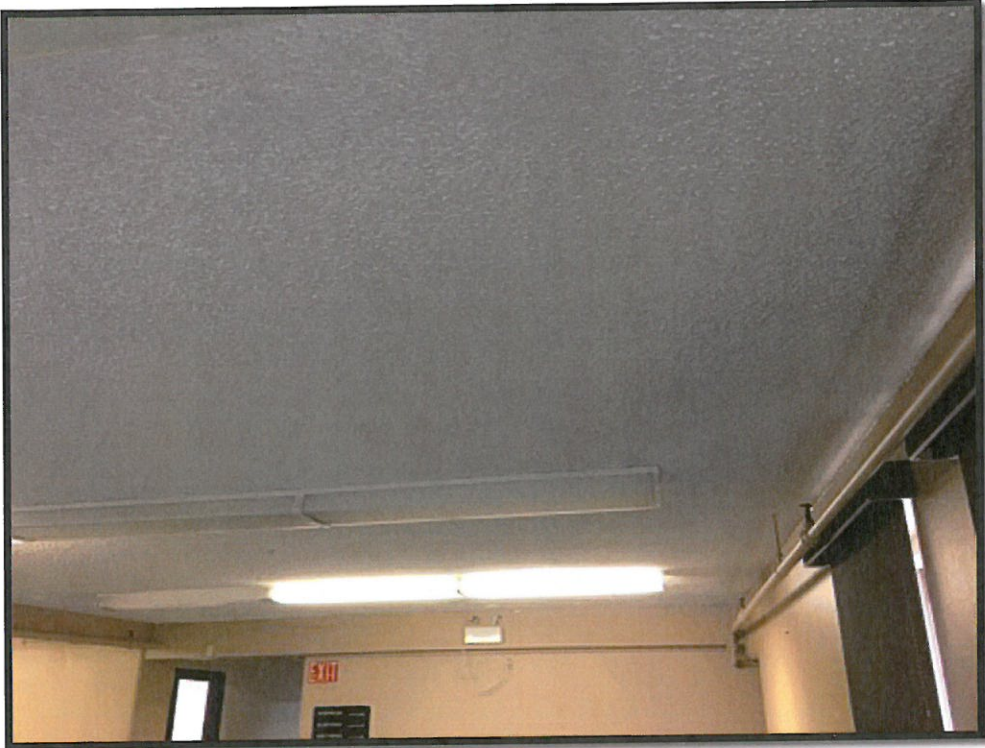
Sample A5 – Ceiling Texture / Main Floor Lobby

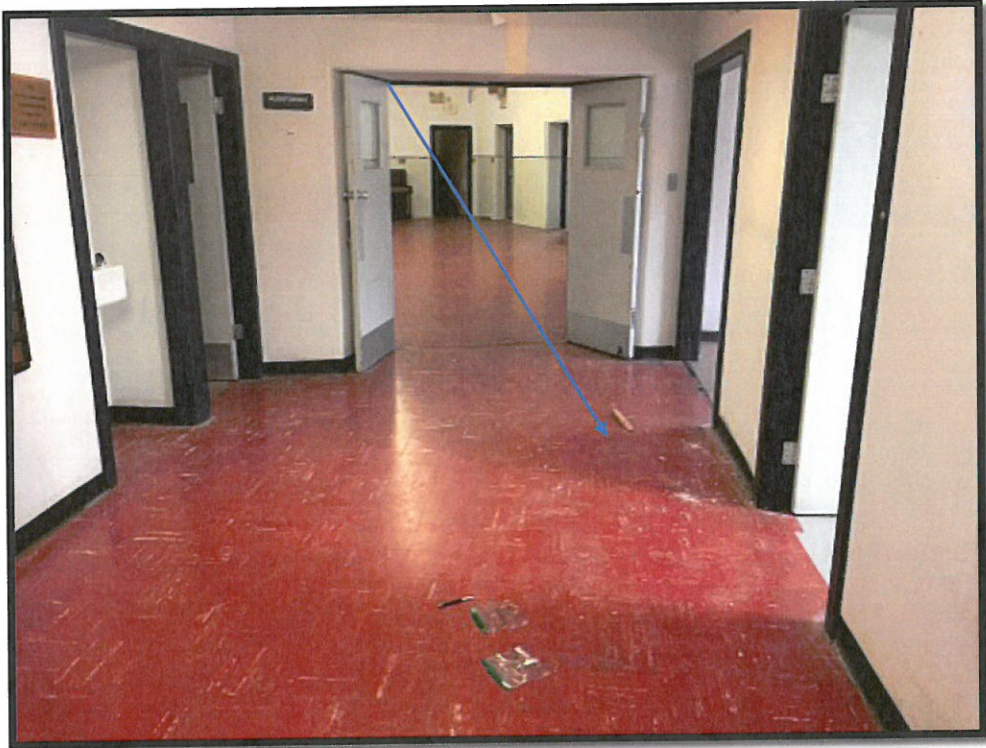
Sample A7 – Red Floor Tile/ Auditorium Entrance

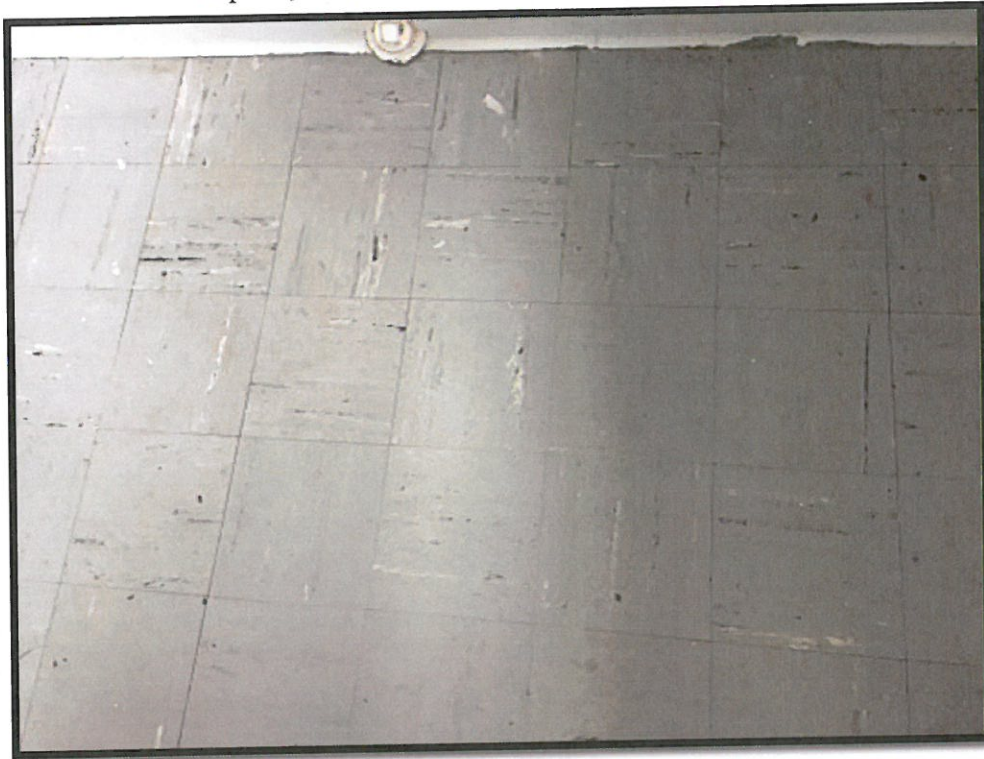
Sample A9 – Blue Floor Tile / Main Women's Washroom

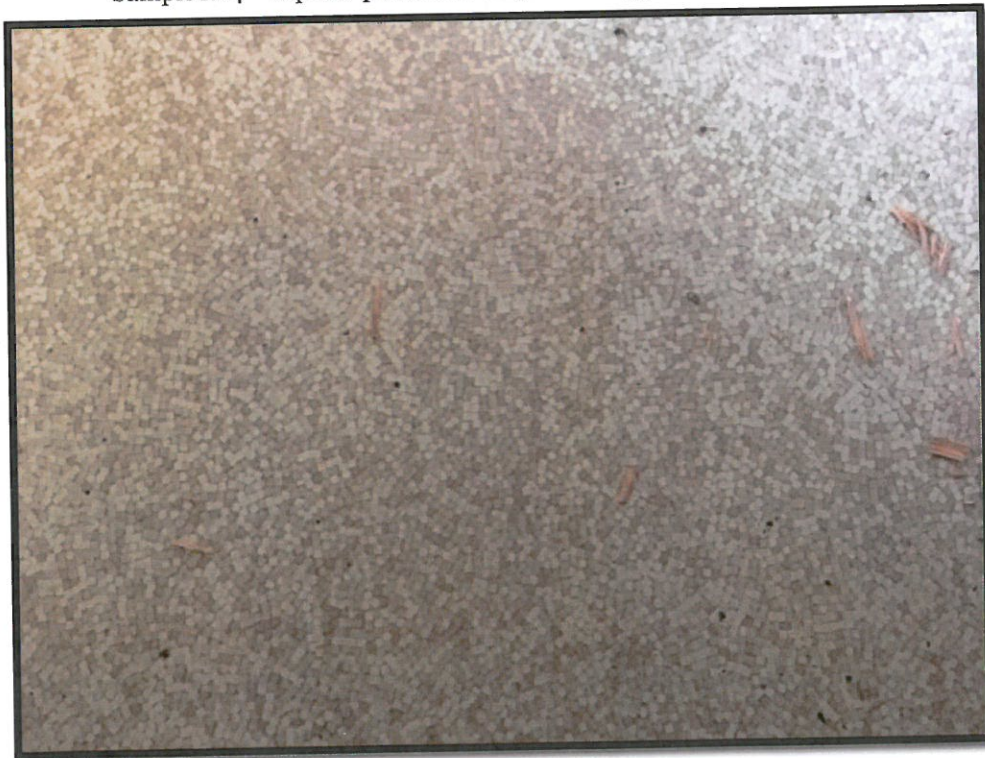
Sample A14 – Square-patterned Vinyl Flooring / Auditorium Kitchen

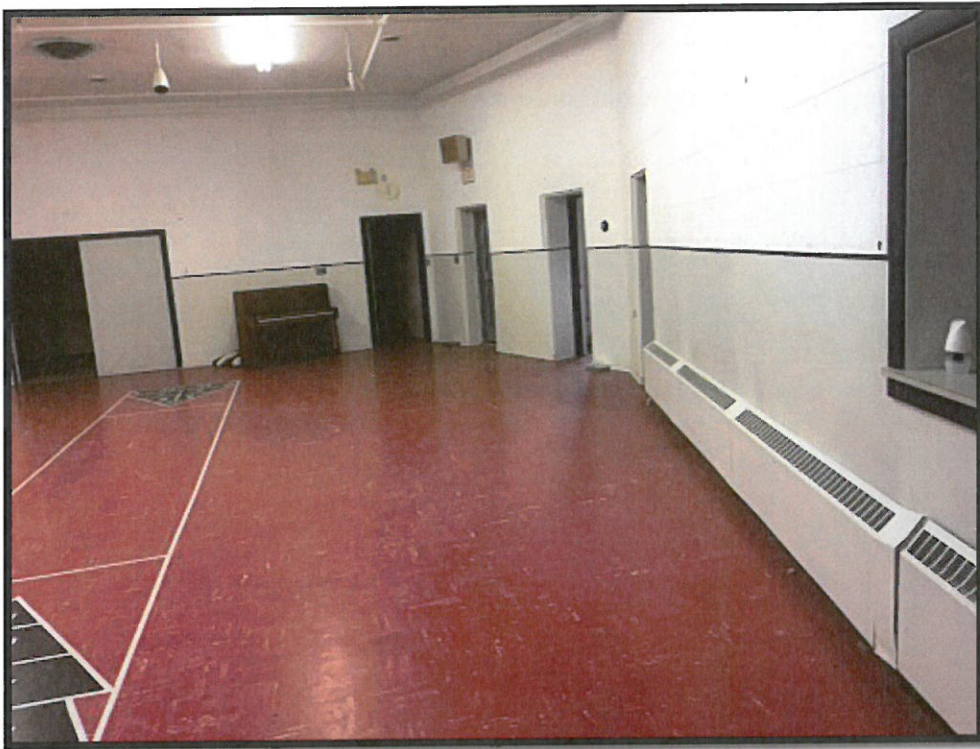
Sample A16 – Joint Compound; Walls / Auditorium

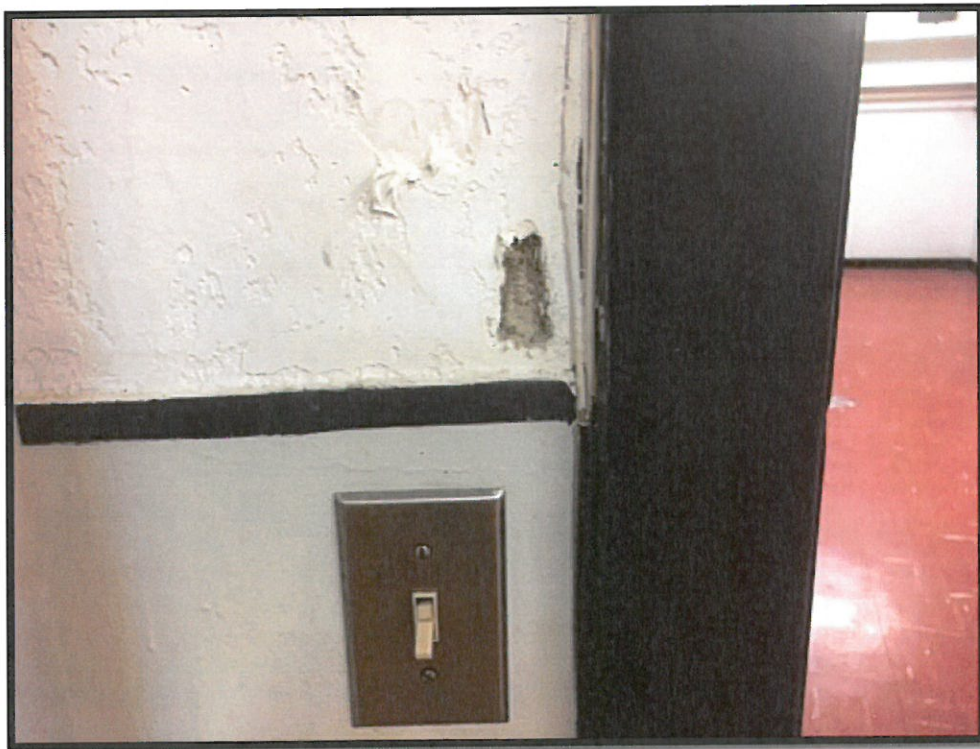
Sample A18 – Grey Wall Material Insulation / Auditorium

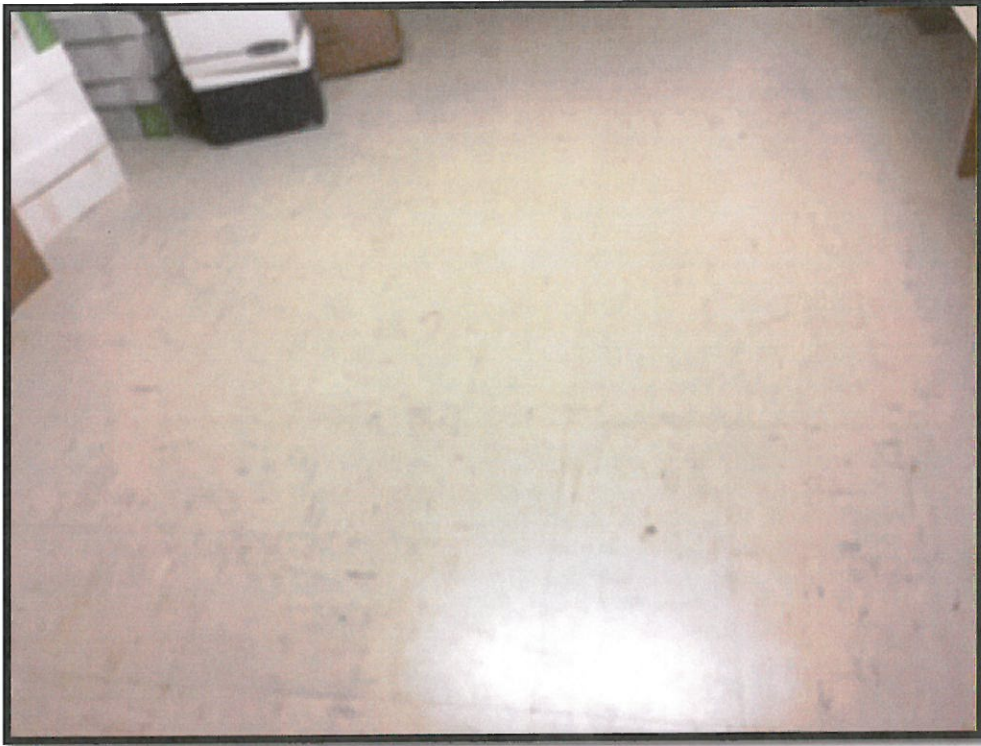
Sample A21 – 12x12 Cream Floor Tile / Upper Auditorium

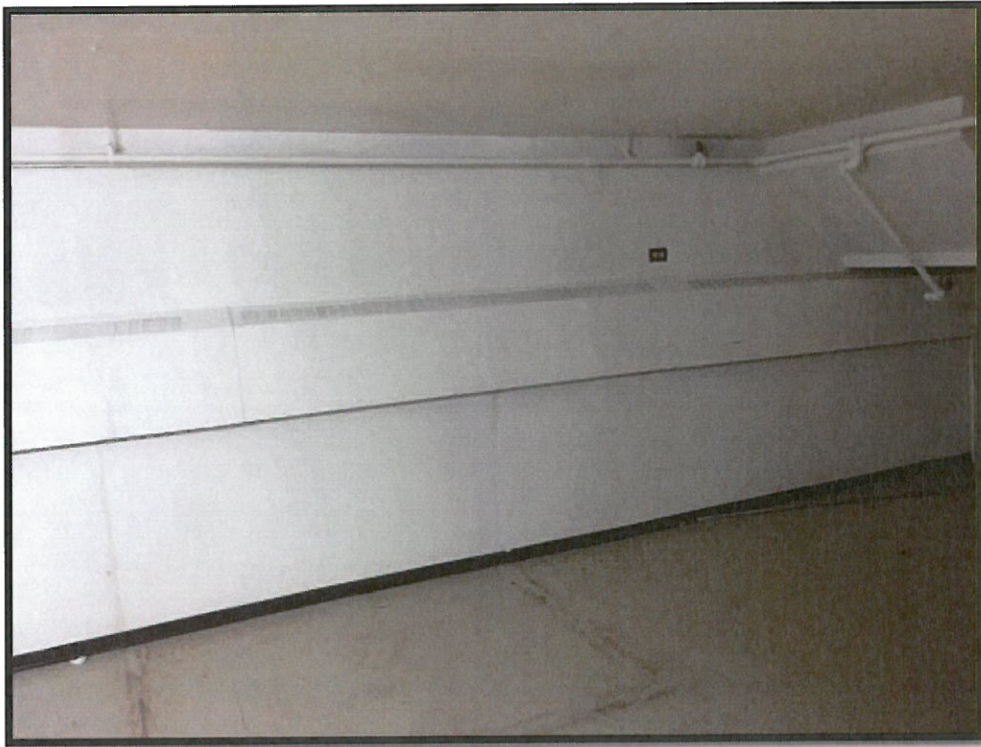
Sample A23 – Joint Compound; Walls & Ceiling / Auditorium Storage Rm

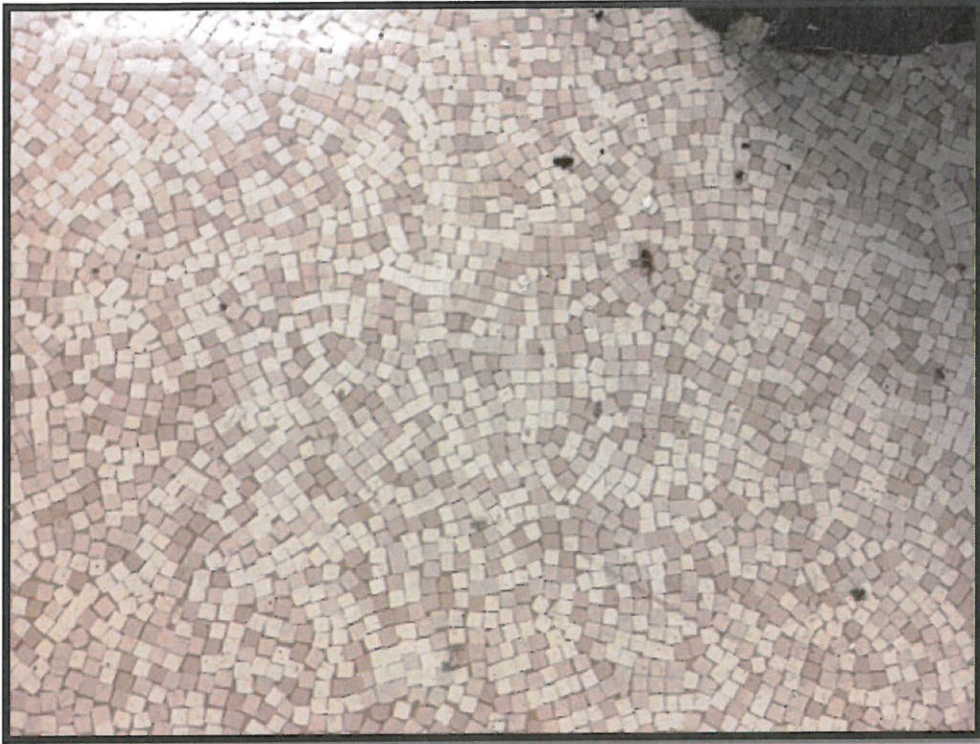
Sample A26 – Square-patterned Vinyl Flooring / Main Floor NW Hallway

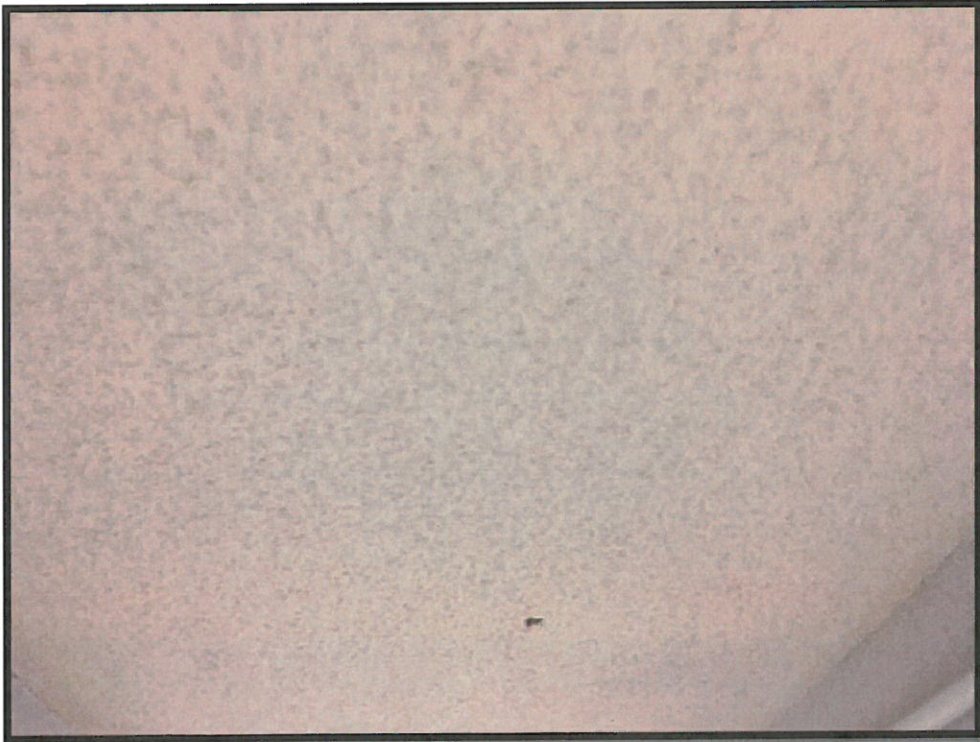
Sample A28 – Ceiling Texture / Main Floor NW Hallway
