2550 Broad Street , Regina, SK HAZMAT Assessment

Project #: SQ1RG18101
August 28, 2018

Squareone Consulting Ltd. was authorized by Connie Conard of Brandt Developments Ltd. to conduct a Hazardous Materials Assessment at 2550 Broad Street, Regina, SK. The assessment was conducted on August 24, 2018 by Squareone's Desmond Slack.

406 Broadway Ave E, Regina, SK HAZMAT Assessment

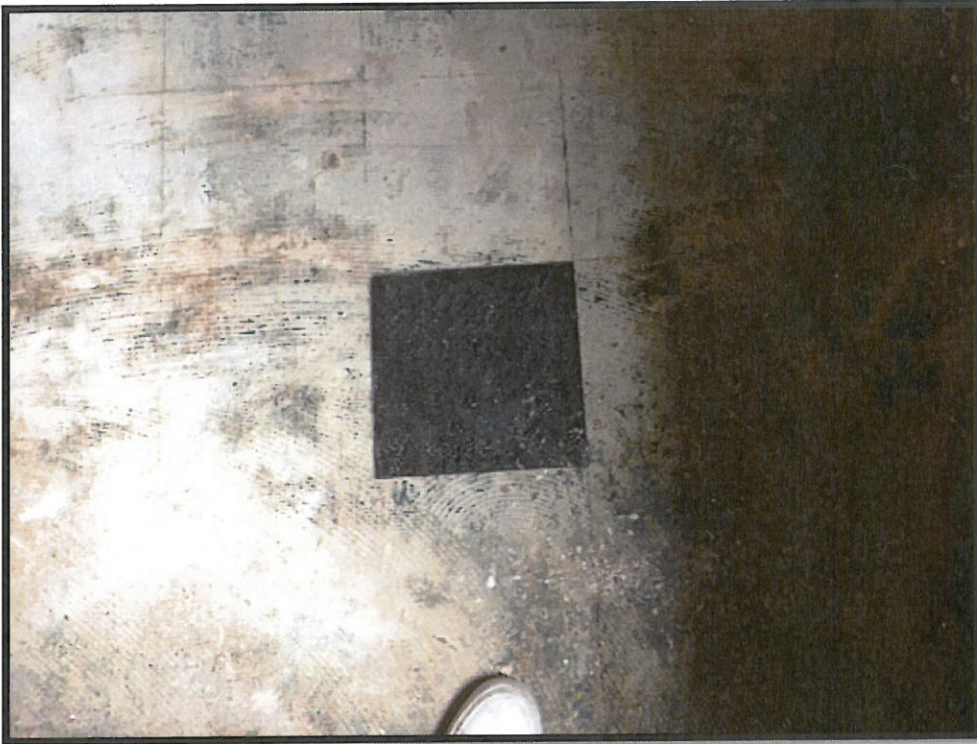
Sample A35 – Blue 9x9 Tile / Main Room 3

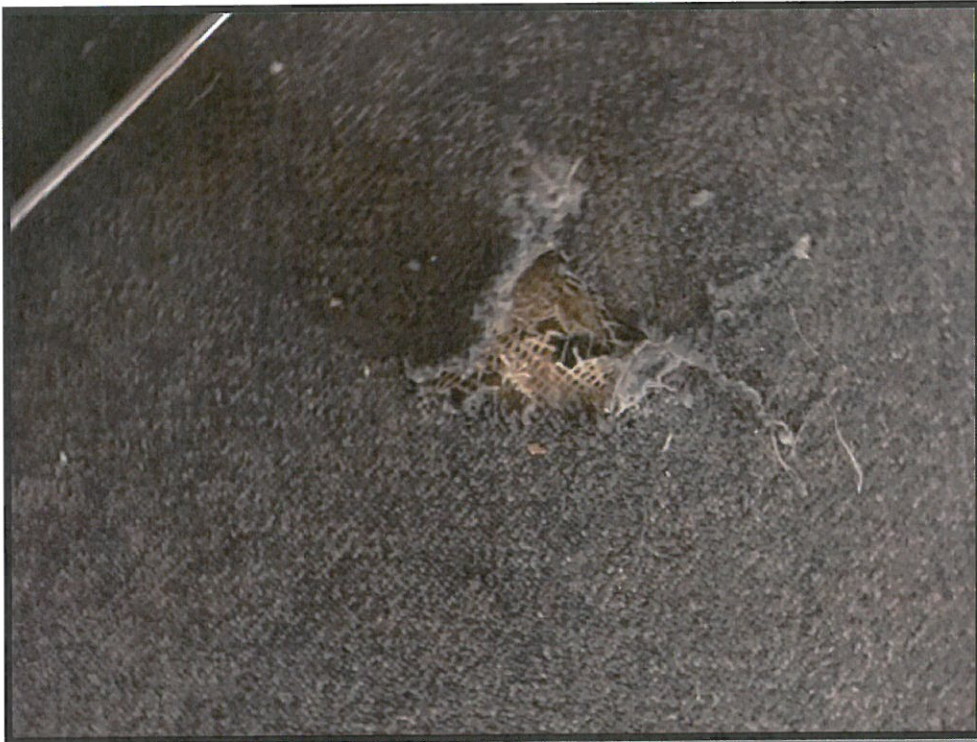
Sample A36 – Grey 9x9 Floor Tile/ Main Room 3

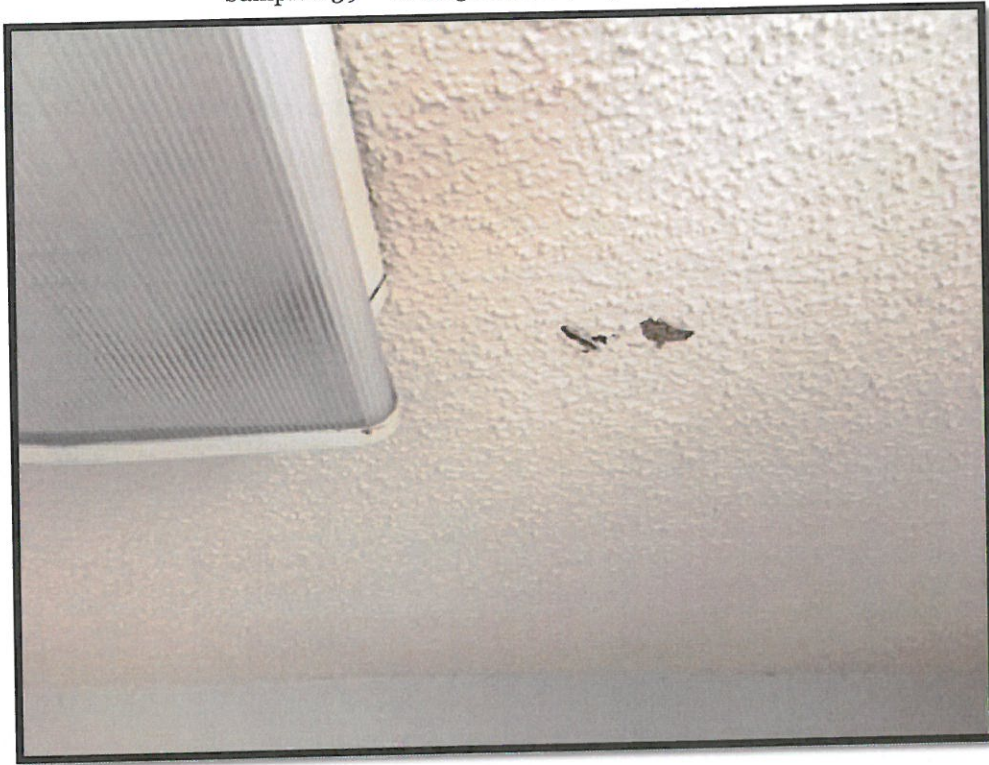
Sample A39 – Ceiling Texture / Upstairs, Room 1

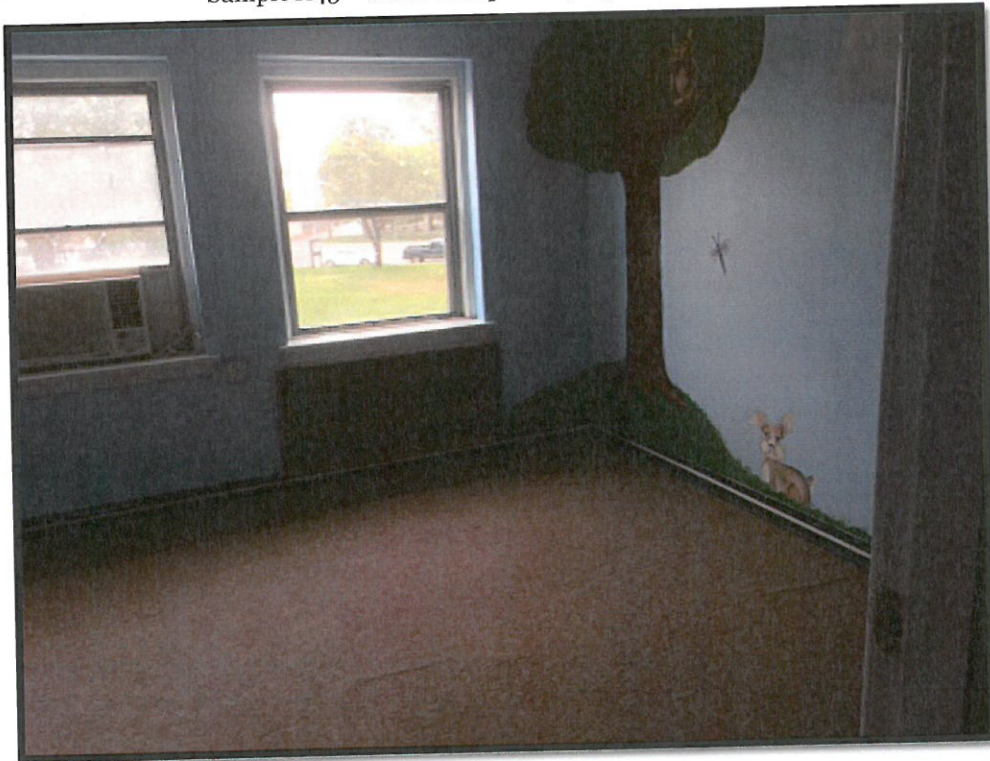
Sample A45 – Joint Compound / Upstairs Room 113

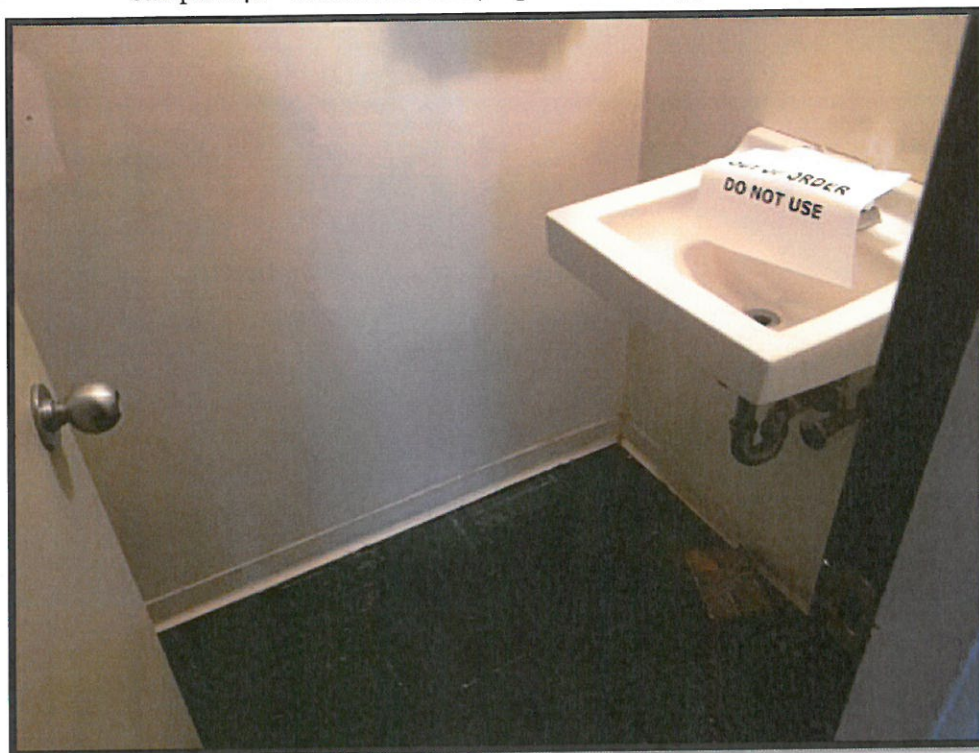
Sample A48- Green Floor Tile / Upstairs Hallway; Janitor's Room

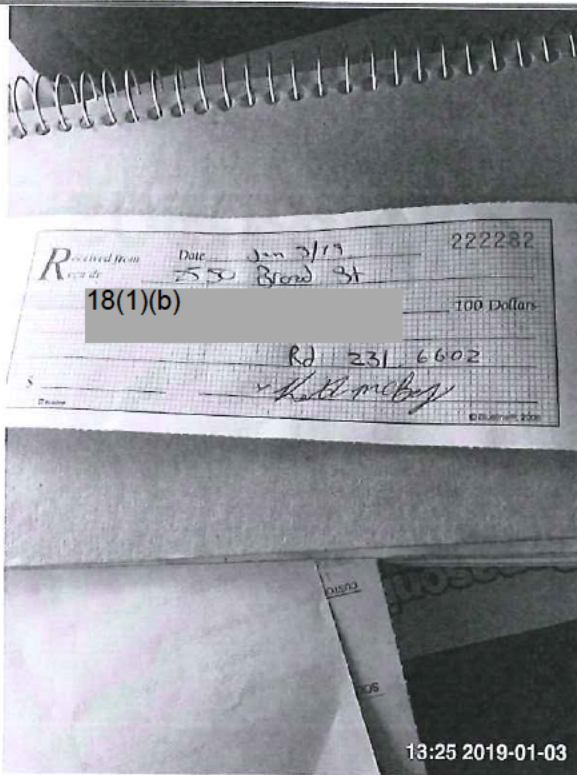
ISSUE 1

Removed water meter from basement of 2550 broad st. Took back to city of Regina

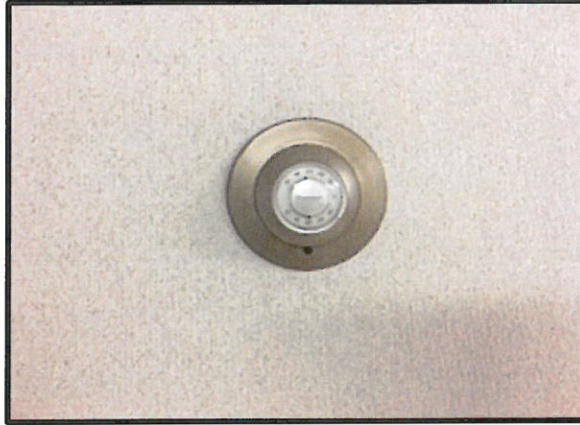
- Approximately ten (10) mercury containing thermostat was observed.

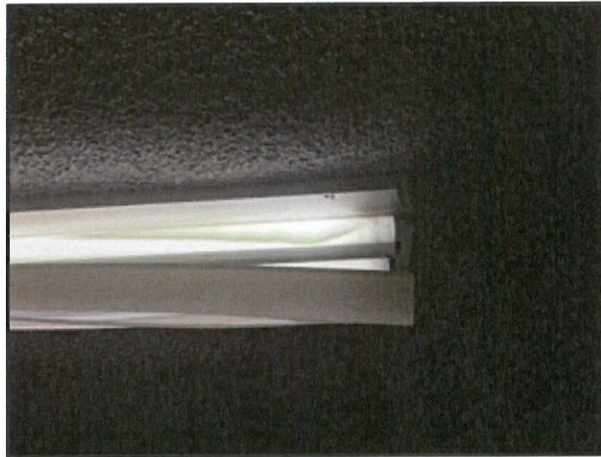
- Approximately 480 fluorescent lighting tubes were counted.

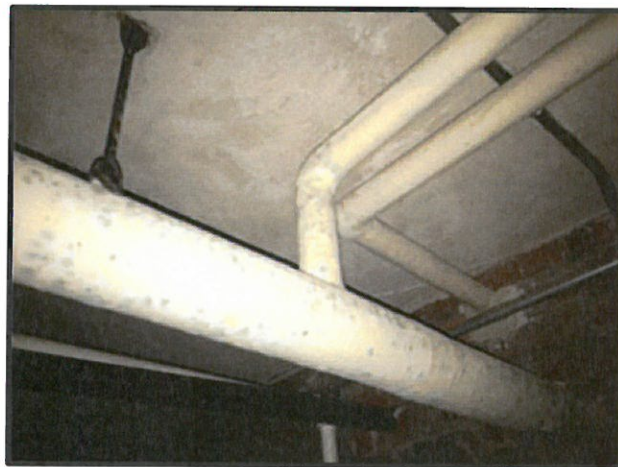
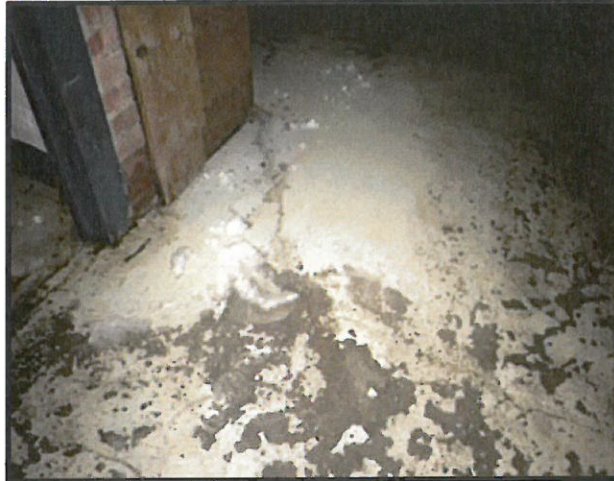
During the assessment, visible water damage was identified in different areas throughout the building. Excess amounts of water were noted in the mechanical room, along with visible calcium hydroxide deposits on the concrete floor in the mechanical room.

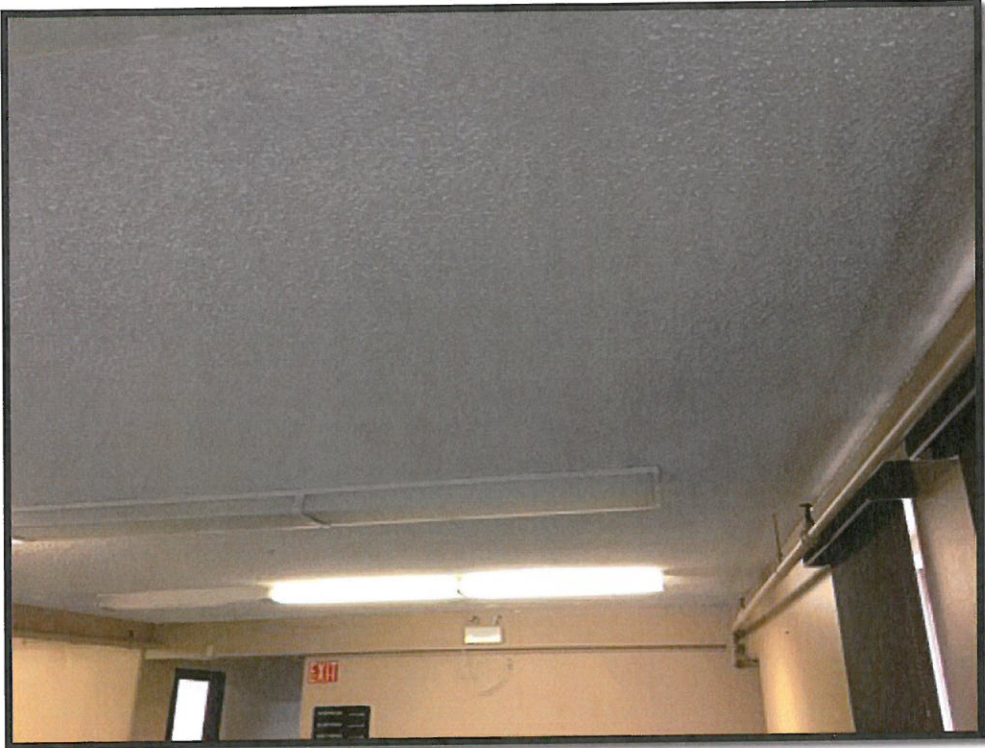
Sample A5 – Ceiling Texture / Main Floor Lobby

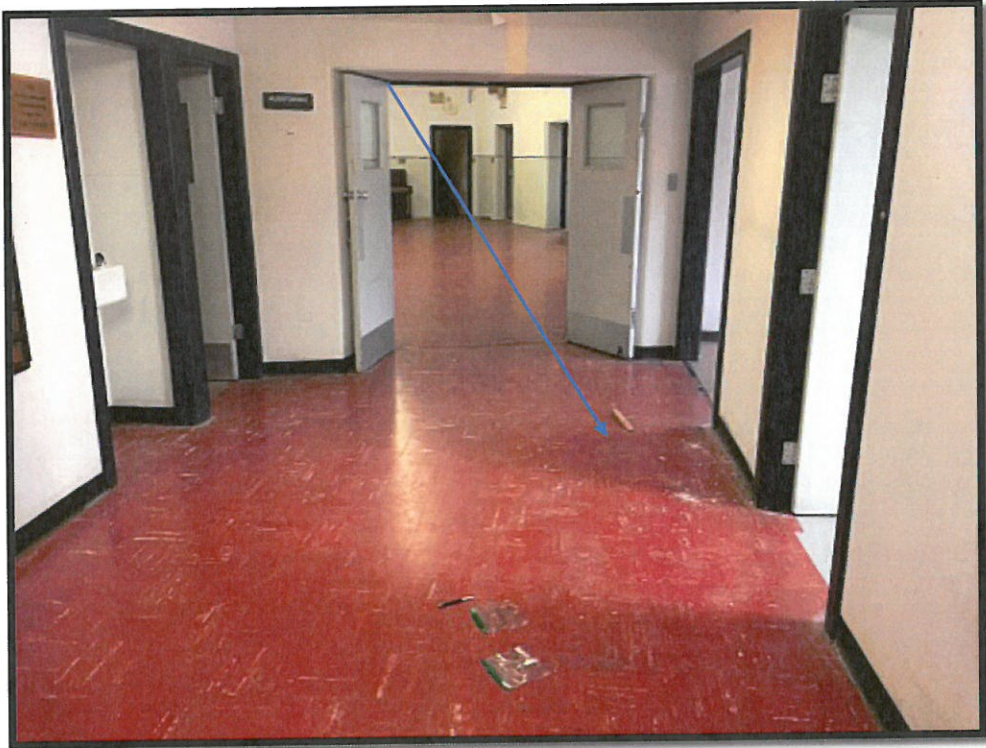
Sample A7 – Red Floor Tile/ Auditorium Entrance

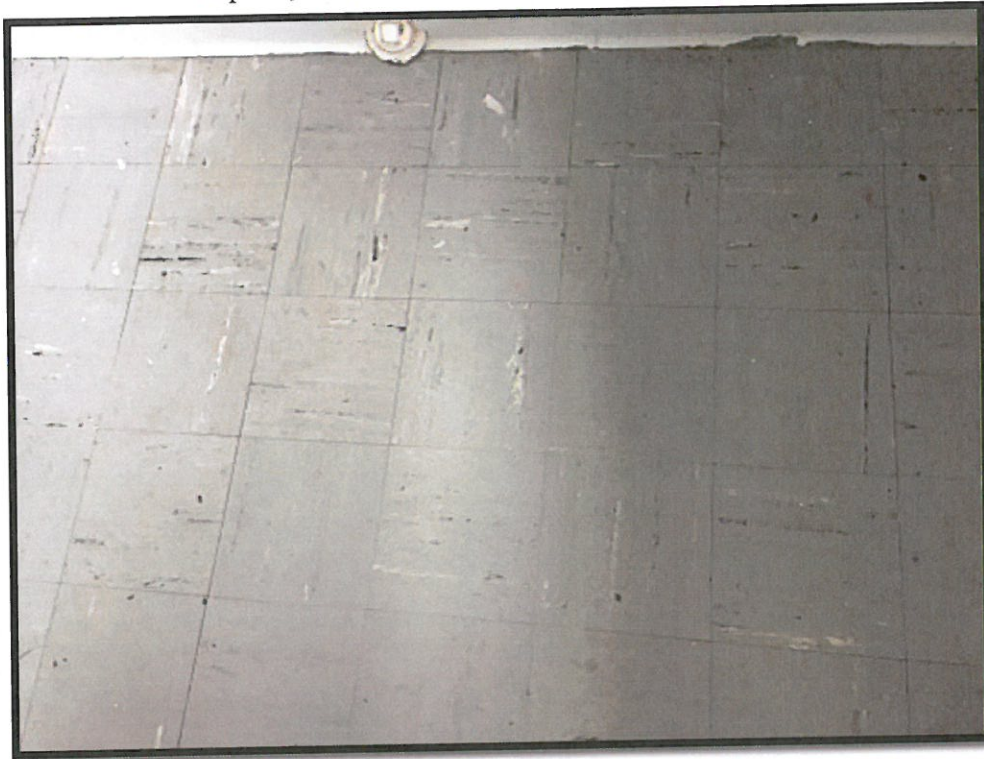
Sample A9 – Blue Floor Tile / Main Women’s Washroom

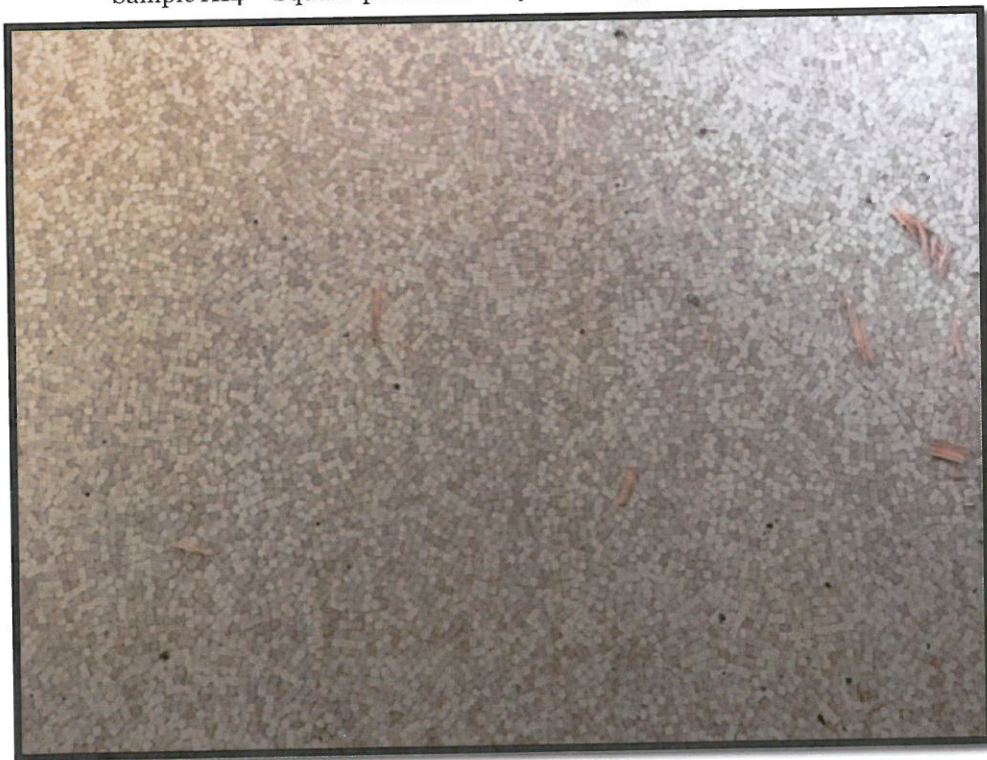
Sample A14 – Square-patterned Vinyl Flooring / Auditorium Kitchen

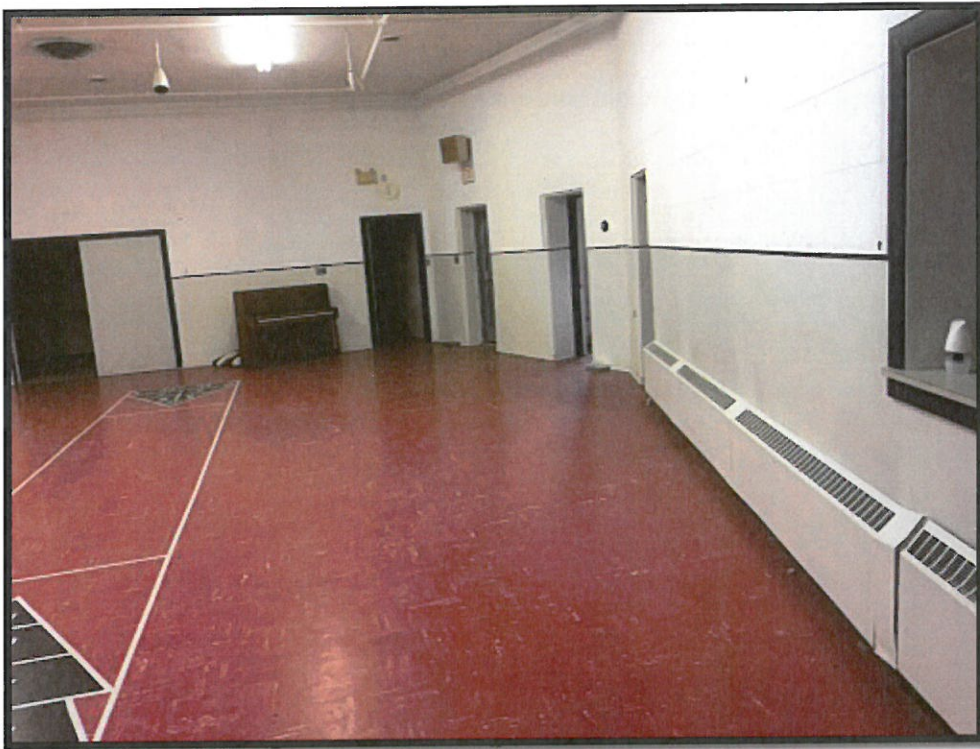
Sample A16 – Joint Compound; Walls / Auditorium

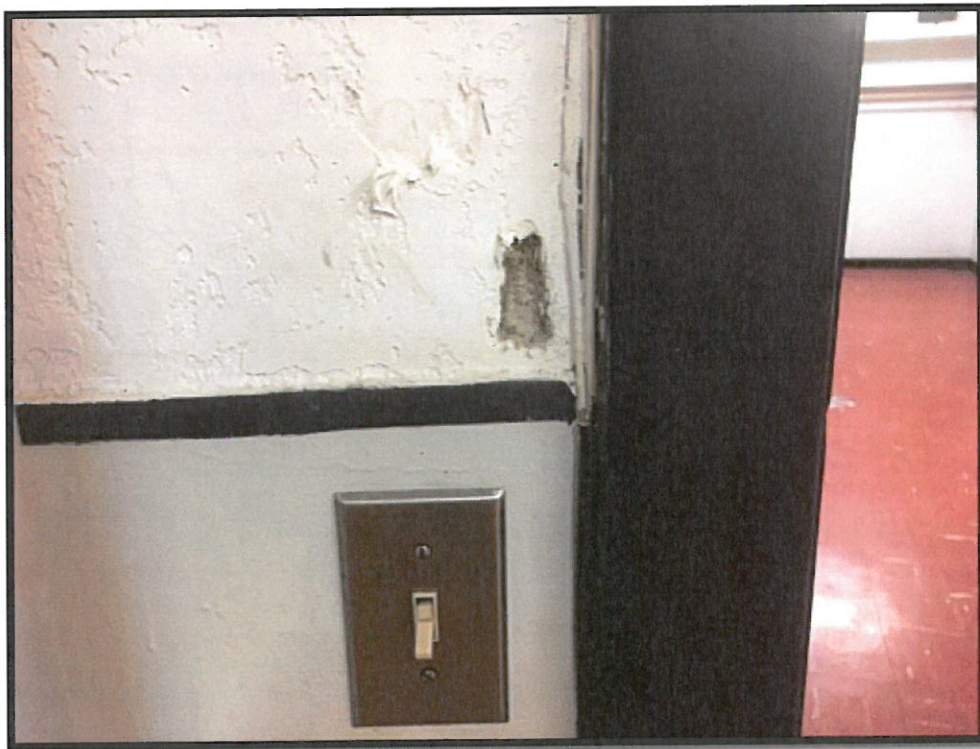
Sample A18 – Grey Wall Material Insulation / Auditorium

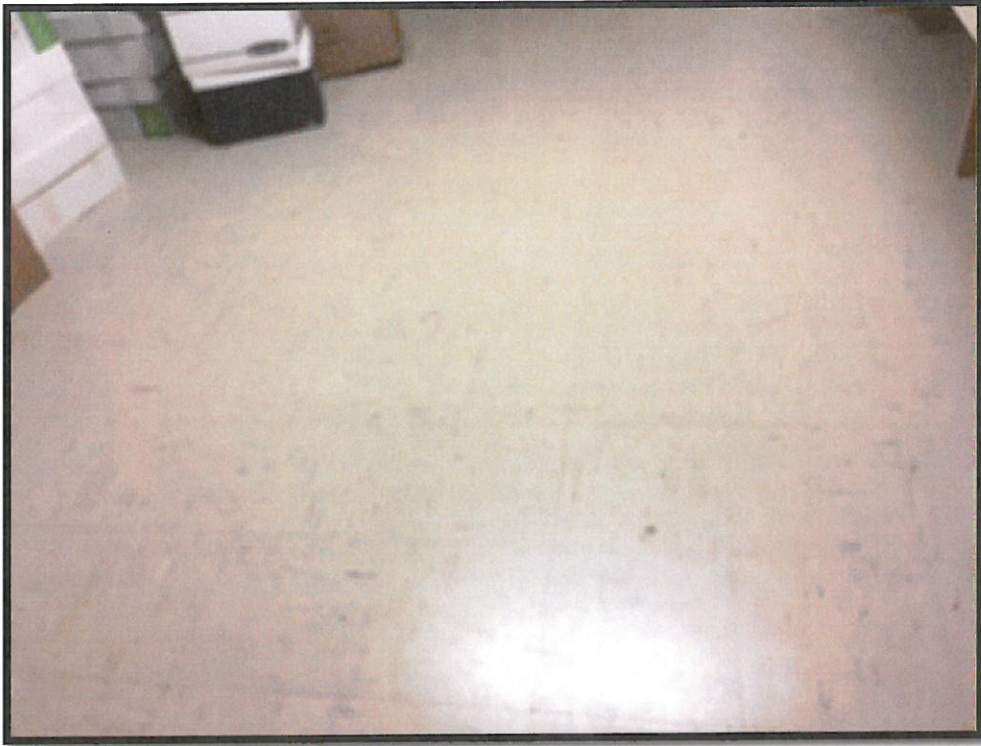
Sample A21 – 12x12 Cream Floor Tile / Upper Auditorium

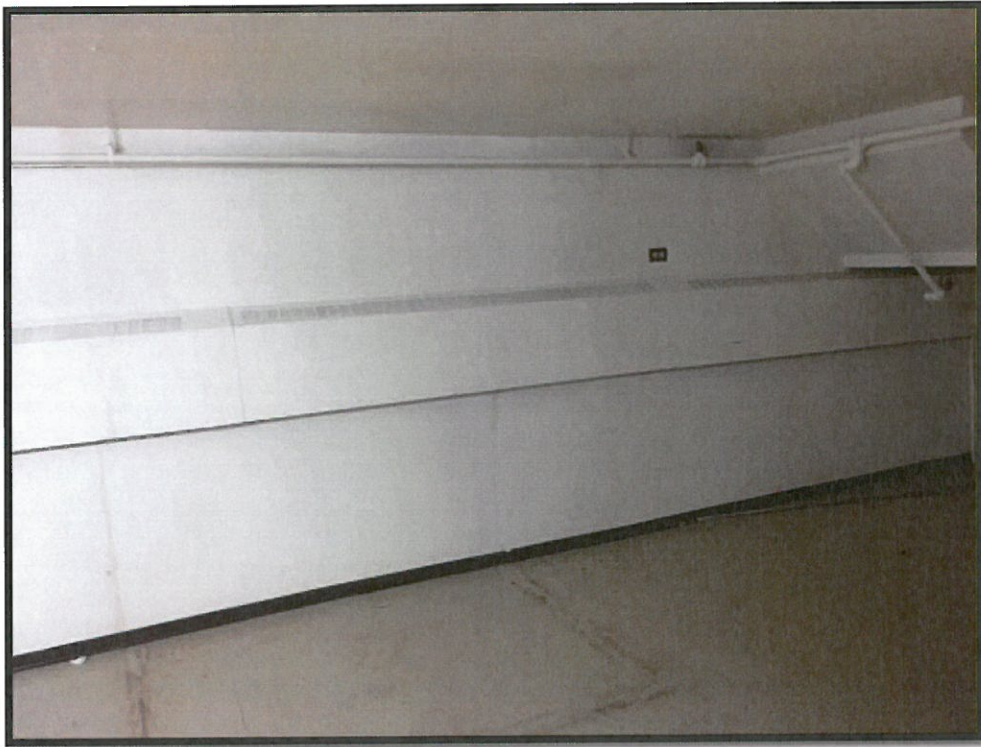
Sample A23 – Joint Compound; Walls & Ceiling / Auditorium Storage Rm

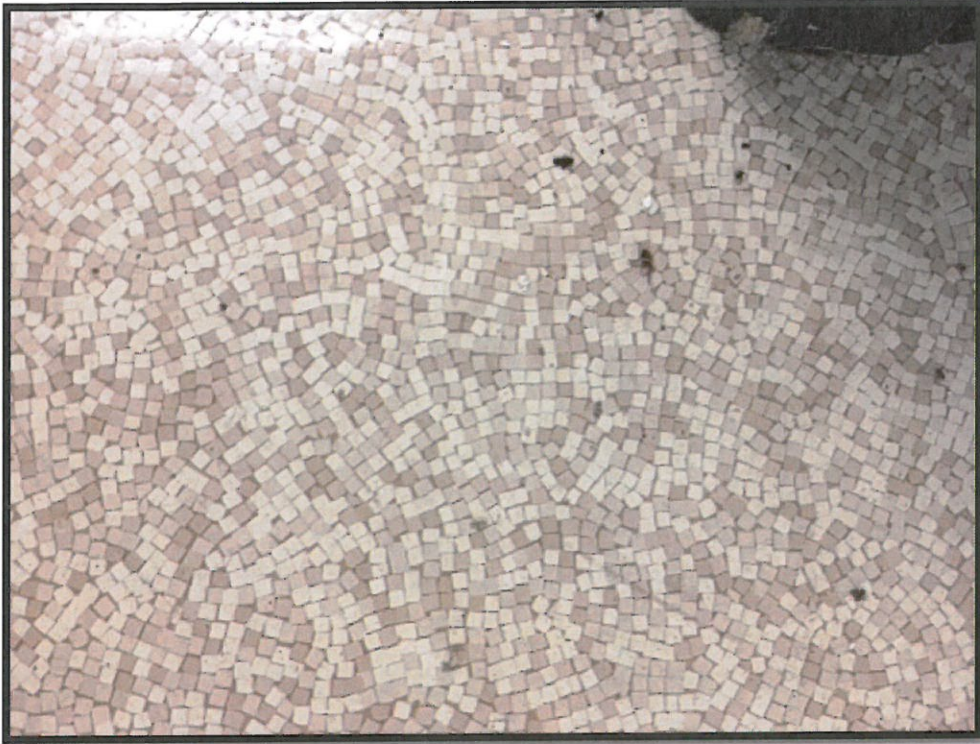
Sample A26 – Square-patterned Vinyl Flooring / Main Floor NW Hallway

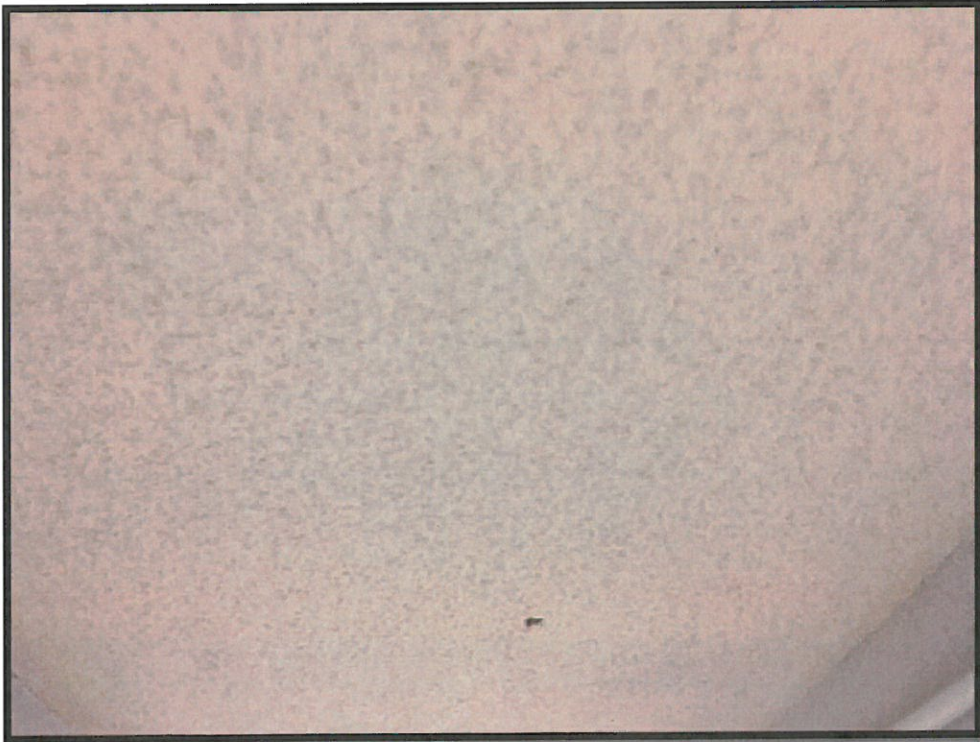
Sample A28 – Ceiling Texture / Main Floor NW Hallway

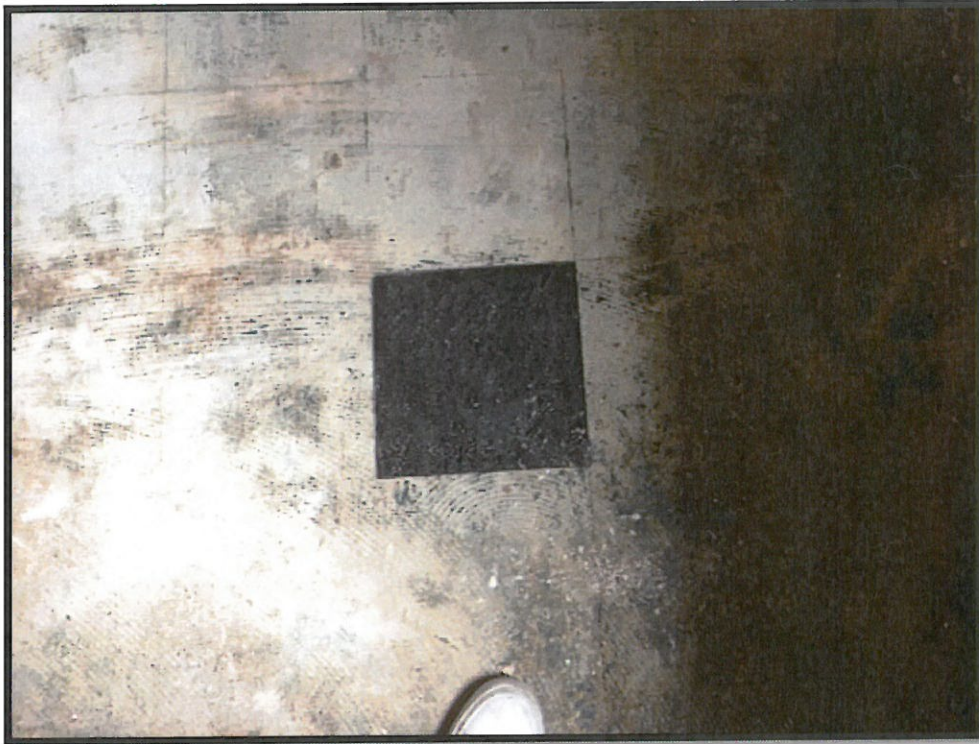
Sample A35 – Blue 9x9 Tile / Main Room 3

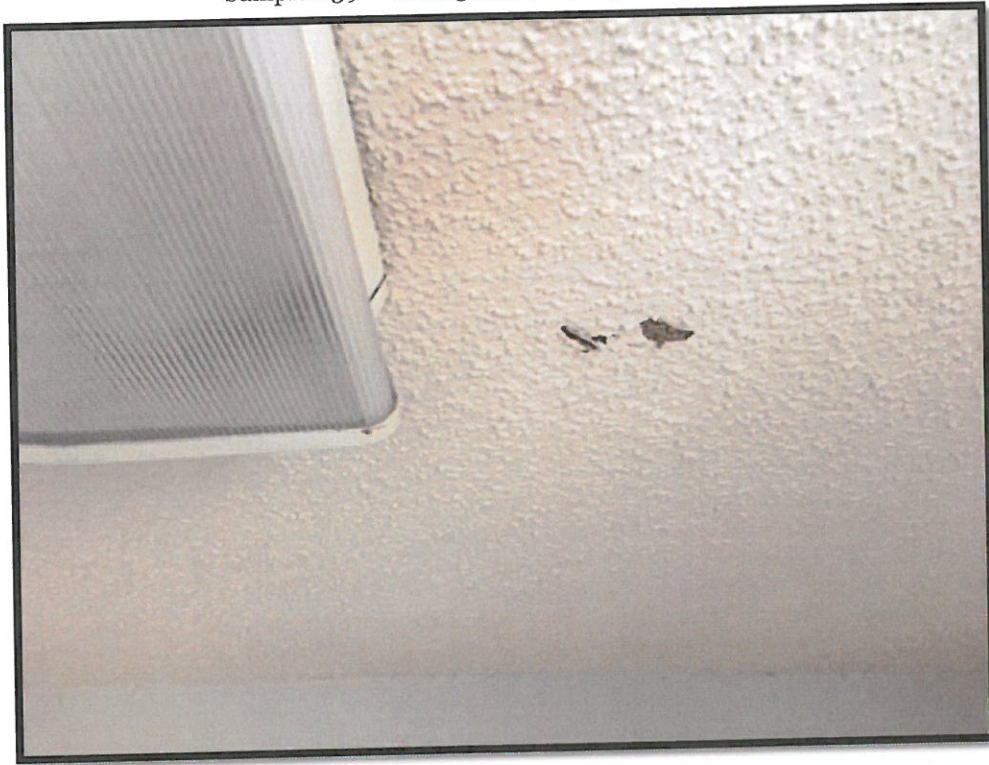
Sample A39 – Ceiling Texture / Upstairs, Room 1

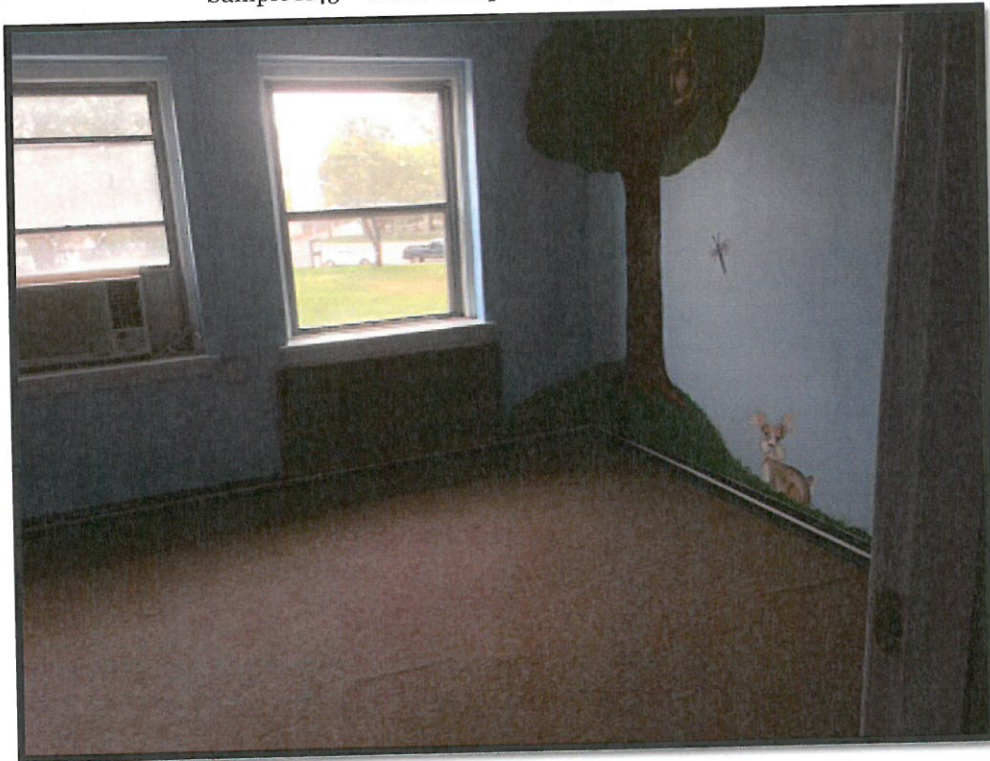
Sample A45 – Joint Compound / Upstairs Room 113

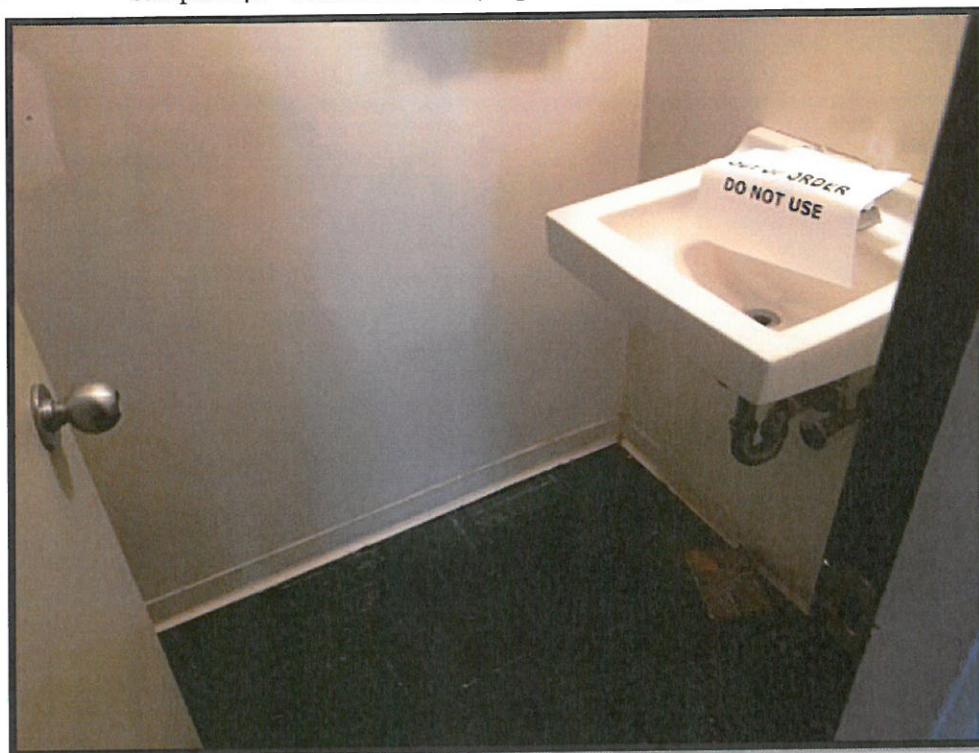
Sample A48- Green Floor Tile / Upstairs Hallway; Janitor's Room
