BYLAW NO. 2019-5

THE CONSERVATION OF HERITAGE PROPERTIES TAX EXEMPTION FOR  
CATHEDRAL COURTS, FORMERLY KNOWN AS SACRED HEART ACADEMY  
LOCATED AT 3225 13<sup>TH</sup> AVENUE BYLAW, 2019

Conservation Report  
2018-04-05

**Cathedral Courts Conservation Plan Supplement**  
2018-05-24

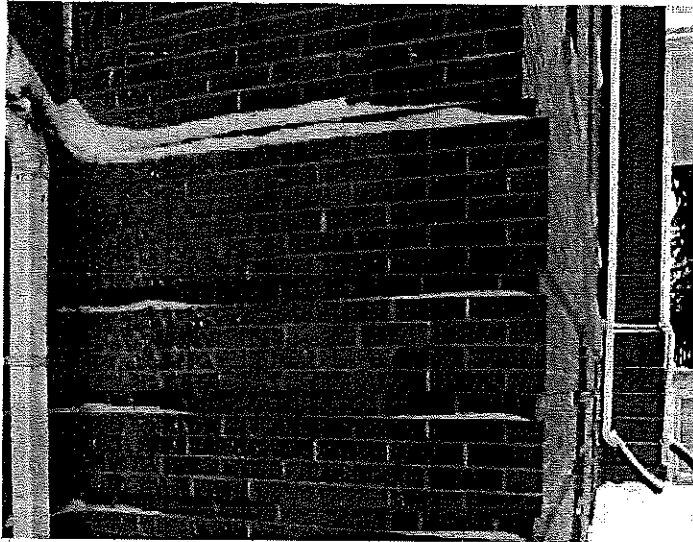
Figure 8 – double projecting brick courses at top of rustication on 1909 and 1914 portions

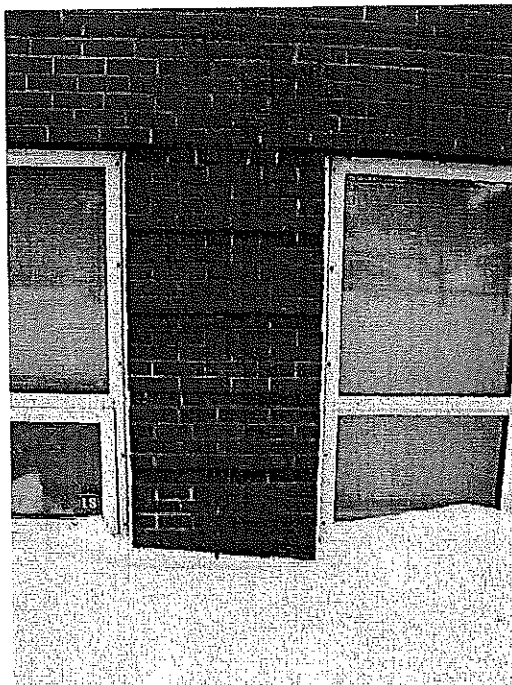
At some point in the past all except one of the brick arches of the lower windows of the 1909 portion was replaced with running bond brick supported on a steel lintel. There is still one arched brick opening just to the east of the main entrance projection. The brick arches still exist west of the main entrance on the 1914 portion.

Figure 9 — running bond on steel lintels (replaced brick arch lintel)

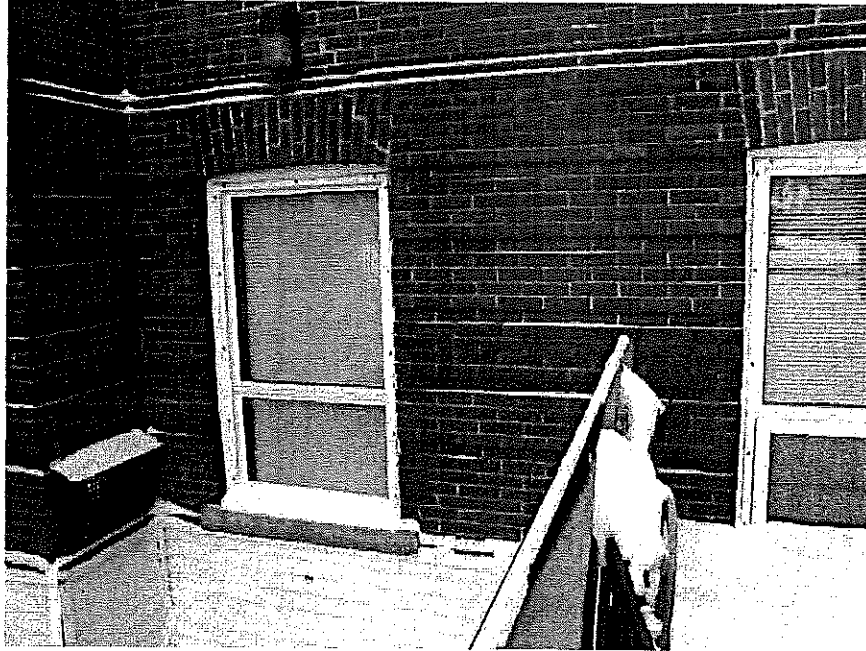
Mortar has been replaced at some time in the past at various locations along this façade, generally along the lower bands of rustication. Currently, the mortar joints on this façade have quite a bit of deterioration. Conditions observed include:

- Weathered vertical joints, especially along the top two stepped brick courses
- Deteriorated joints with a high degree of weathering both horizontal and vertical
- Localized areas of missing horizontal and vertical joints
- Very soft mortar (powder) localized in areas west of the main entrance
- Localized areas at the west end of the facade that has been previously raked out but mortar not replaced (appear to have been ground out as some damaged bricks noticed)
- Staining of brick between windows below stepped brick courses

Figure 11 – Area of 1914 portion with deteriorated mortar joints

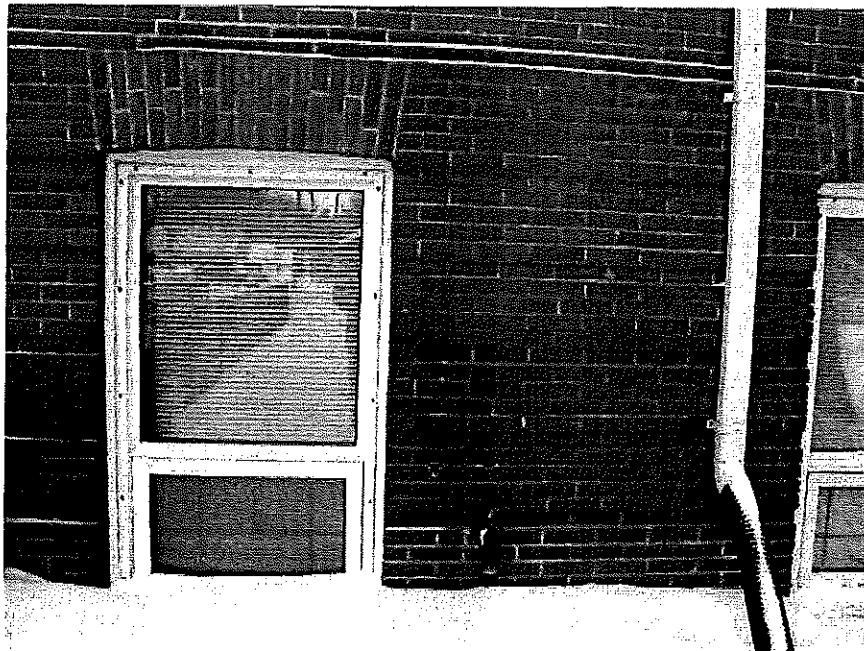
Figure 12 – Area of 1914 portion with deteriorated mortar joints (note dark staining at stepped bricks)

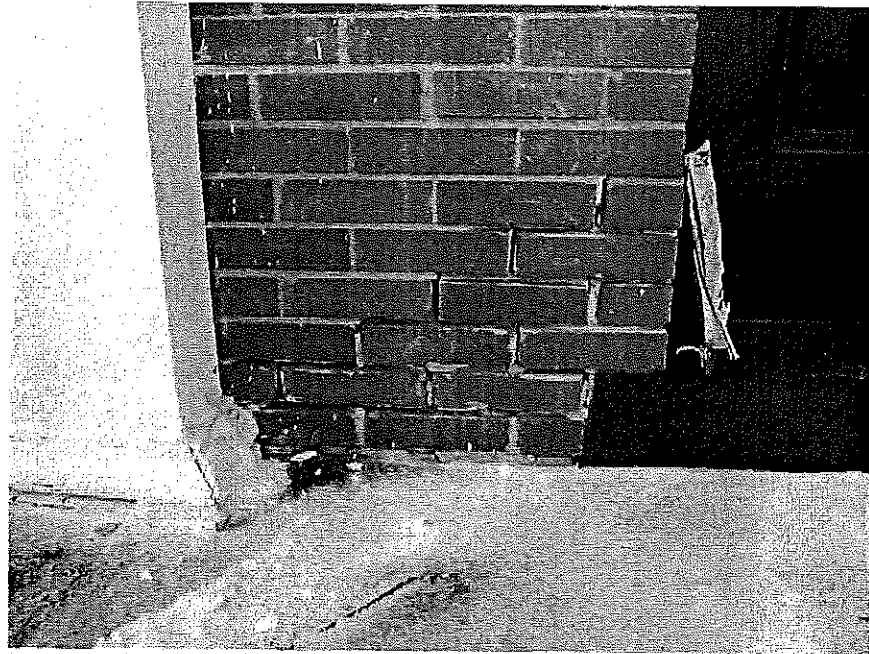
There are areas around the main entrance on the North side of the building where the brick has broken and fallen out, likely due to the differential movement between the stair structure and the masonry wall. Some areas of brick appear to have been replaced at some time in the past, such as at the west side of the stair, possibly when the ramp was installed. The pilasters on the east side of the stair are damaged. The small pedestals at the bottom of the stair need repointing below the stone cap.

Figure 14 – Damaged masonry at both sides of the main entrance doors at top of stairs

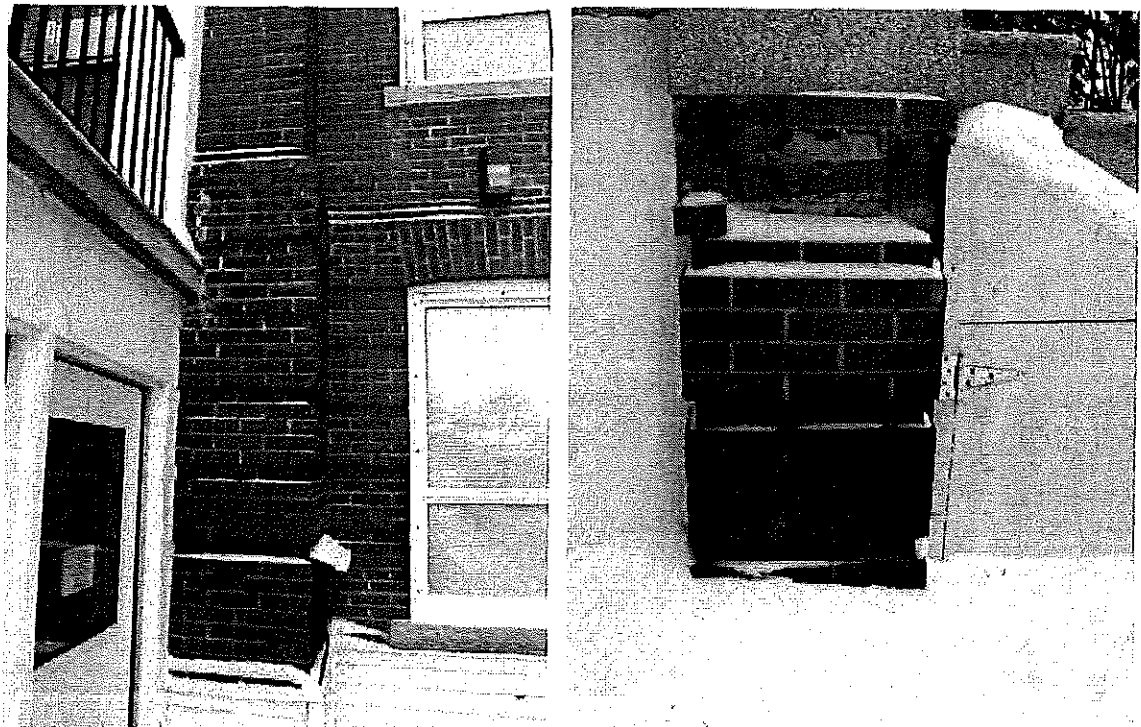
Figure 15 (left) – West side of stair – similar damage at landing both sides of main entrance  
Figure 16 (right) – East side of stair – bricks missing on pilaster of main entrance

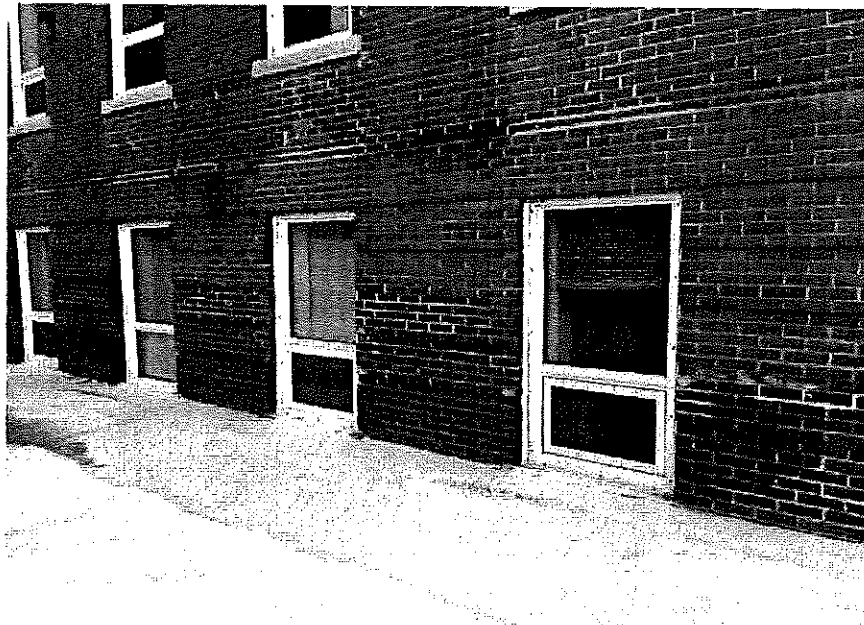
Figure 21 – South façade – note running bond above windows where original brick arches have been replaced

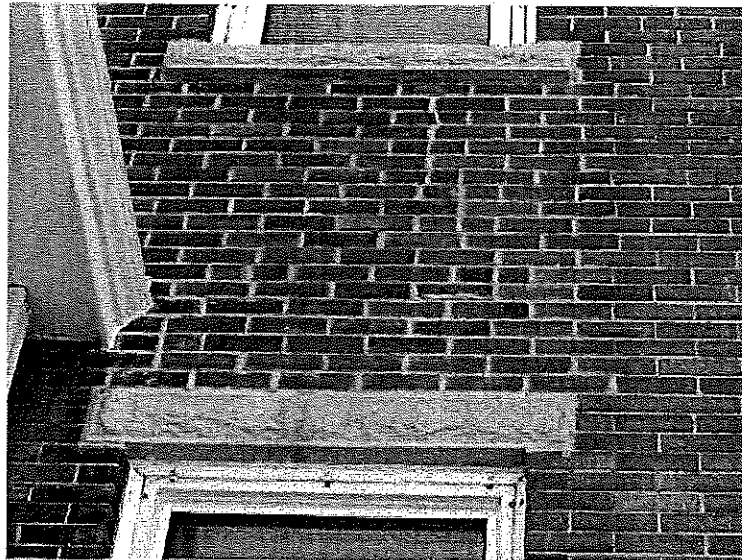
The method used to repair the stone lintels and sills at this end of the building entailed removal and replacement of the brick masonry above and below the affected windows. The resultant work has a significant impact on the historic masonry work on the building due to full removal of the original work. It has been replaced using a different treatment of the final mortar joint. The original mortar joints are tooled in a slightly “weathered” joint, whereas the reinstalled masonry has used a “coved” tooled joint. Further to this, the brick work was not cleaned off sufficiently after work was completed, leaving mortar around the edges of the bricks. The removal and replacement of the brick masonry has also left some of the bricks damaged. There was no effort to replace these broken bricks and they have been reinstalled into the wall.

Figure 23 – East façade – note brick joints in area of replaced wall above and below windows

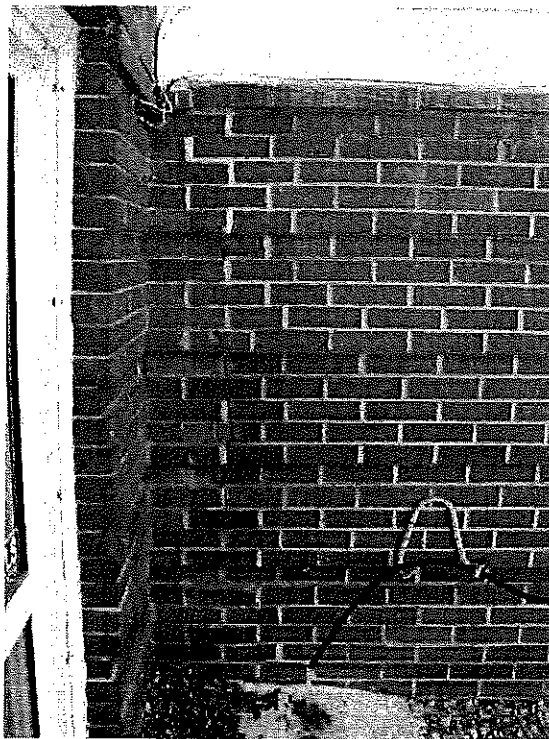
The porch on the East side of the building is experiencing some movement, as illustrated by the open crack and repointing work adjacent to it.

Figure 24 – Vertical crack on south side of porch on east side of building

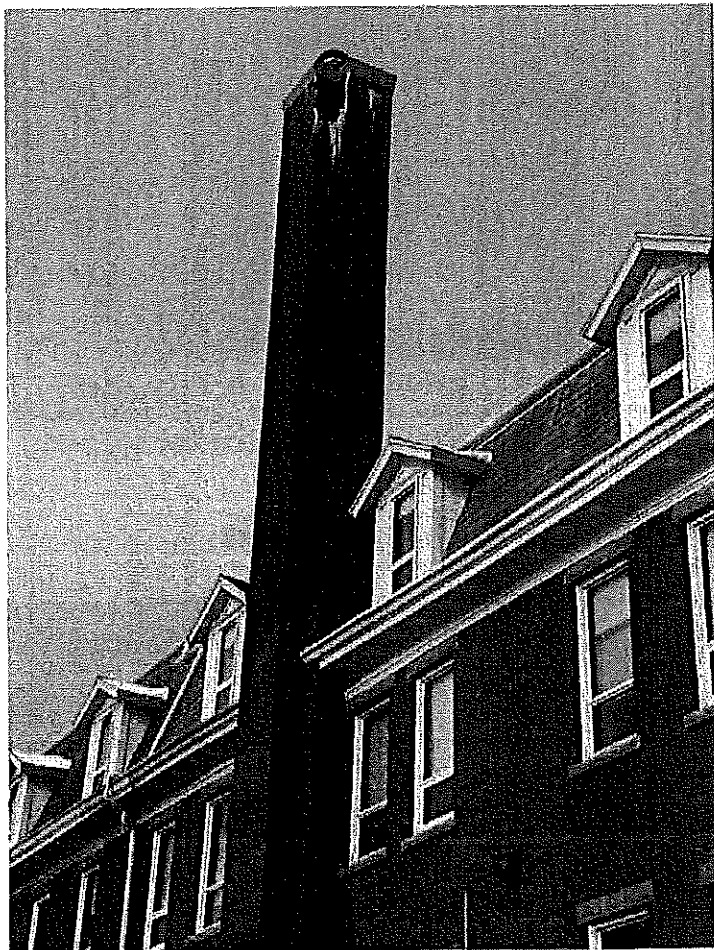
Figure 25 a) – Chimney is wet from combustion gasses seeping through flue liner.

We are recommending removal of the upper part of the chimney, as it is overly high, rebuilding of the chimney from the eave line up to 1 metre above the upper roof level, and repointing of the remainder of the chimney. More investigation may be necessary. We propose similar brick detailing at the top of the rebuilt chimney to that on the existing chimney at the west end of the building. Reducing the height of the chimney will make future repair and maintenance more reasonable in effort in cost.

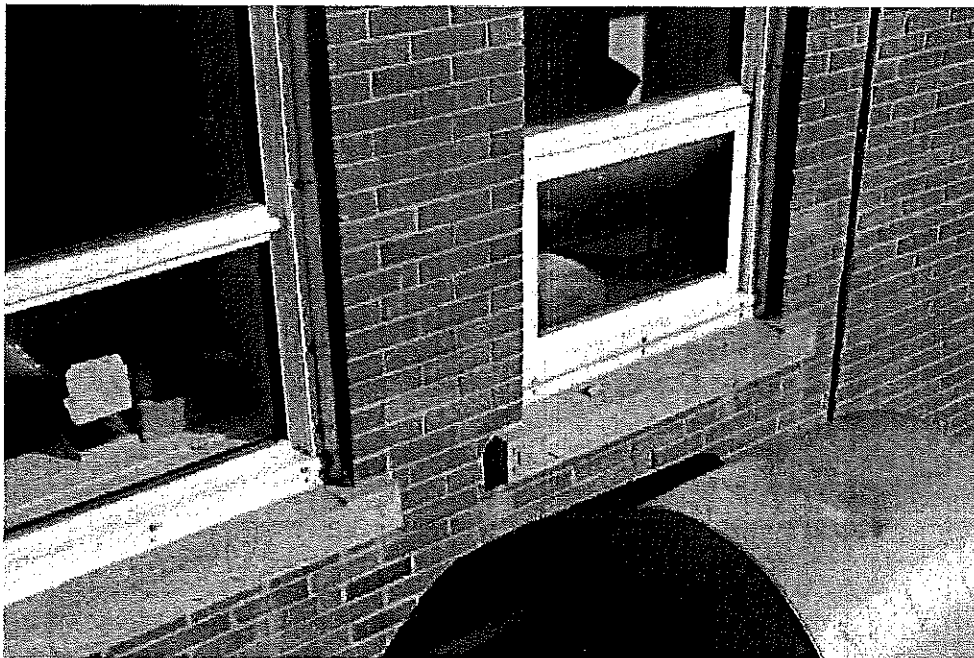
Figure 26 – Example sills with evidence of previous repairs on South face of building

For the stone sills that are cracked we recommend repairing in-situ. Similar methods can be used to fill narrow cracks as described for the lintels. That would employ injection crack fill and sufficient removal of any loose stone material around the crack to sufficient depth to allow for bonding of the repair mortar. Where there are large loose pieces of stone that have broken away, these may be removed, loose material cleaned away, and then set in place using a setting mortar and pinning in place or anchoring the material. The resultant crack can be repaired using proprietary repair mortar. Piecing in may be required where large pieces of stone are missing or where the break is at a corner or edge. Finding matching stone would be the greatest challenge for piecing in work. See Figure 27 for example of a severe crack in the sill where a large amount of stone material is missing.

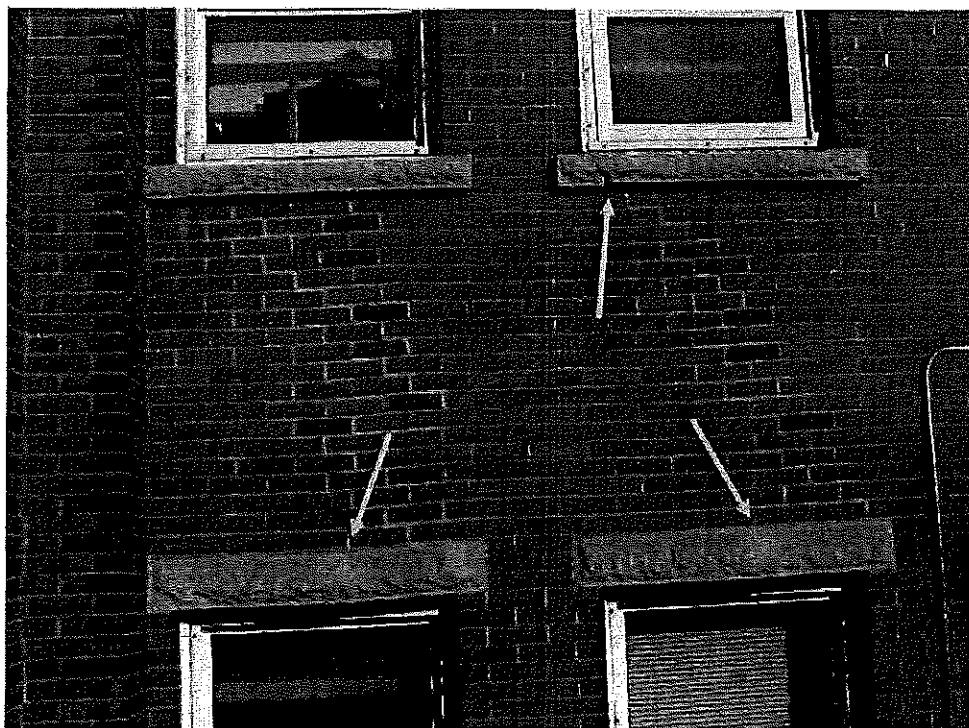
Figure 27 – Examples of cracked stone sills and lintels with evidence of previous repairs on South face beside chimney

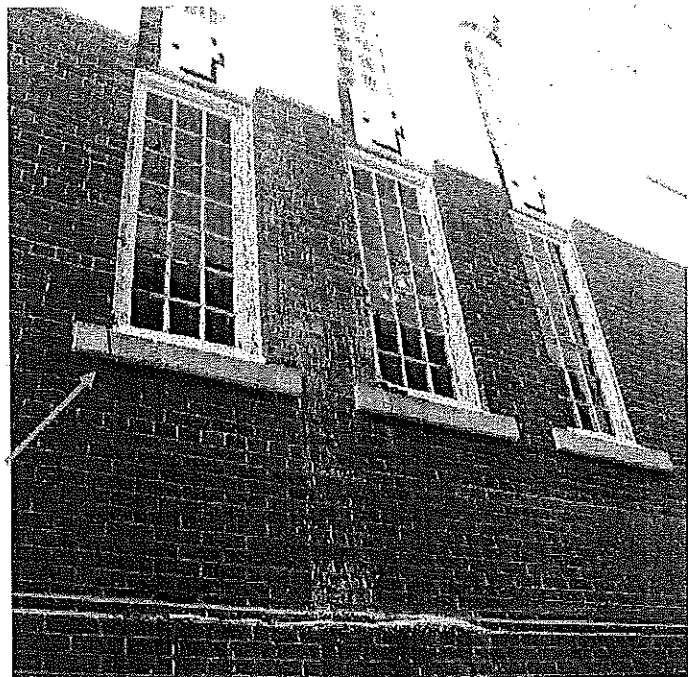
Figure 29 – South face of Chapel showing cracked Tyndall Stone sills on two windows

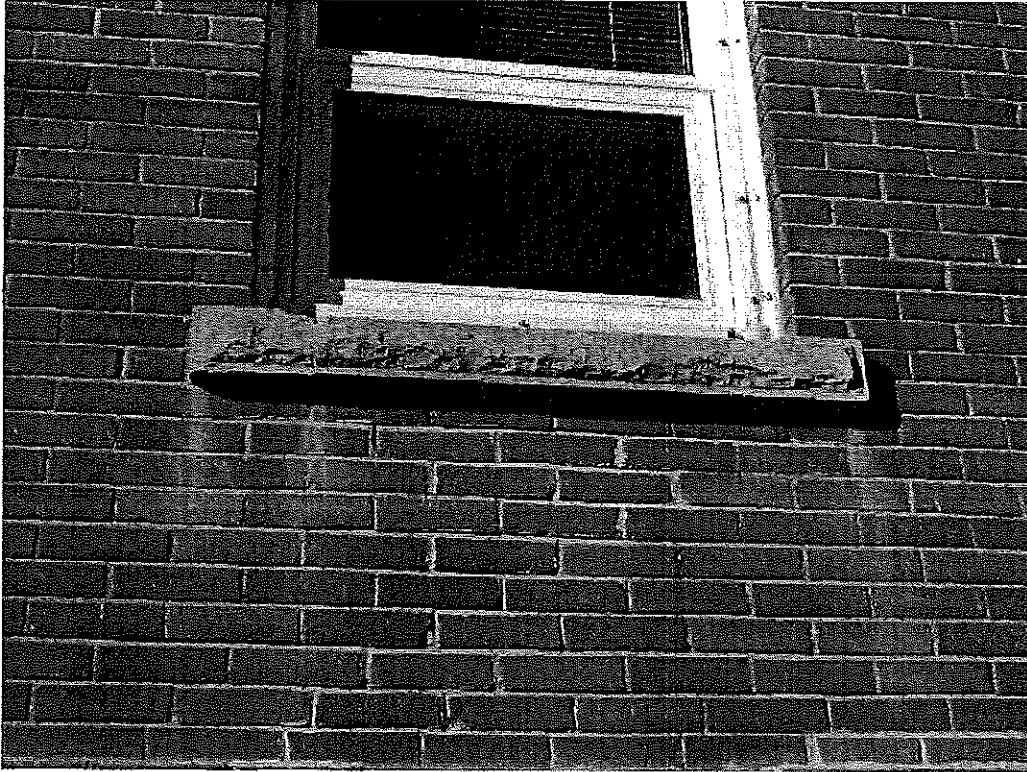
Figure 30 – Cracked limestone sill on South face of building

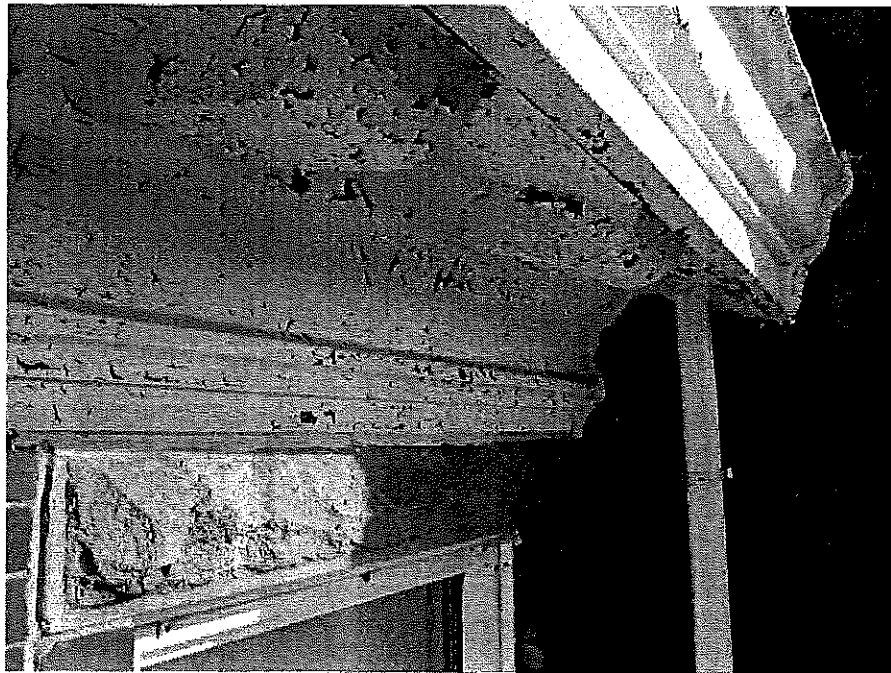
Figure 33 – profilled metal cornice on south face – noticeable deflection

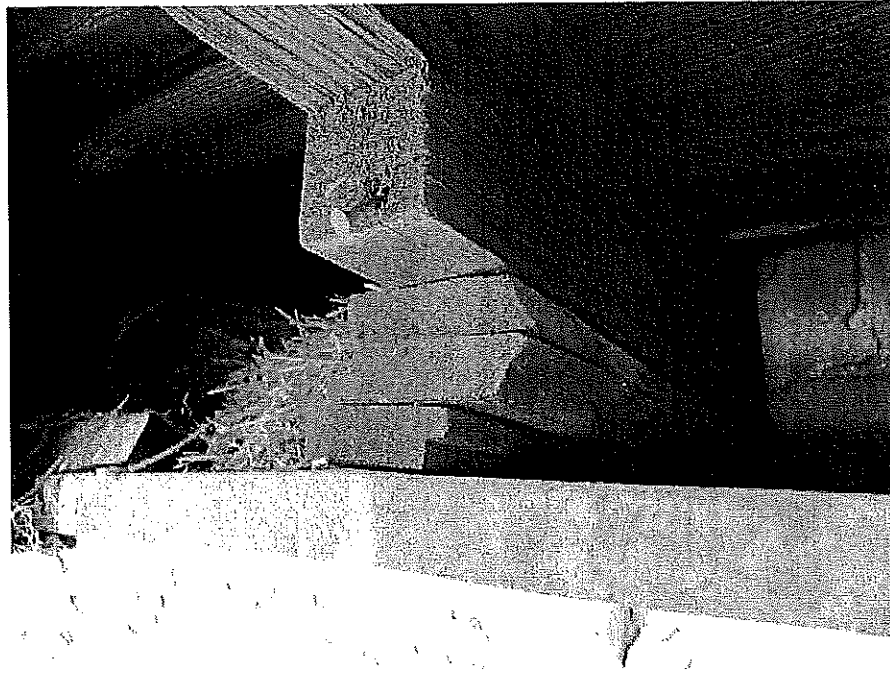
Figure 34 – showing wood framing and furring (note bird nest)

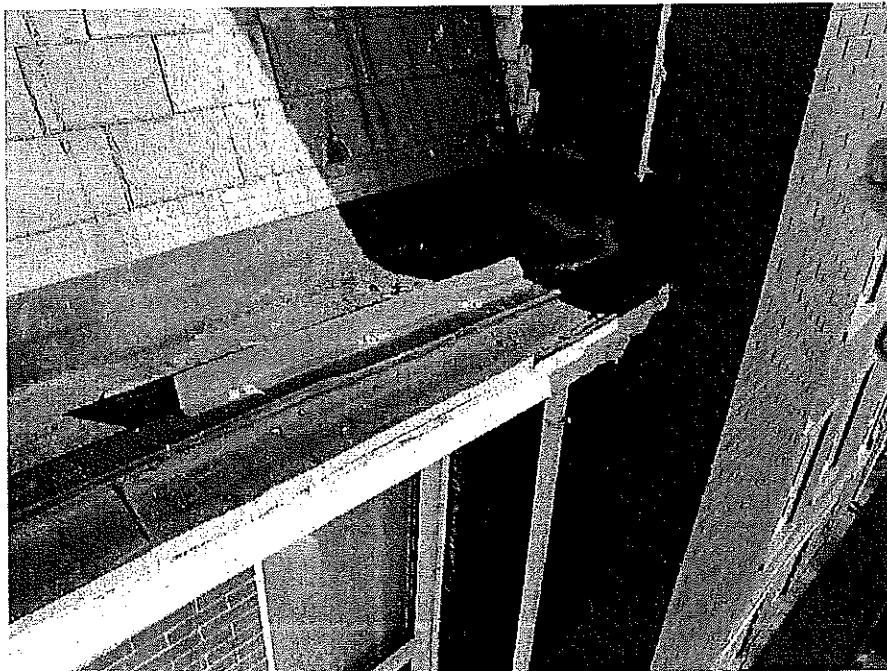
Figure 35 –top side of cornice with EPDM roofing (wet condition at chimney)

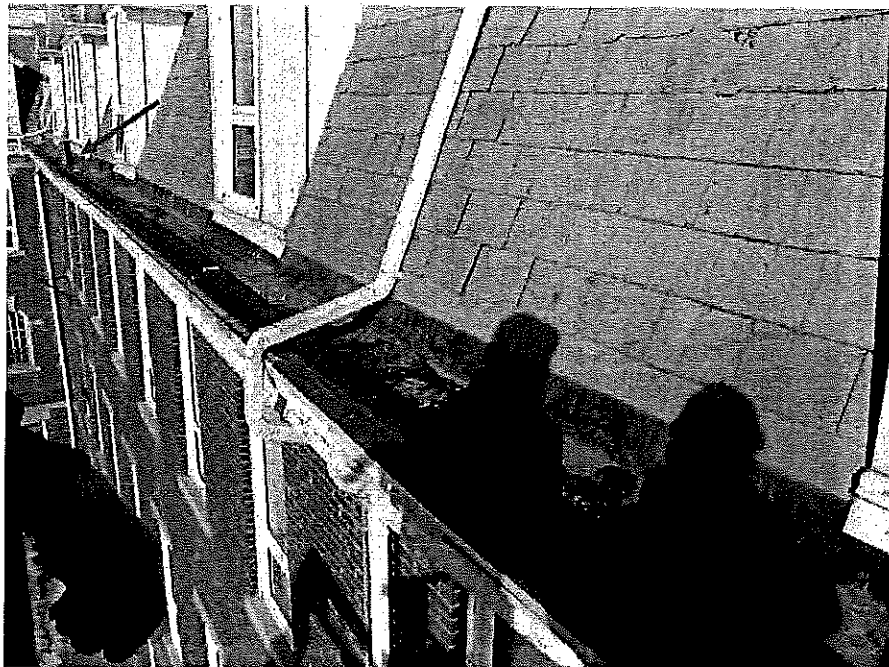
Figure 37 – top side of cornice with EPDM roofing – at least one roof drain in the cornice appear to have been closed off (red arrow).

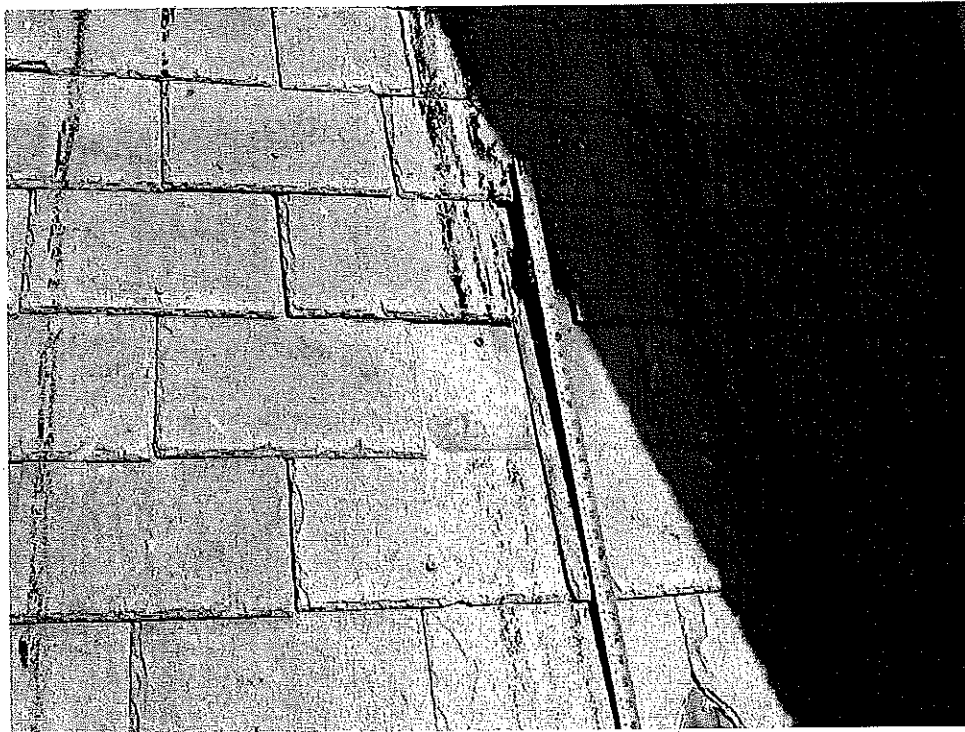
Figure 38 – South façade - missing and broken slates and fasteners through face of slates (common around building)

Where the slate is missing it should be replaced. The flashing around the dormer roofs should be replaced (none is evident). Some joints have been caulked, perhaps to address moisture ingress at some point in time. There may be limited tradespersons who can do the slate repair work. Consideration should be given to replacing the areas of the slate roof with the most damage. The areas where screws have been installed through the face of the slates should be observed periodically to ensure that any damage can be addressed.

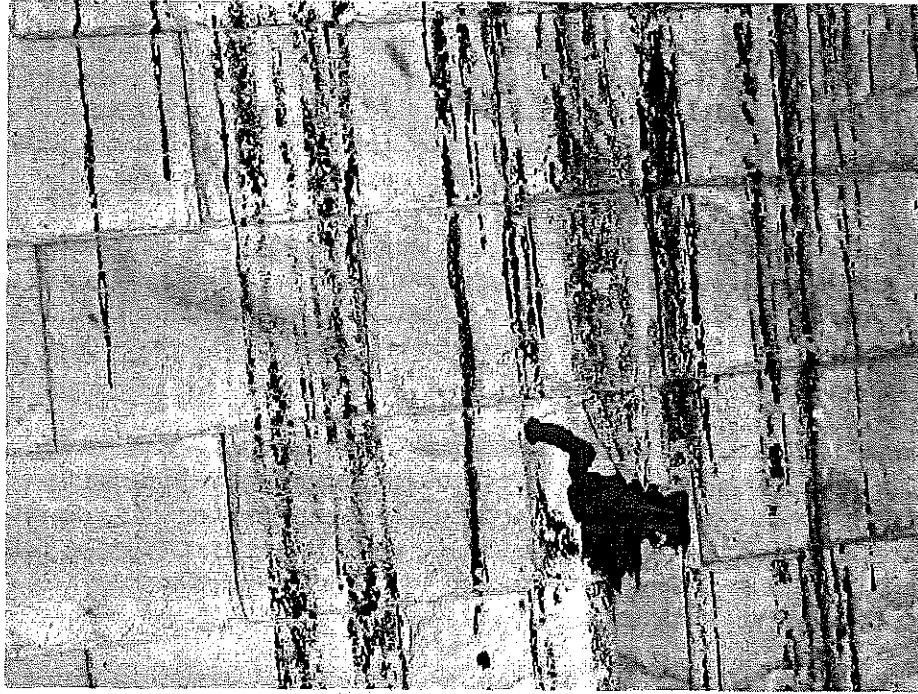
Figure 39 – South façade— asphalt or tar on slates (common around building)

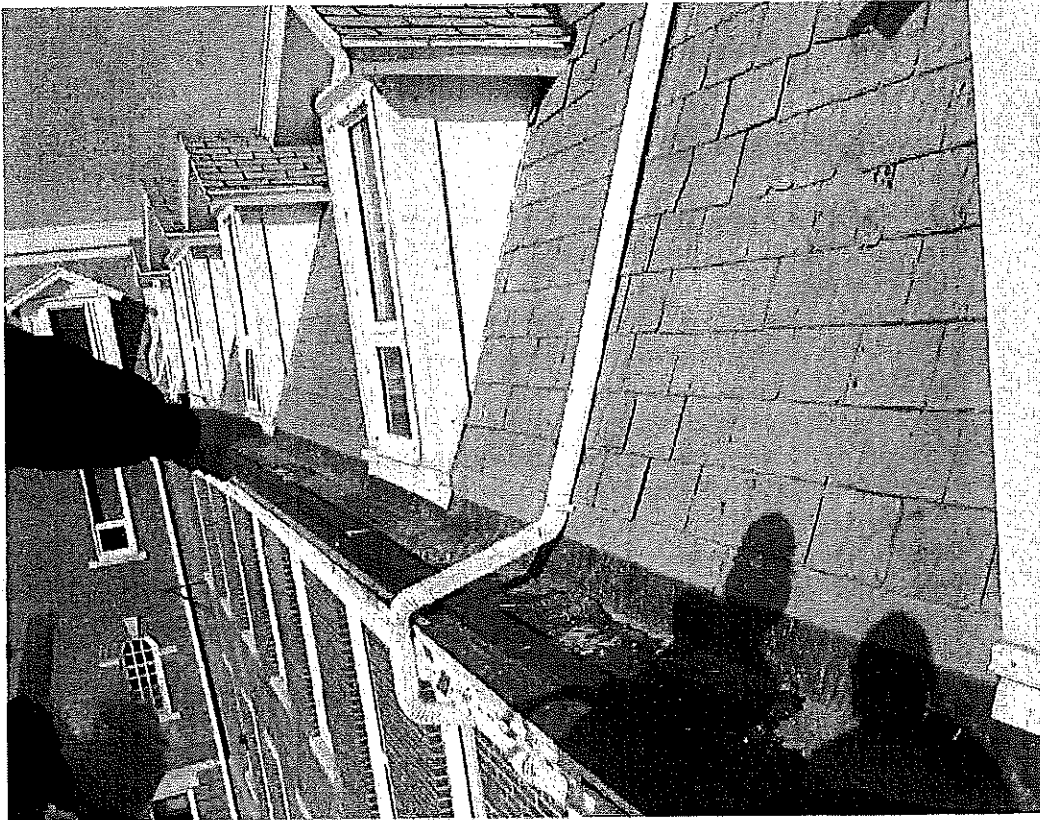
Figure 41 – South façade – plugged off roof drain location (below downspout). Also note broken, loose slates with face fastening.

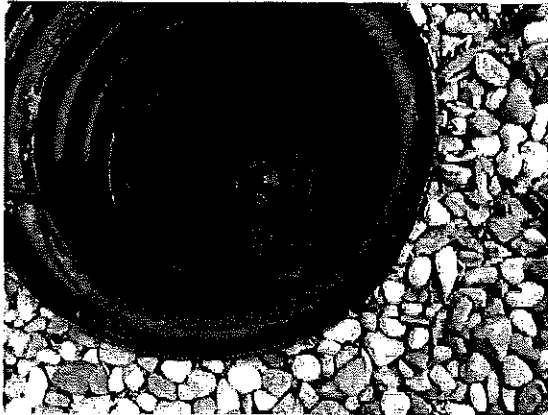
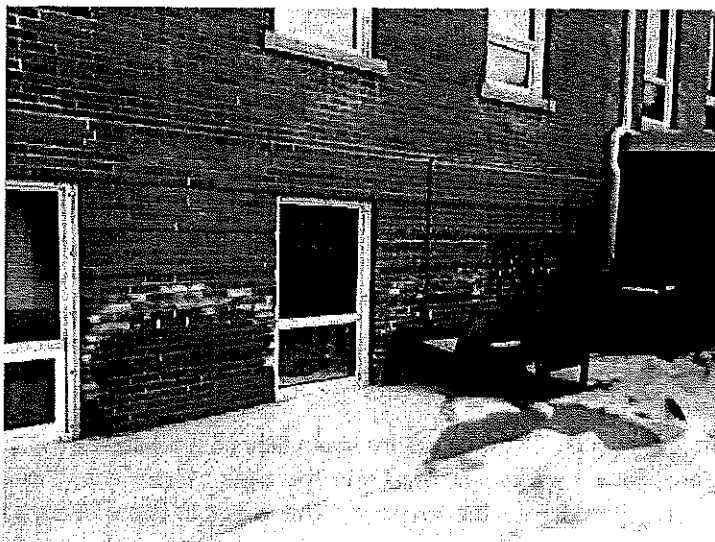
Water staining on the brick masonry above grade on the south side of the building indicates that the masonry is wicking up moisture from ground level into the walls. There is also evidence of water splash up onto the wall, noticeable on the windows. This is due to there being a concrete apron immediately next to the building.
