2550 Broad Street , Regina, SK HAZMAT Assessment

Project #: SQ1RG18101
August 28, 2018

Squareone Consulting Ltd. was authorized by Connie Conard of Brandt Developments Ltd. to conduct a Hazardous Materials Assessment at 2550 Broad Street, Regina, SK. The assessment was conducted on August 24, 2018 by Squareone's Desmond Slack.

406 Broadway Ave E, Regina, SK HAZMAT Assessment

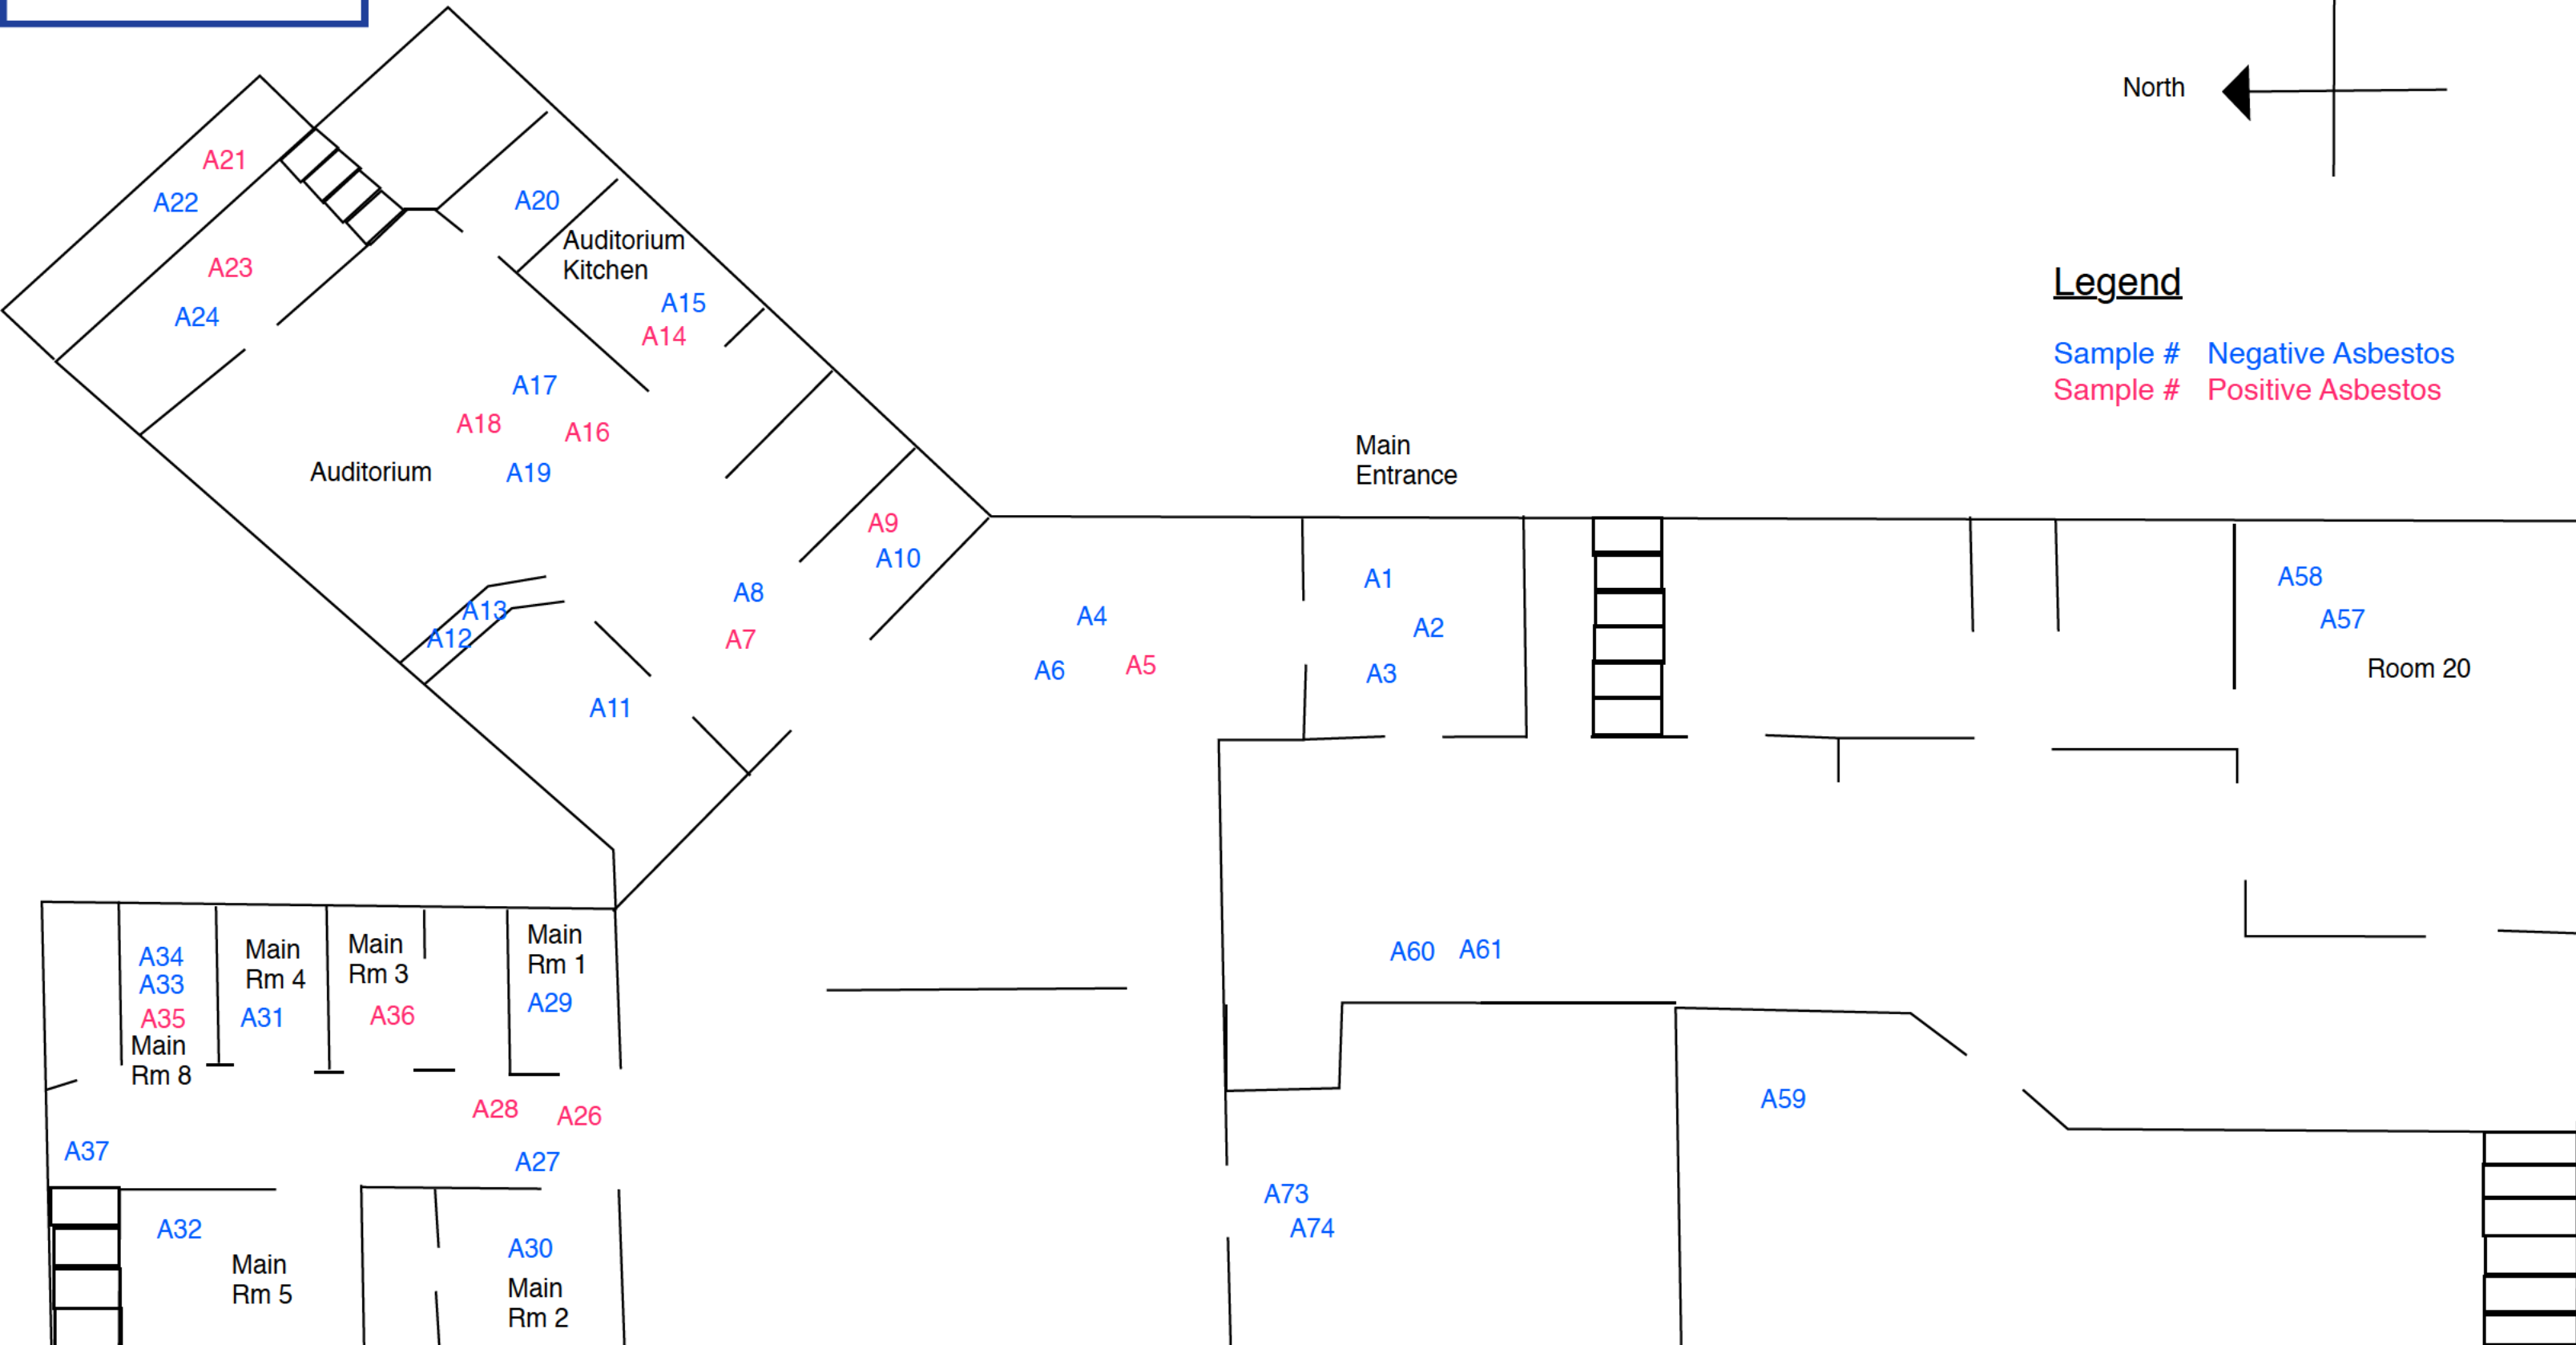
2550 Broad Street, Regina, SK, Main Level Floor Plan

During the assessment, multiple products were suspected to possibly contain asbestos, were noted and were sampled. Results show that sixteen (16) samples returned positive for asbestos content: joint compound, vinyl sheet flooring and floor tile, ceiling texture, and wall material.

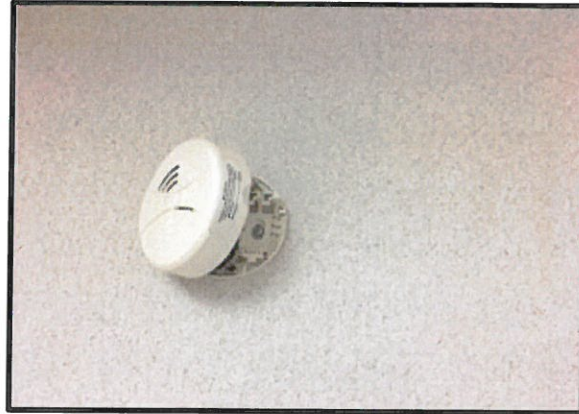
4.5 Radioactive Components

During the assessment, 14 radioactive component products are considered to radioactive components.

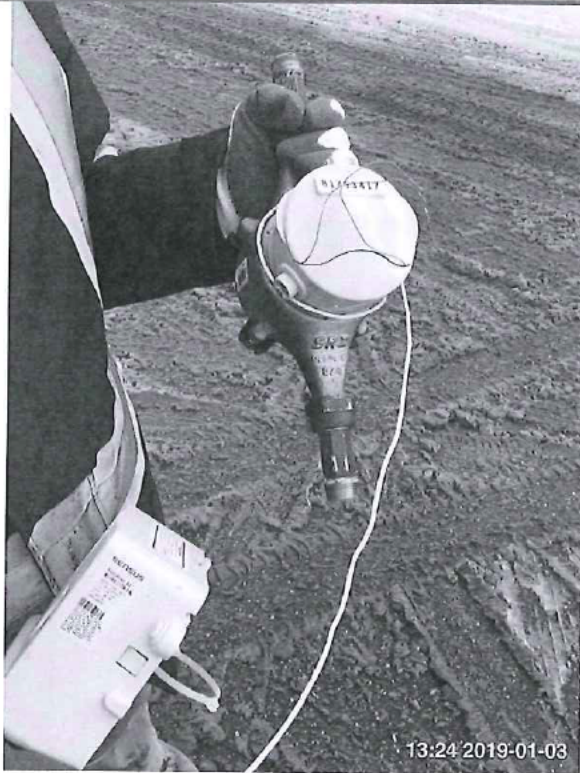
ISSUE 1

Removed water meter from basement of 2550 broad st. Took back to city of Regina
