9 Inspections

9.1 Sidewalks Evaluation

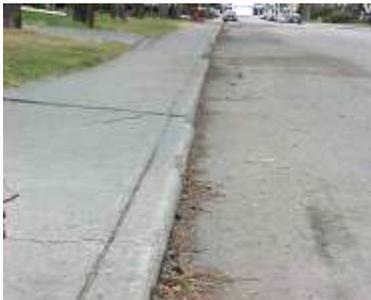
Combined Walk and Curb (CWC) sidewalks only appear in the older areas of the city, as this type is about 30 years old. The distinguishing feature is that the walk and curb are combined without a gutter. The road asphalt is set right next to the curb and it provides the drainage for water. This method is no longer used because current sidewalk standards for Regina require a gutter. CWC walks cannot be mud jacked in most cases.

Figure 16: Combined Walk and Curb (CWC)

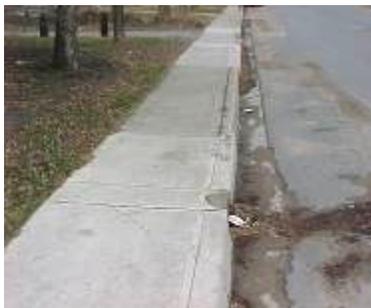
The Monolithic sidewalk is the most common type and can be found in every area of Regina. It is a combined walk and curb with an 18-inch concrete gutter. The walk, curb and gutter are installed together during construction. Standard monolithic walks are 1.2 or 1.5 meters in width with a 3% cross slope toward the gutter.

Figure 17: Monolithic Walk (MONO)

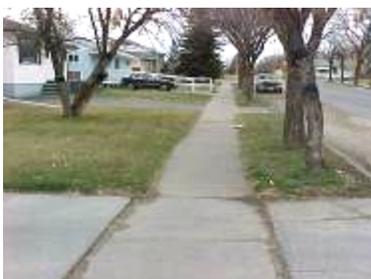
The Separate Walk & Curb/Gutter type is when a boulevard separates the walk from the curb and gutter. An example of this can be found on Elphinstone Street near Avonhurst Drive where trees are planted between the sidewalks and curb. The defining feature is that the separation is landscaped with grass, trees, and/or landscape rock.

Figure 18: Separate Walk & Curb/Gutter (SEP)

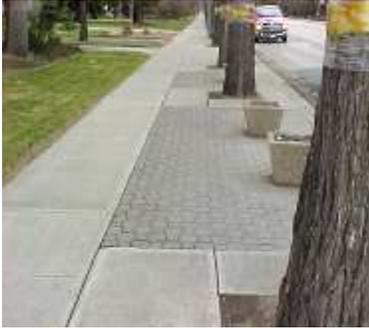
The Enhanced sidewalk is similar to a separate walk in that the sidewalk is separate from the curb and gutter. The defining feature is the presence of paving stones or concrete pads. These sidewalks require higher maintenance investment as the paving stones may shift individually causing distresses. For these walks, distresses in the paving stones must also be rated. In Regina, this type of walk can largely be found in the downtown area. Ratters must be sure to differentiate paving stones from stamped concrete which is poured like a monolithic walk and then stamped to resemble paving stones. Stamped concrete exists in Regina's downtown and should be noted on the rating form.

Figure 19: Enhancement (Paving Stone) (EN)

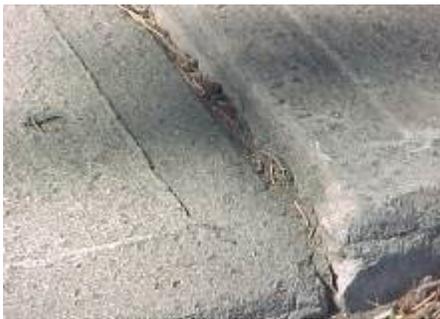
Differential Settlement occurs when two adjacent pieces of sidewalk have separated and the vertical displacement is causing a tripping hazard.

1. Distress Code (D)
2. Chainage at the beginning of the first affected panel
3. Width of crack at widest point in millimetres (Widest Full Depth)
4. Maximum vertical displacement of crack
5. House number (if available)
6. Any relevant comments

Figure 20: Differential Settlement (DS)

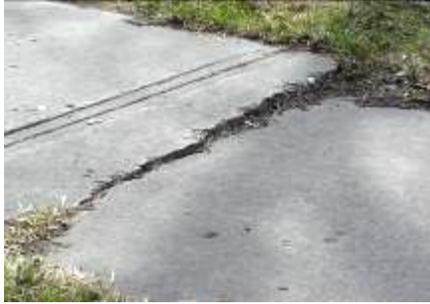
A transverse crack is a full-depth crack in the sidewalk that is roughly perpendicular to the direction of the walk or curb.

1. Distress Code (T)
2. Chainage at the beginning of the first affected panel
3. Width of crack at widest point in millimeters (Widest Full Depth)
4. Maximum vertical displacement of crack
5. House number (if available)
6. Any relevant comments

Figure 21: Transverse Cracking (T)

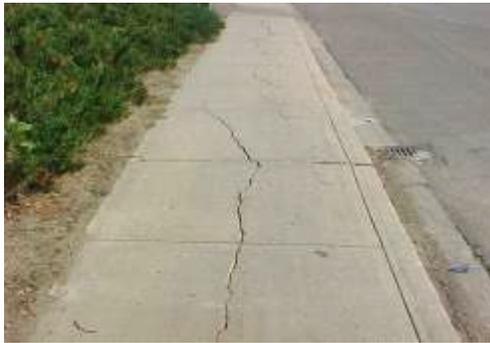
A longitudinal crack is a full-depth crack in the sidewalk that runs parallel to the direction of the walk. In many areas, a crack can run for the entire length of the block.

1. Distress Code (L)
2. Chainage at the beginning of the first affected panel
3. Length of crack
4. Width of crack at widest point in millimeters (Widest Full Depth)
5. Maximum vertical displacement of crack
6. House number (if available)
7. Any relevant comments

Figure 22: Longitudinal Cracking (L)

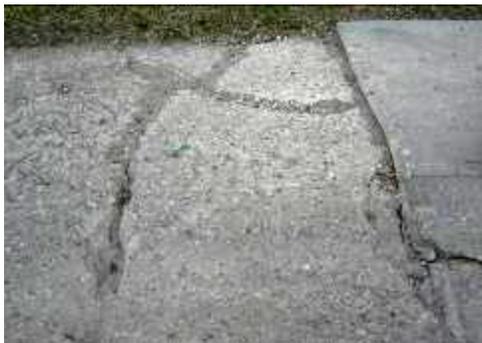
A sidewalk that has begun to deteriorate and disintegrate exposing a coarse, granular surface is called spalling.

1. Distress Code (S)
2. Chainage at the beginning of the first affected panel
3. Length of the affected panels
4. House numbers (if available)
5. Any relevant comments

Figure 23: Spalling

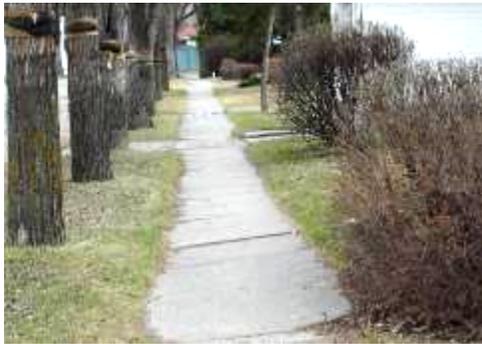
An Excessive Cross Slope occurs when heaving or settlement takes place causing the cross slope of the sidewalk to vary from the normal design slope of 3%. A positive cross slope would slope to the gutter and a negative slope away from the gutter.

Figure 24: Excessive Cross Slope (EXS)

1. Distress Code (EXS)
2. Chainage at the beginning of the first affected panel
3. Length of the affected panels
4. Greatest slope over 10% (to gutter) or under 0% (to property)
5. House number (if available)
6. Any relevant comments

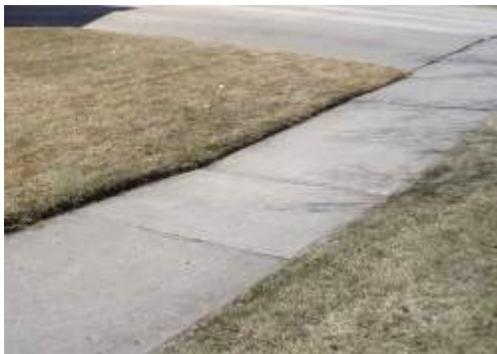
Poor Drainage is when water ponds along the gutter or in a depression on the sidewalk surface. This is usually due to settlement of the curb, walk or pavement. The severity is difficult to measure if it occurs over a long distance, but for the purpose of the evaluation, only the instance where water is ponding on the sidewalk is recorded.

1. Distress Code (PD)
2. Chainage at the beginning of the first affected panel.
3. Length of affected panels
4. Using a string line find the maximum height from the the first affected panel, to the last affected panel
5. House number (if available)
6. Any relevant comments

Figure 25: Poor Drainage (PD)

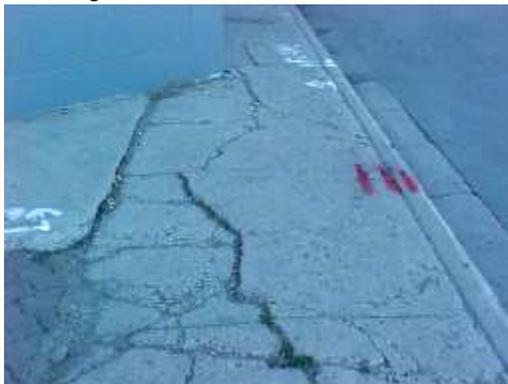
A sidewalk is considered a Broken Walk when one or more panel(s) of walk has multiple full-depth cracks and has been broken into 3 or more pieces. Broken walk occurs when transverse and/or longitudinal cracks meet or branch through progressive deterioration, damage due to heavy vehicles or equipment driving or sitting on the sidewalk, or excessive bad spalling which weakens the sidewalk and causes breakage.

1. Distress Code (BW)
2. Chainage at the beginning of the first affected panel
3. Length of the affected panels
4. The maximum vertical displacement of the most severe crack
5. House number (if available)
6. Any relevant comments

Figure 26: Broken Walk (BW)

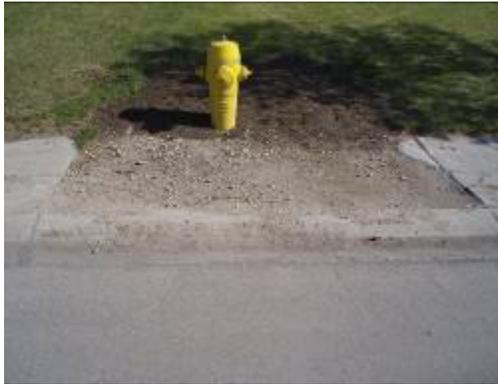
On the backside of the data forms is a list of reported Cuts (where the walk has been cut out leaving dirt or gravel). If you come across a Cut that is not reported, it must be marked as a distress. This information will be passed on so that it can be reported.

1. Distress Code (C)
2. Chainage at the beginning of the first affected panel.
3. House number (if available).
4. Type of cut (Lawn, Concrete, Pavement)
5. Any relevant comments

Figure 27: Cut (C)

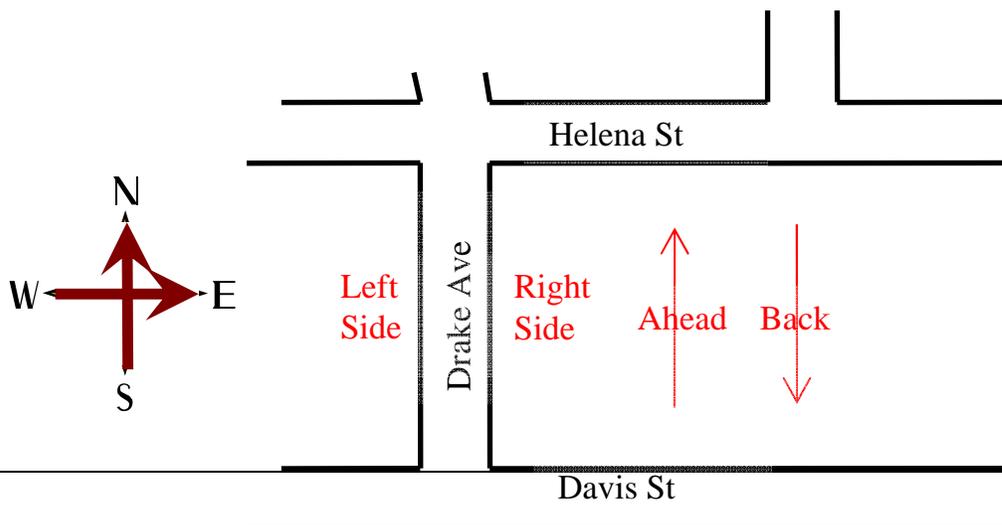
The following example (Fig 40) shows the segment From: Davis St To: Helena St.

To determine the RIGHT and LEFT side, imagine you are standing on Drake Avenue where it intersects with the From street (Davis) looking toward the To street (Helena). The RIGHT side is to your right, and LEFT side to your left.

If you start rating Drake Ave at the From street (Davis) proceeding toward the To street (Helena), then you would be working in the AHEAD direction. If you start from the To street (Helena) and proceed toward Davis, then you would be working in the back direction. The Walk Side stays the same regardless if you rate it in the ahead or back direction.

Figure 29: Ahead/Back Direction and Left/Right Side Example

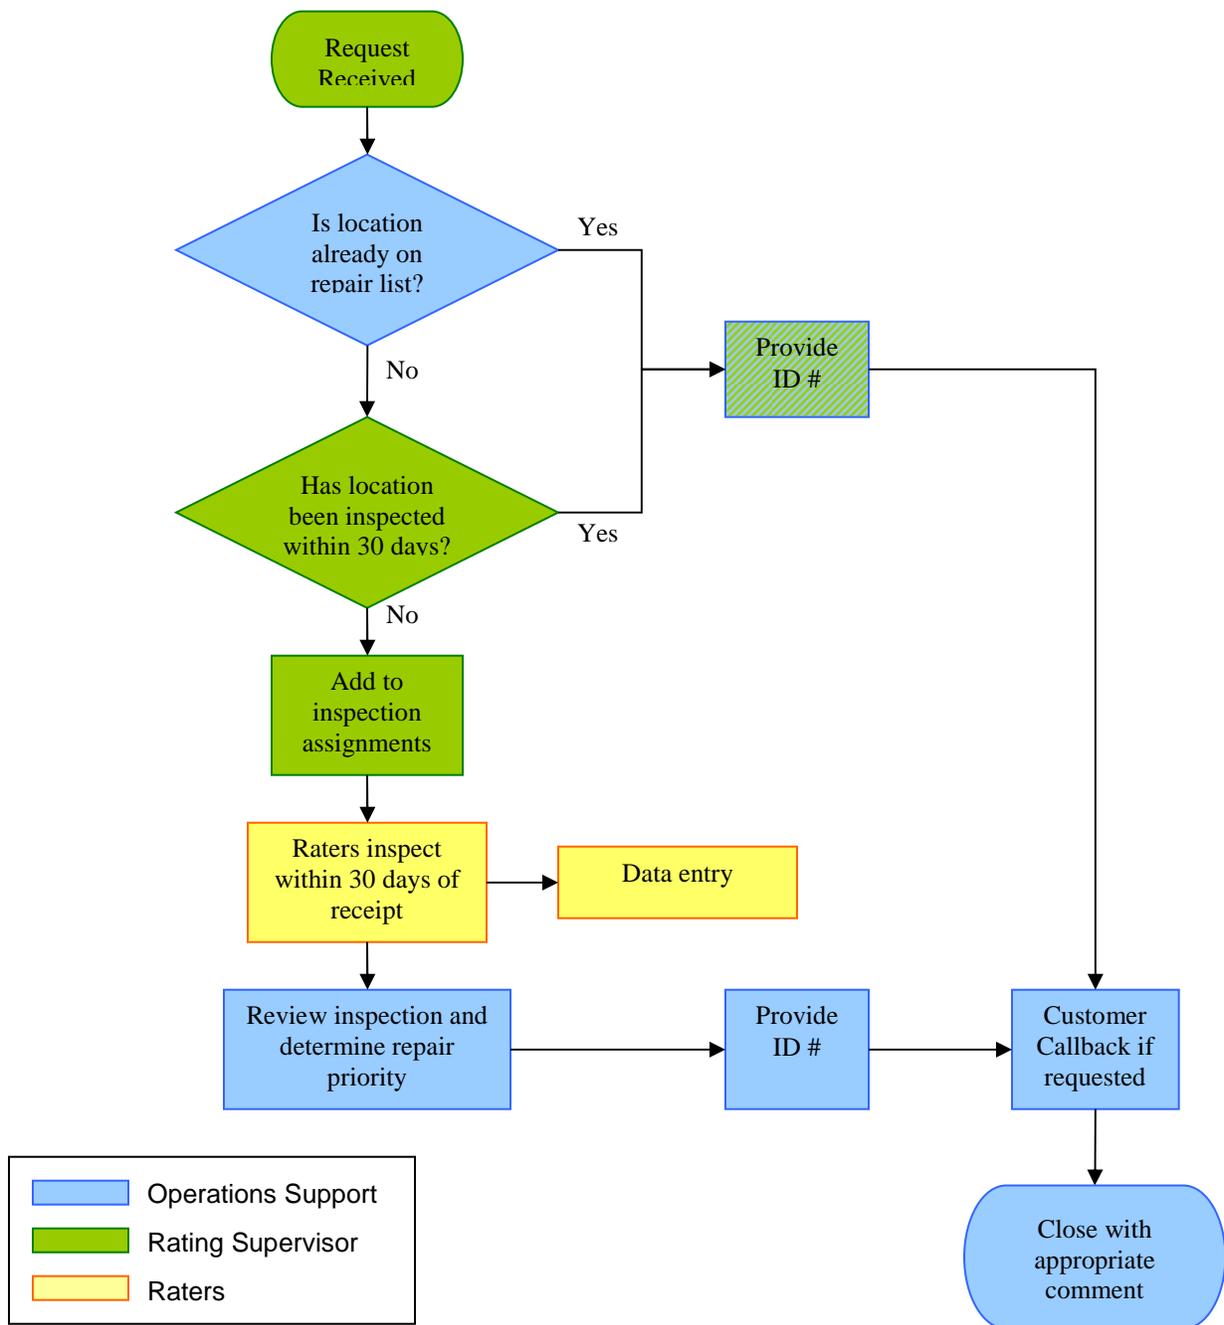
Figure 31: Service Request Procedure
Service Request Set-Up on PDF Maps

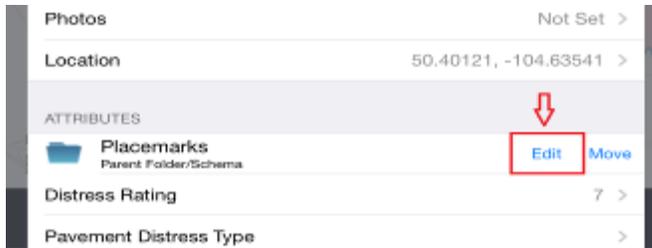
- Upon loading the SR layer, drop a pin in an arbitrary location
- Open this pin and click "Edit"

- In the "Edit" section, create 5 new attributes
- These attributes include:
 1. Comments: For the inspector's findings to describe what the problem area is like. For example the approximate size of a ponding issue.
 2. Pavement Distress Type: Choose from Cracking(CR), Drainage(DR), Ravelling(RA) and Ride(RI)
 3. Pavement Rating: Using the scale provided determine the severity of this location
 4. Sidewalk Distress Type: Choose from Excessive Cross Slope(ECS), Poor Drainage(PD), Spalling(SP) and Trip Hazard(TH)
 5. Sidewalk Rating: Using the scale provided determine the severity of this location
 6. Service Request Number: The provided SR number for the task
 7. Vertical Displacement: The height of a trip hazard or any other vertical displacement

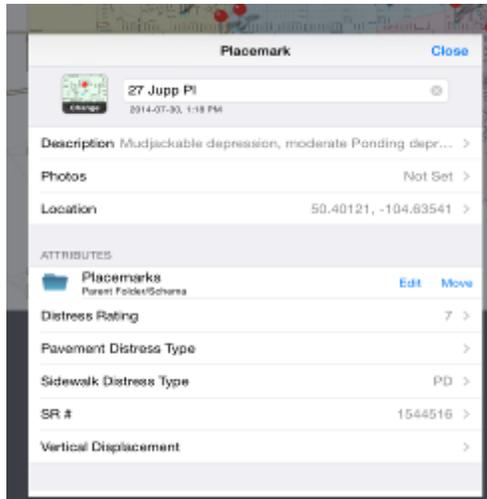
- Upon setting up this layout the arbitrary pin can be deleted and you can begin normal service requests
