New Indoor Aquatics Facility Feasibility Study

City of Regina

City of Regina Lawson Aquatic Centre

Building Suitability and Existing Condition Assessment
April 25, 2022

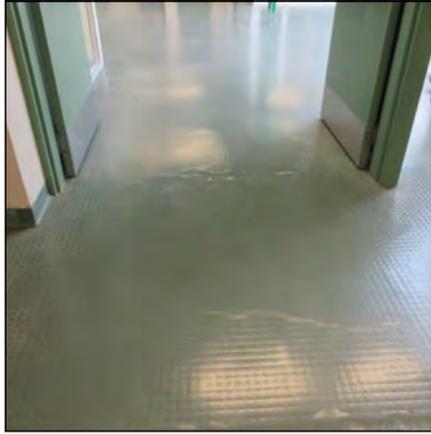
Figure 3.5.1 Entry Resilient Flooring

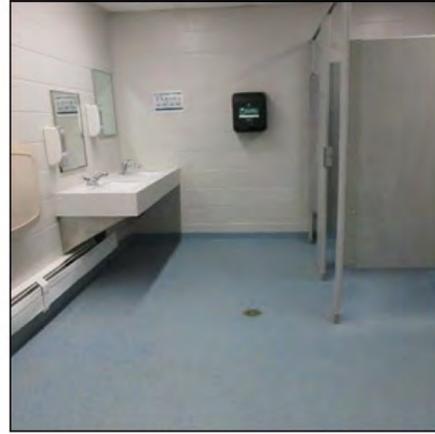
Figure 3.5.4 Men's Public Restroom

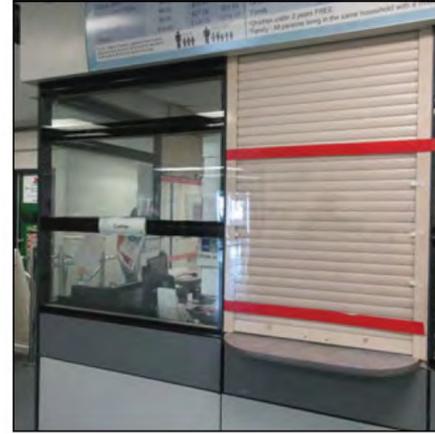
Figure 3.5.9 Reception

A3	Reception Desk	Demountable walls were added to enclose the reception desk. The carpet tile is past its life expectancy. The acoustic ceiling tile is damaged, stained and has reached the end of its life expectancy. There is unprotected wiring and cables penetrating the ceiling tiles. Recessed light covers are missing covers in various locations. The desk is not welcoming or accessible.	P - F	E - 36 Years (1985)		Carpet tile should be replaced. Acoustic ceiling tile should be replaced and any water damaged should be further reviewed. All exposed wiring and cabling is to be re-routed and concealed. The desk is not welcoming and should be reconsidered for accessibility and inclusivity.	\$ 30,000.00		
A4	Offices	Carpet tile has been damaged and has started to delaminate. Acoustic ceiling tiles are stained and damaged. Unprotected wiring and cables penetrate ceiling tiles at various locations. Recessed light covers are missing covers in various locations. Offices are not accessible on the mezzanine, hardware is not accessible.	P - F			Carpet tile should be replaced. Acoustic ceiling tile should be replaced and any water damaged should be further reviewed. All exposed wiring and cabling is to be re-routed and concealed. Access to offices is not accessible. Offices should be redesigned and renovated to suit accessibility standards	\$ 11,000.00		\$ 120,000.00

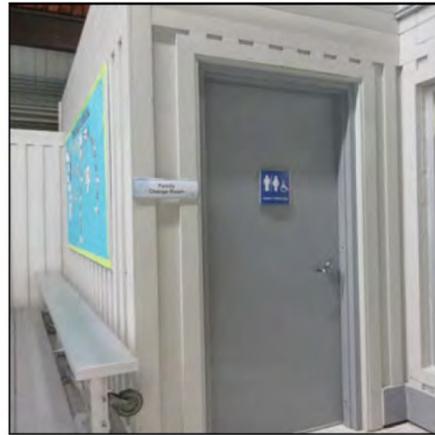
Figure 3.5.6 Family Change room

A5	Change Rooms	There appears to be water infiltration behind resilient flooring in the shower and washrooms. Further investigation is required to determine the source of the water. Resilient flooring also has various locations of staining and discoloration which has become a maintenance issue. Grout for the wall tile is stained and has started to erode. Acoustic ceiling tile has some damage and staining. The finish on the ceiling diffusers has begun to rust and erode. Locker rooms are not best practice for inclusivity.	F	A - 5 years (2016)		Resilient flooring will need to be replaced in about 2-5 years. The walls need to be refinished and painted in about 2 years. Acoustic ceiling tile will need to be replaced in about 2-5 years. Lockers and toilet partitions need to be replaced in about 5-10 years. Wall tile will need to be regouted in about 2-5 years. Ceiling diffusers are to be refinished or replaced, however, the entire building and strategy to meet inclusivity would require extensive renovations. .	\$ 250,000.00	\$ 50,000.00	\$ 500,000.00

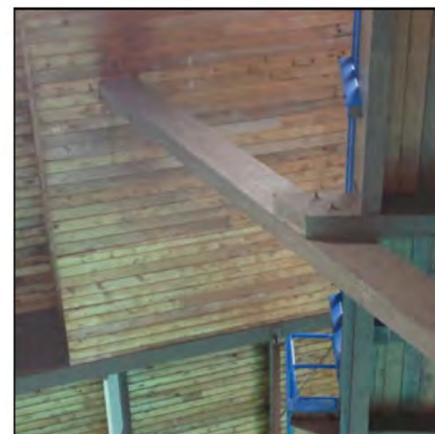
Figure 3.5.30 Diving Tower Ceiling

A14	Boiler Room	Concrete floor and finish is in poor condition and needs to be replaced to eliminate water penetration and spalling.	F	E - 47 Years (1974)	Floor finish is to be replaced to protect concrete from further erosion. There are various wall penetrations that need to be repaired.		\$ 3,000.00	
A15	Pool Storage	Acoustic ceiling tile is damaged in various locations. Demisable wall is beyond the life expectancy.	F	E - 47 Years (1974)	Acoustic ceiling tile is to be replaced in about 2-5 years. Demisable wall is to be replaced in about 2-5 years.		\$ 2,000.00	
A16	General Storage	Stainless steel door has started to rust and needs to be refinished. Stainless steel louver is in good condition.	F	A - 5 years (2016)	Stainless steel door is to be refinished to eliminate further erosion.		\$ 1,200.00	
A17	Diving Tower	Resilient flooring has various locations of staining and discolouration which has become a maintenance issue. Diving platform retains dirt and debris which has become a maintenance issue.	F	A - 5 years (2016)	Resilient flooring is to be replaced in about 2-5 years. Diving platform is to be replaced in 6+ years.		\$ 5,000.00	\$ 55,000.00

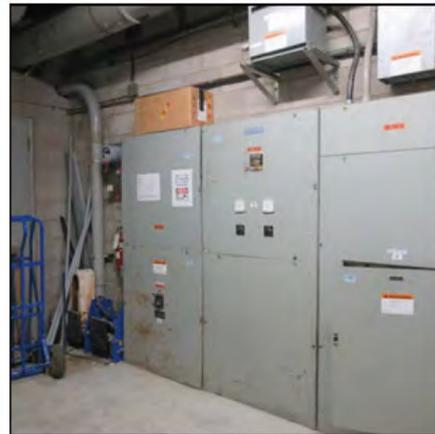
Figure 3.5.39 Electrical Room

A12	Electrical Room	Concrete floor and finish is in poor condition and needs to be replaced to eliminate water penetration and spalling.	F	E - 47 Years (1974)	Floor finish is to be replaced to protect concrete from further erosion. There are various wall penetrations that need to be repaired.		\$ 5,000.00	
A13	Filter Room	Concrete filter tank finish has eroded causing water infiltration and spalling. Concrete floor and finish is in poor condition and needs to be replaced to eliminate water penetration and spalling. Steel grates are rusting and require refinishing.	F	E - 47 Years (1974)	Concrete filter tank needs to be refinished to eliminate further damage and spalling. Floor finish is to be replaced to protect concrete from further erosion. Steel grates are to be refinished to eliminate further erosion. There are various wall penetrations that need to be repaired. Rigid gate is to be provided at filter tank opening.		\$ 25,000.00

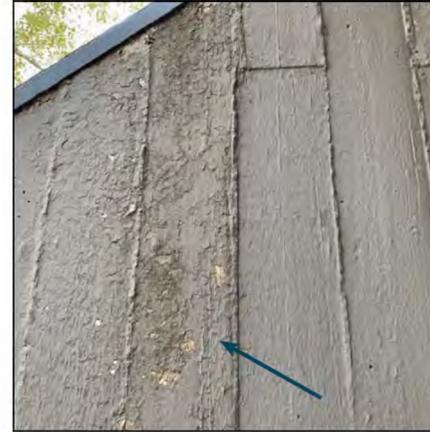
Figure 4.4.1 Peeling Paint, Concrete Buttress

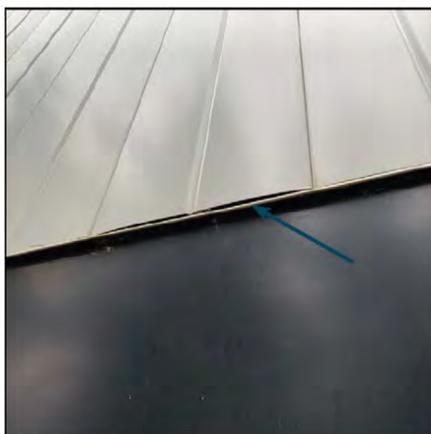
Figure 4.4.13 Separation of Metal Cladding From Wall

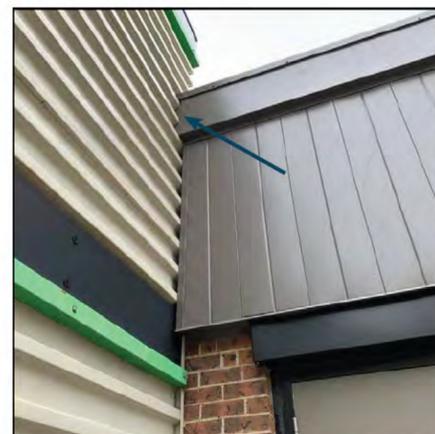
Figure 4.4.21 Cladding Cut to Form Around Linking Building Cladding, East Elevation

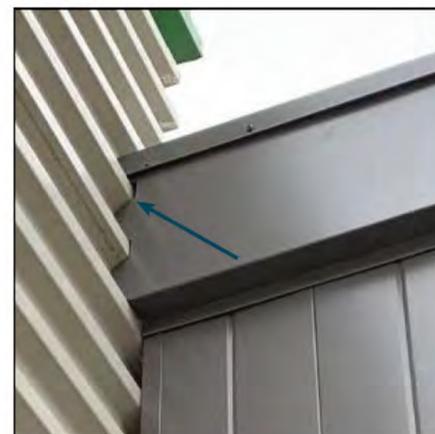
Figure 4.4.22 Gaps at Cladding Interface, East Elevation

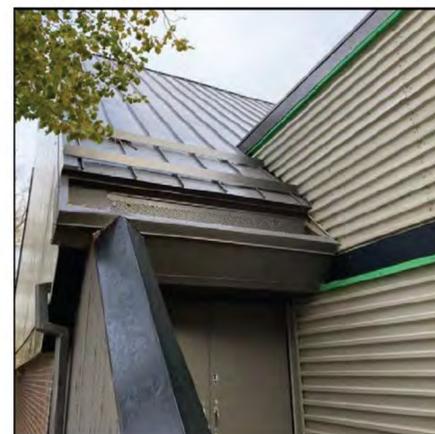
Figure 4.4.23 Wall and Roof Interface, West Elevation

- An evaluation and related repairs of the west wall in relation to the issues that were reported. As the scope is unknown without intrusive testing and in-depth evaluation, a preliminary budget of \$115,000 has been included within the next five years. It should be noted that this will not solve the overall building envelope continuity issues. Replacement and installation of the sealants throughout the building has been budgeted to occur within the next five years. We have allotted \$30,000 for replacements and installations. This budget includes replacement of sealants throughout the linking building.

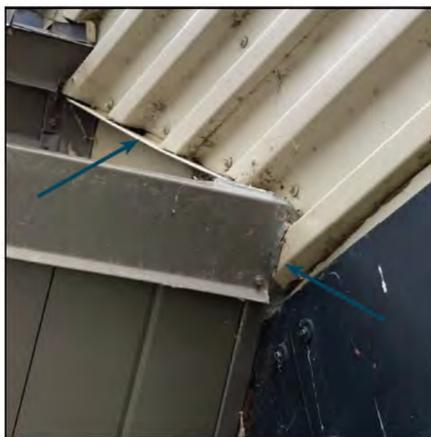
Figure 4.4.25 Interface with Gaps and Poor Sealants, West Elevation

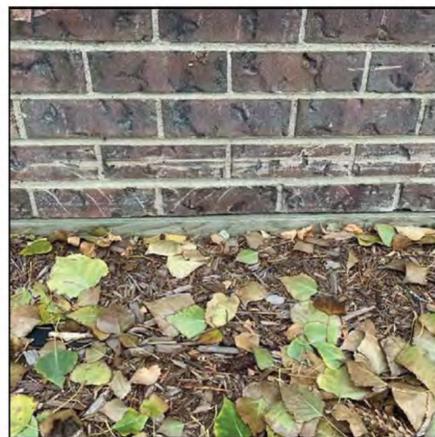
Figure 4.4.26 Wood at Base of Brick Veneer, West Elevation

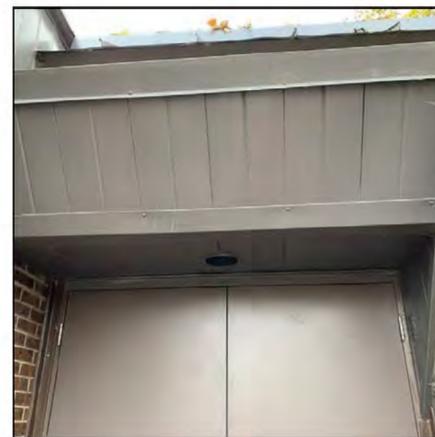
Figure 4.4.33 Soffit Over Doors

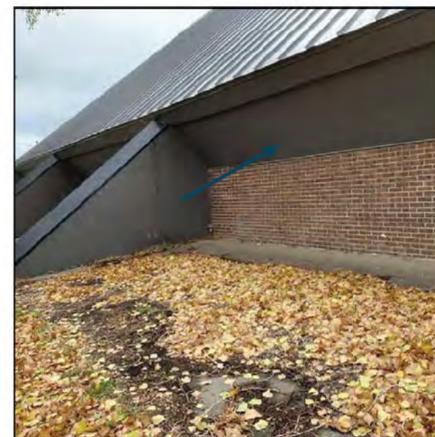
Figure 4.4.34 Sloped Soffit

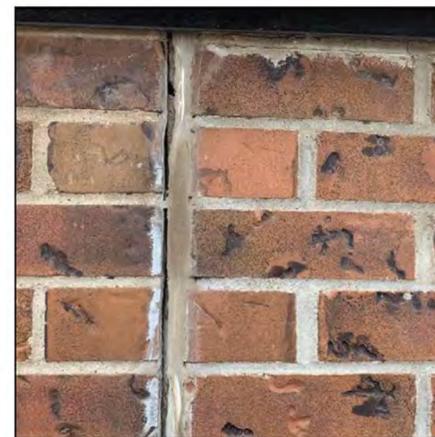
Figure 4.4.36 Split Sealant at Brick Control Joint

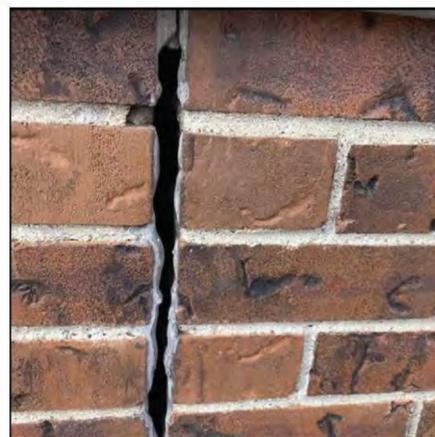
Figure 4.4.31 Control Joint at Brick Veneer

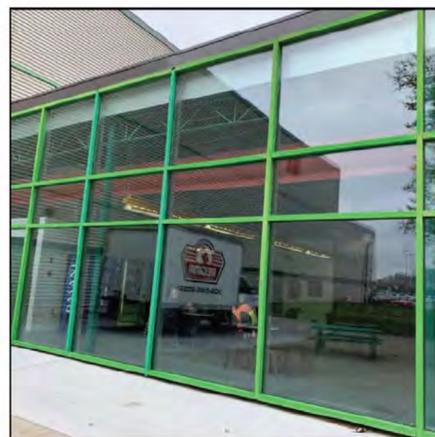
Figure 4.4.32 Curtain Wall Assembly, Linking Building

- A refurbishment project for the curtain walls located at the linking building has been budgeted to occur near the end of the report term. We have allotted \$74,000 for a refurbishment project.
- Replacement of some service doors has been budgeted to occur near the end of the study period. We have allotted \$24,000 for replacements.
- Replacement of the EPDM membrane low-sloped roofing assemblies has been budgeted to occur near the end of the study period. We have also included a budget to complete localized repairs prior to the full replacement project.

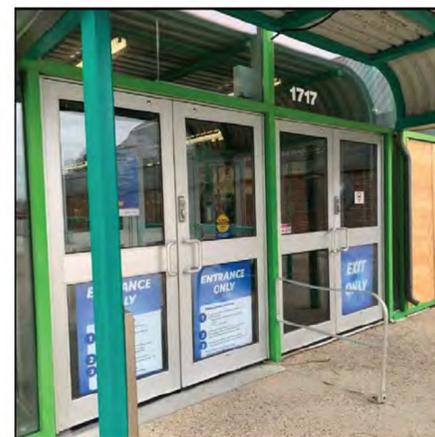
Figure 4.4.40 Main Entrance Doors, Linking Building

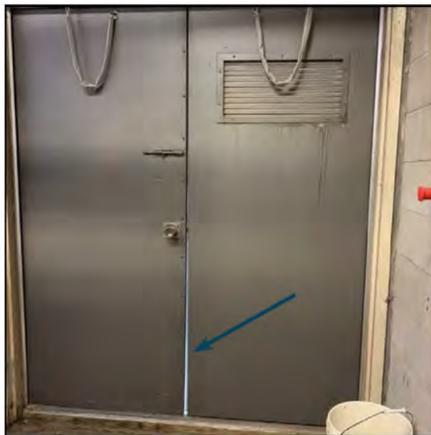
Figure 4.4.41 Gaps at Service Doors

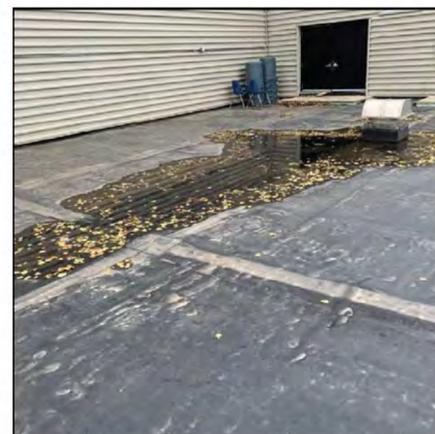
Figure 4.4.53 Ponding at EPDM Membrane Roofing, Linking Building

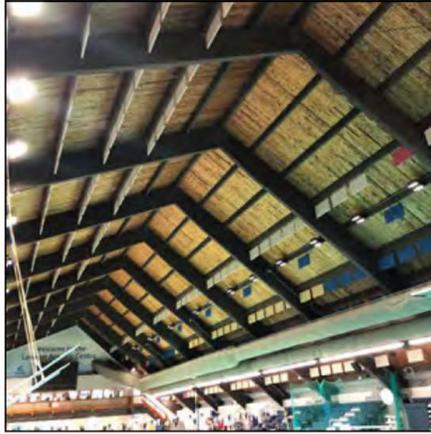
Observations to the main wood framed superstructure were taken from the pool deck area and the upper mechanical room above the mezzanine level. Minor water staining on the underside of the wood roof decking was

noted, which appears to be caused from condensation within the humid pool environment. This appears to only be surface staining which we anticipate has not compromised the structural integrity of the decking.

Figure 5.3.1 Roof Structure

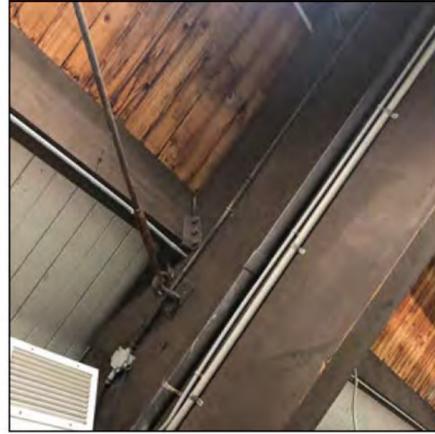
The primary glulam frames and purlins appear to be in good condition. In the areas observed, the glued laminations did not display any signs of delamination or material degradation due to moisture ingress. The steel purlin connections generally appeared to be in good condition without any significant signs of corrosion or delamination of the paint coating (Figure 5.3.2). Overall, the main wood superstructure which forms the shell of the building appears to be performing adequately but would require a re-finish to renew its life.

Figure 5.3.2 Roof Purlin Connection

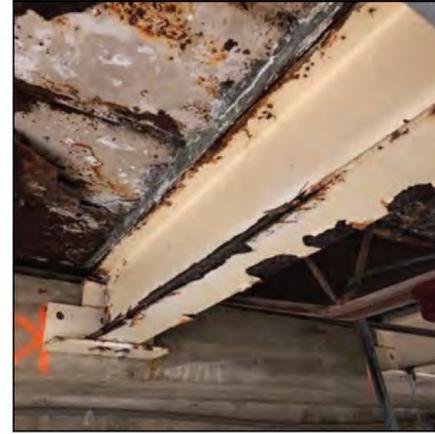
Figure 5.3.9 Steel Reinforcing Beam

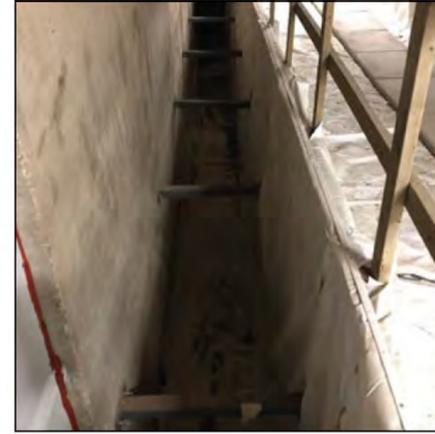
- In 1997, remedial steel reinforcement was added to the pool deck structure to address extreme corrosion in the OWSJ's and the crawlspace deepened.
- In 2017, the wood cribbing around the deep end of the pool was replaced with a structural steel and wood

lagging shoring system. This cribbing replacement project was part of a major excavation and refurbishment of the entire crawlspace to address soil failure and water infiltration.

Figure 5.3.12 New Deep End Shoring

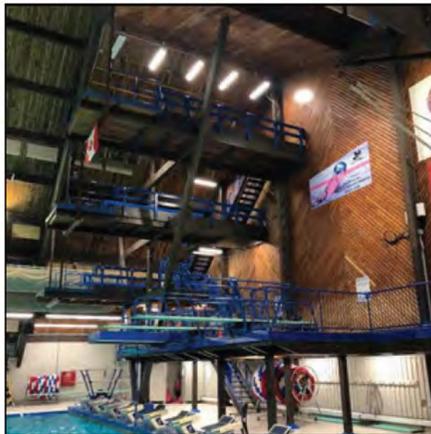
Figure 5.3.5 Diving Tower

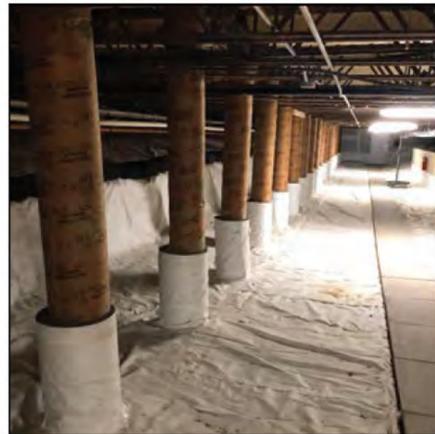
Most of our main floor observations were taken from the underside within the crawlspace area. Here we were able to observe the remedial steel reinforcement added in 1997 (Figure 5.3.6 / Figure 5.3.7) complete with the new concrete sonotube columns and support piles. This reinforcement was added to relieve floor load from the adjacent corroded steel floor joists (Figure 5.3.10). During our review we also observed mild corrosion to some of the new remedial steel beams (Figure 5.3.9) and to the connections at the concrete foundations (Figure 5.3.8). Currently the corrosion is not severe; however, we recommend that the corrosion is cleaned to bare steel and a new protective coating be applied in the near future.

Figure 5.3.6 Main Floor Reinforcing Foundations

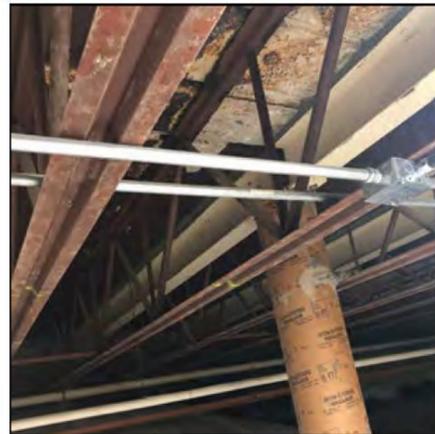
Figure 5.3.7 Main Floor Steel Reinforcing

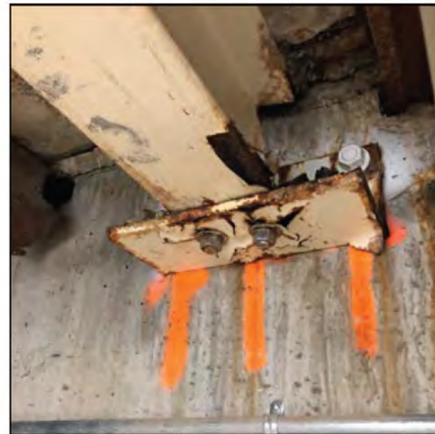
Figure 5.3.8 - Beam Connection

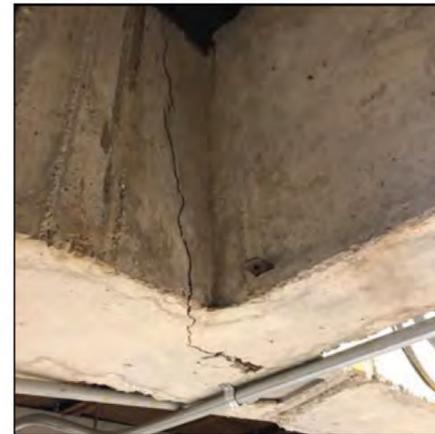
Figure 5.3.14 Concrete Floor Beam

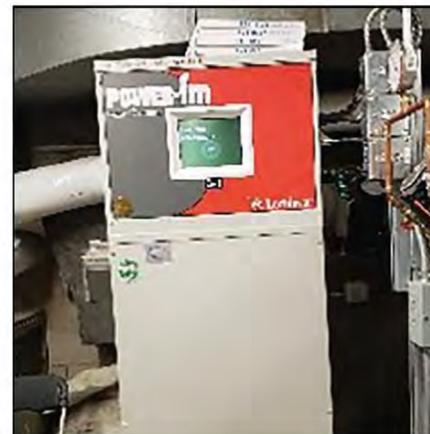
Figure 6.5.1 Lochinvar Heating Boiler

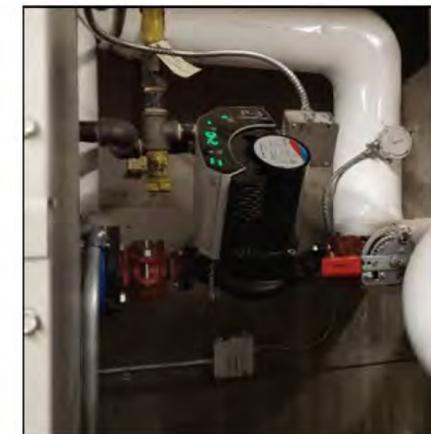
Figure 6.5.2 Boiler Circulation Pump

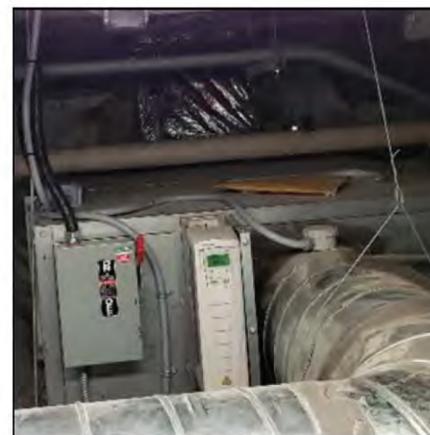
Figure 6.5.5 Crawspace Make-Up Air Ventilation Unit

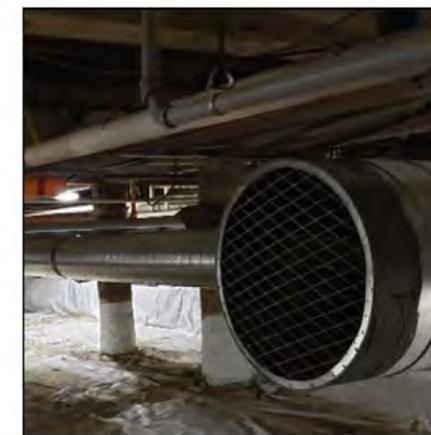
Figure 6.5.6 Crawspace Ventilation Ductwork

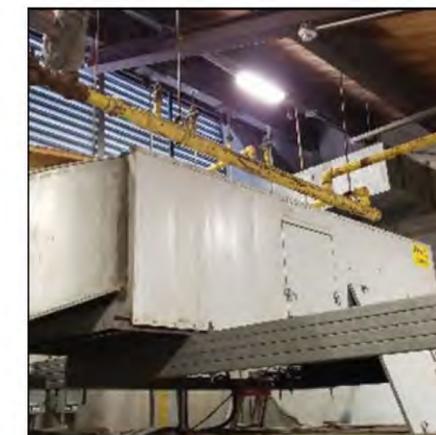
Figure 6.5.7 MUA-1 Make-Up Air Unit

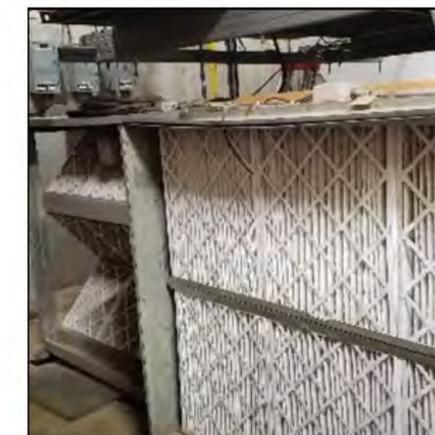
Figure 6.5.8 Pool Area Make-Up Air Units MUA-2 and MUA-3

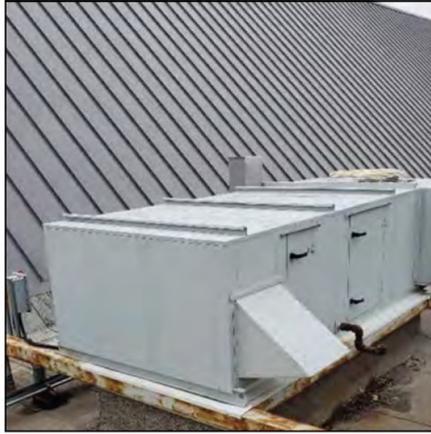
Figure 6.5.9 Roof-Top Unit Rtu-1

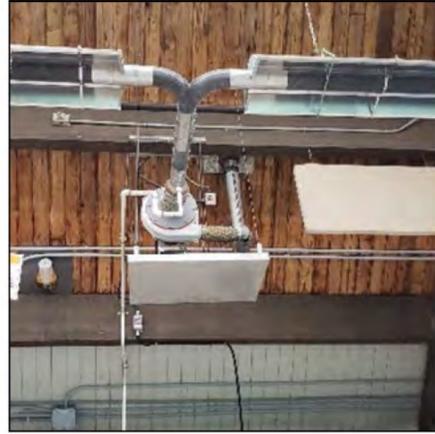
Figure 6.5.10 Pool Cell Radiant Heating System

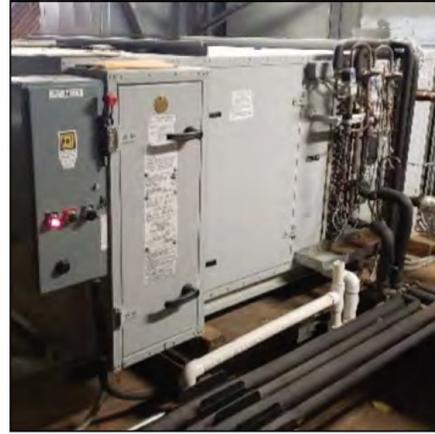
Figure 6.5.11 Fitness Area HVAC Unit

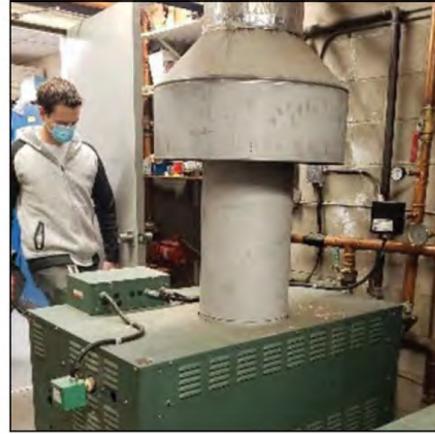
Figure 6.5.12 Domestic Hot Water Boilers

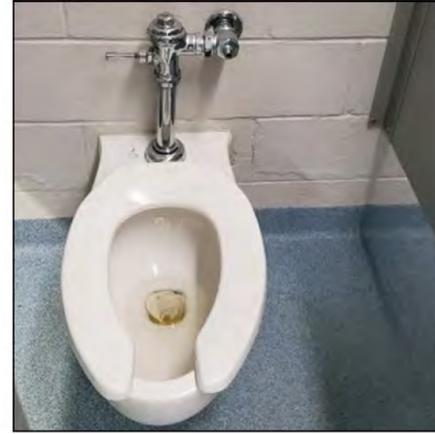
Figure 6.5.17 Water Closet with Manual Flush Valve

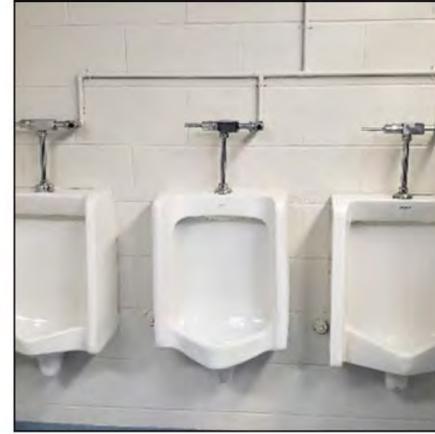
Figure 6.5.18 Urinals with Manual Flush Valves

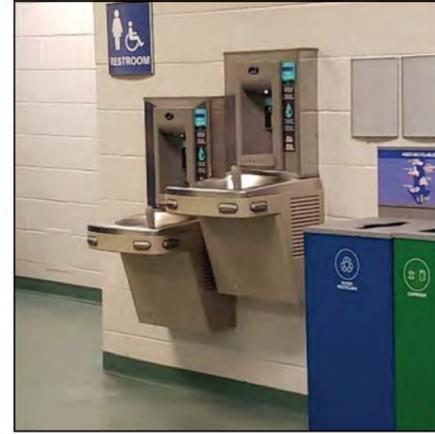
Figure 6.5.19 Drinking Fountain / Bottle Filler Units

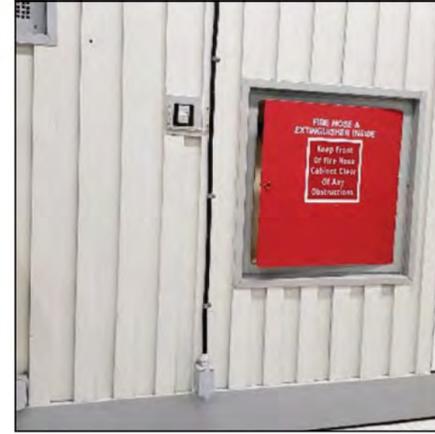
Figure 6.5.20 Firehose / Extinguisher Cabinets

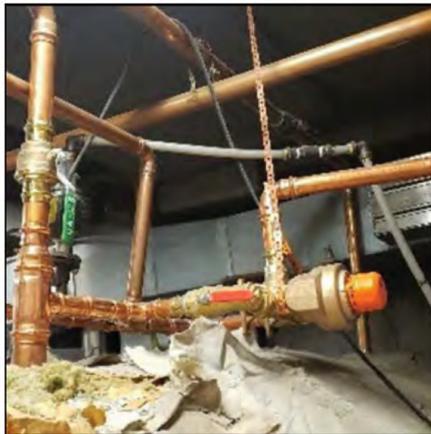
Figure 6.5.13 Domestic Hot Water Piping in Boiler Room

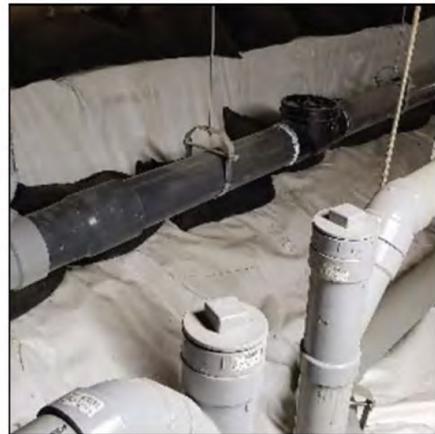
Figure 6.5.14 Crawspace Sanitary Piping

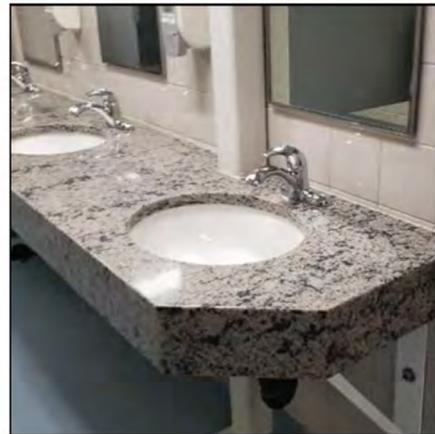
Figure 6.5.16 Lavatories With Single Lever Handles
